Ice House Log Hazards

April 25, 2026

Documented By Jeff Wasielewski

Introduction

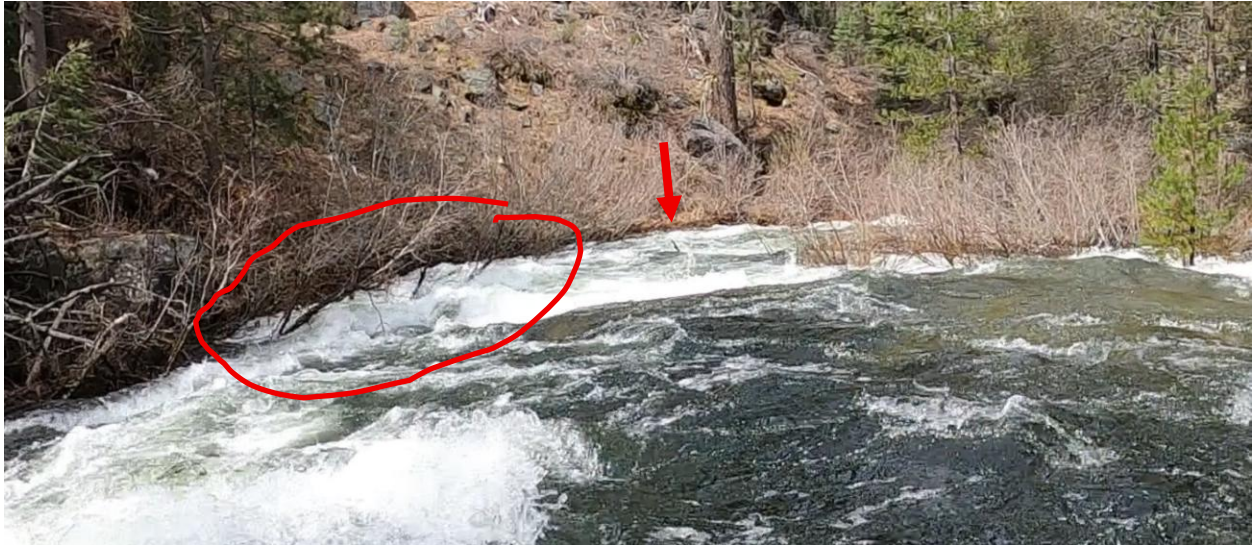
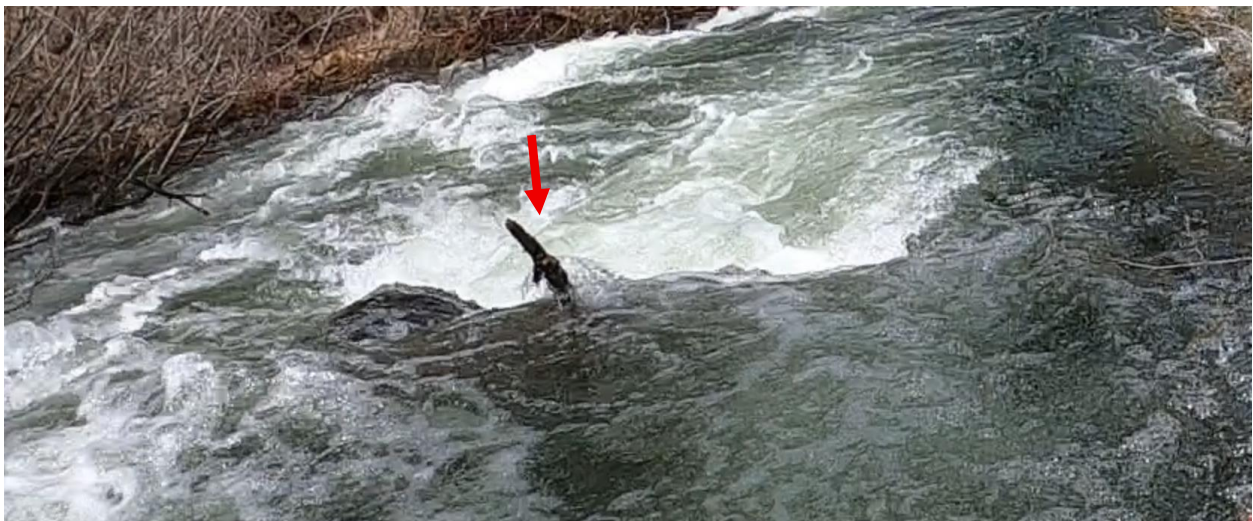
Log 1

This is at the first right turn below the Ice House Road Bridge put in. It is easily accessible for remediation, so I included it in this document. The brush on the left has caused problems in the past. In addition, there is a new branch, possibly attached to a log in the middle of the current (see red arrow). The branch is pointed upstream and on the 4/25/26 trip a hardshell kayak got stuck against it.

4/25/26 at 460 cfs

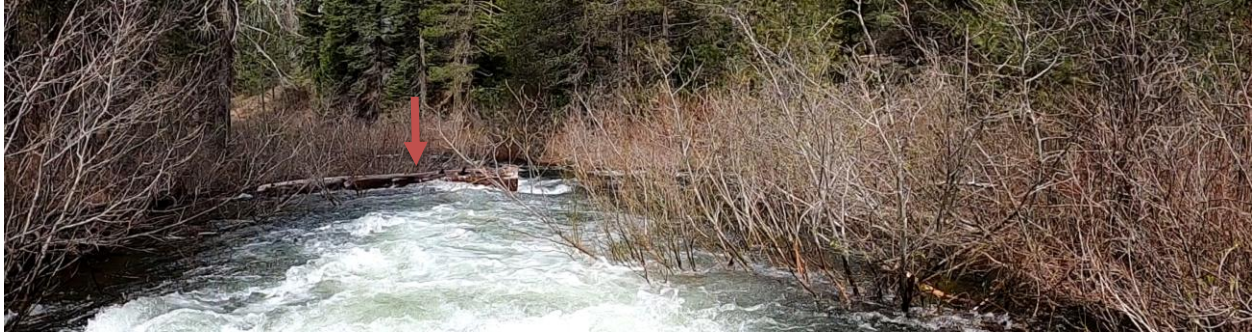
Log 2

This log is not a significant hazard, except to a swimmer.

4/25/26 at 460 cfs

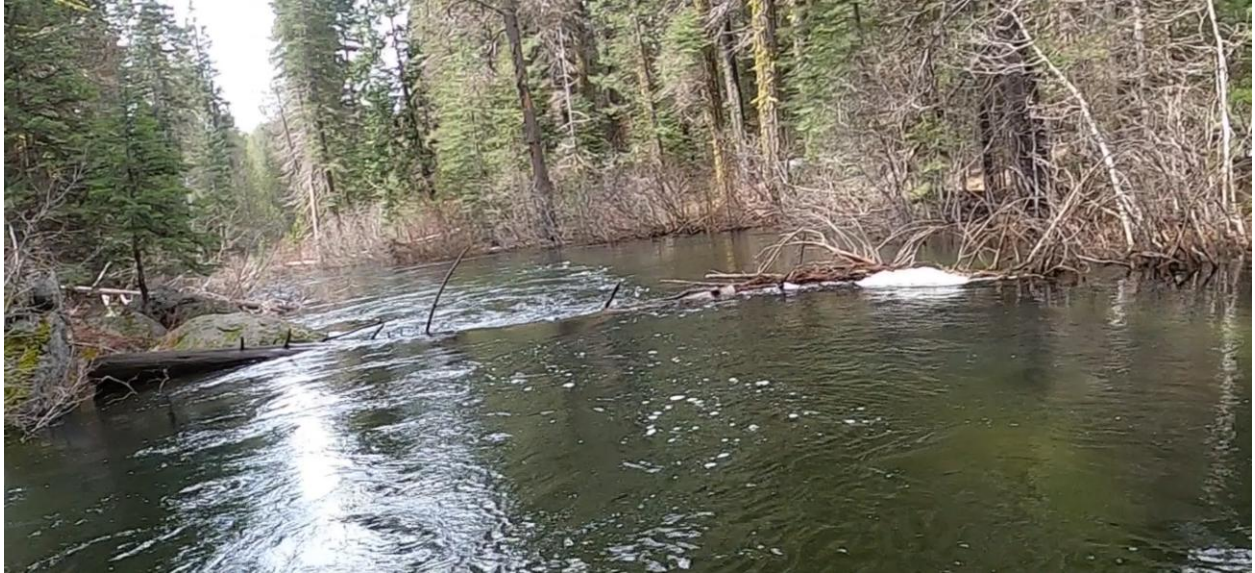
Log 3

This log had already been cut, and we were able to remove a center piece. However, there appears to be a second log underneath it.

4/25/26 at 460 cfs

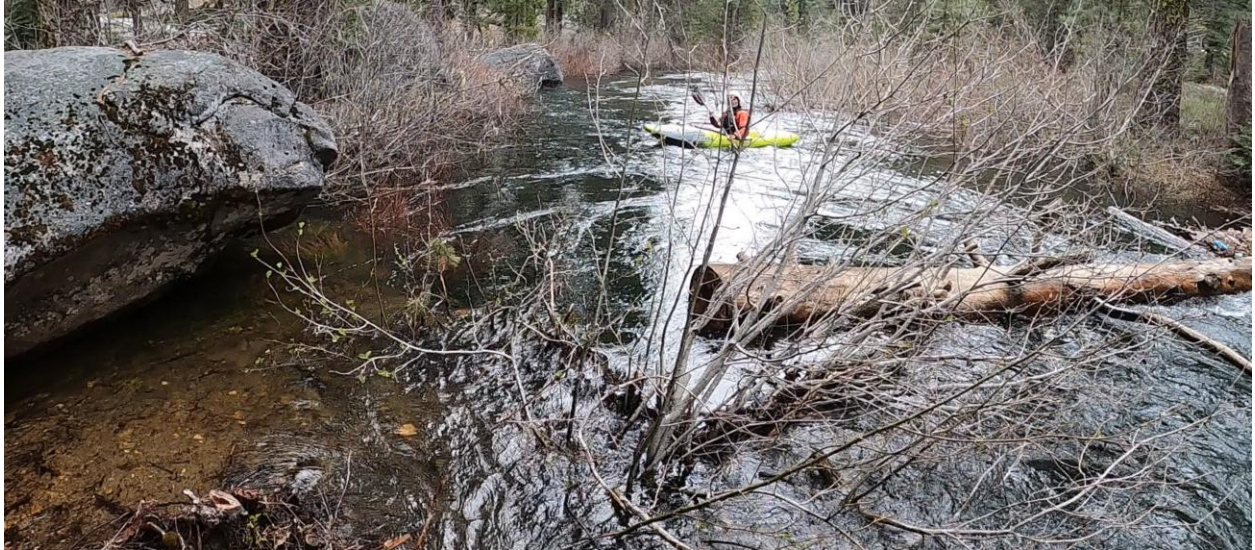
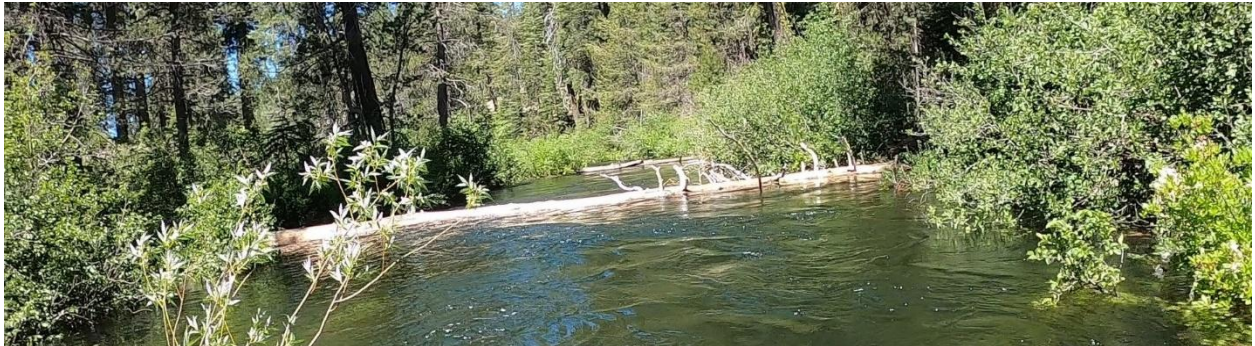
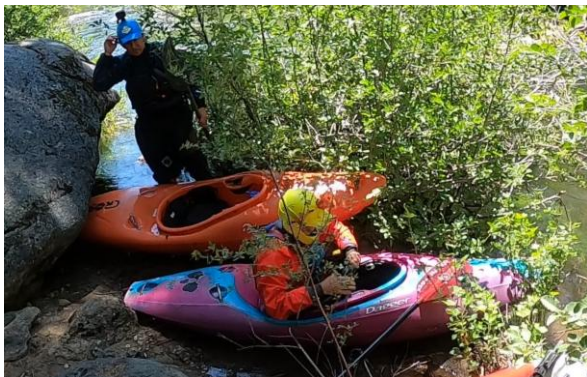
Log 4

This log is much easier to get around due to work performed in 2025 by Dustin Bell and his USFS crew. There is now a shallow channel around the right side of the log that kayakers can go through.

4/25/26 at 460 cfs

6/28/25 at 410 cfs.

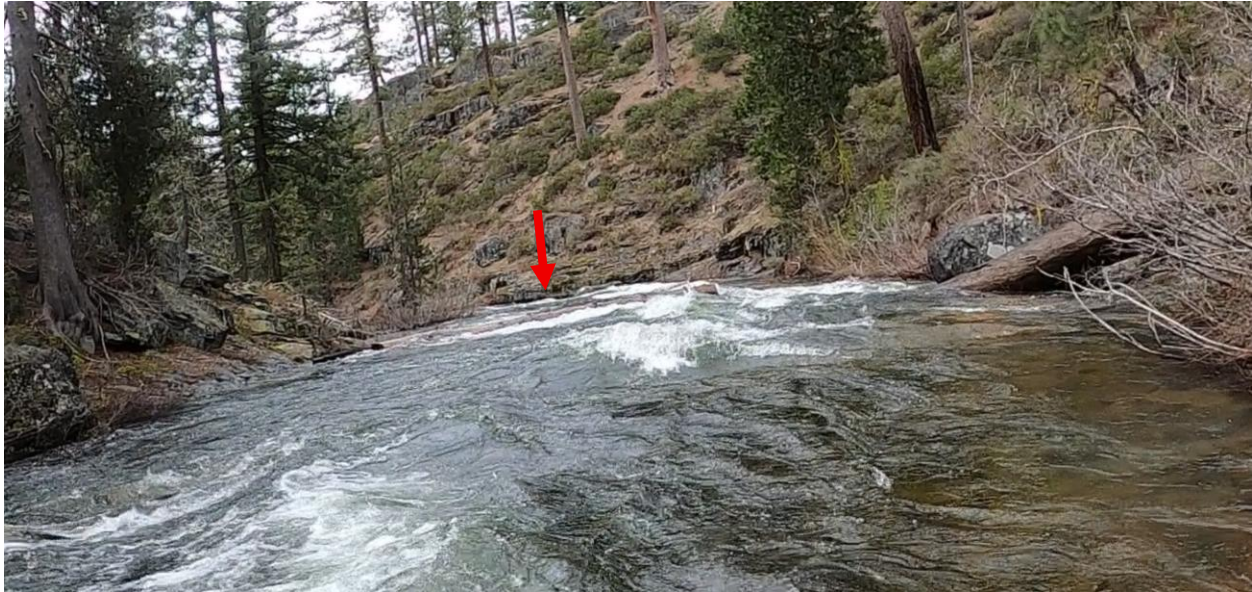
Log 5

This is a new log and is in the most hazardous log on the run. Boats can go around it on the right. It is located 400' above the right turn that starts Triple Drop Rapid, so care will need to be cut in no longer than 4' lengths to reduce the chance of it becoming a hazard in Triple Drop.

4/25/26 at 460 cfs

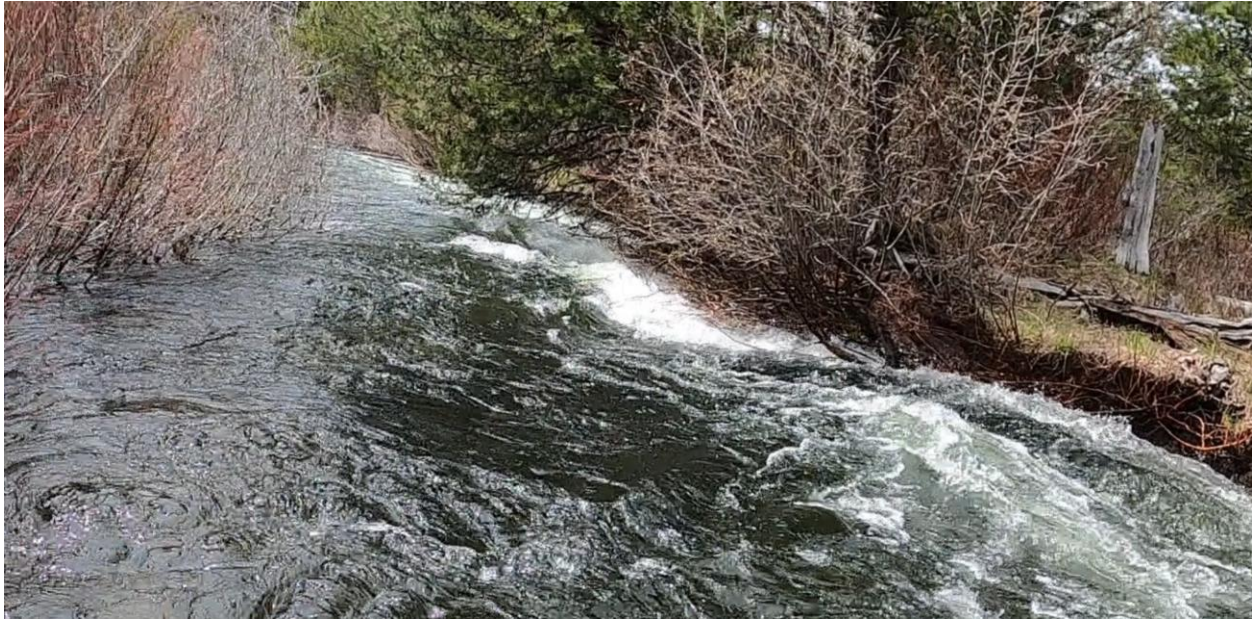
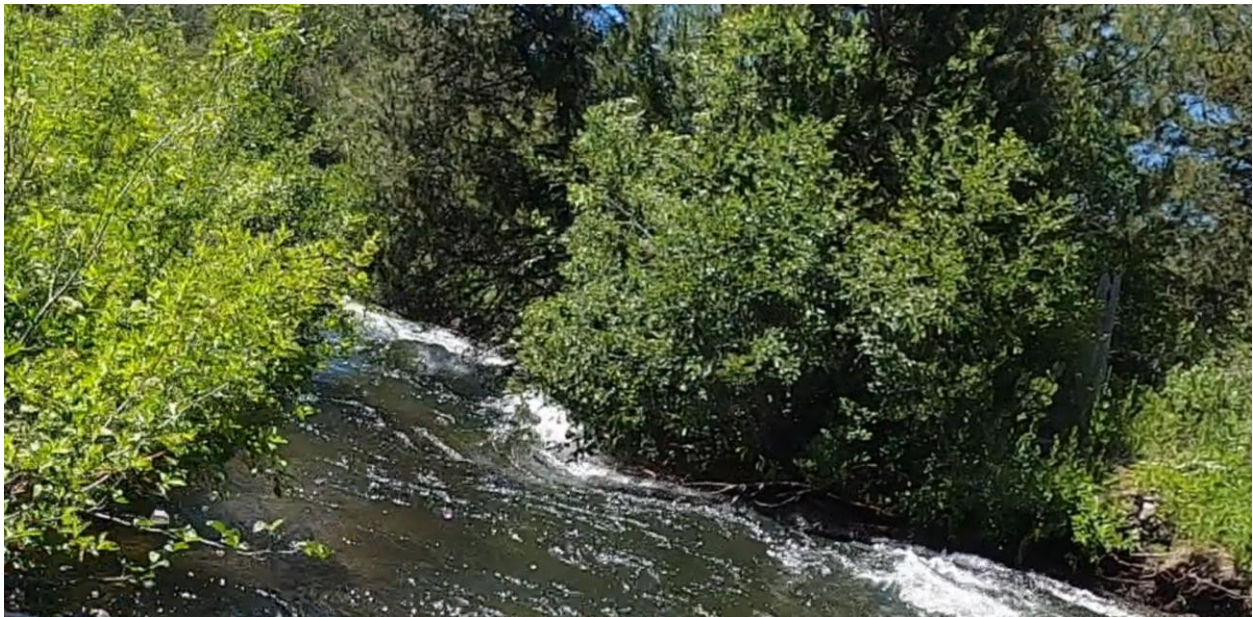
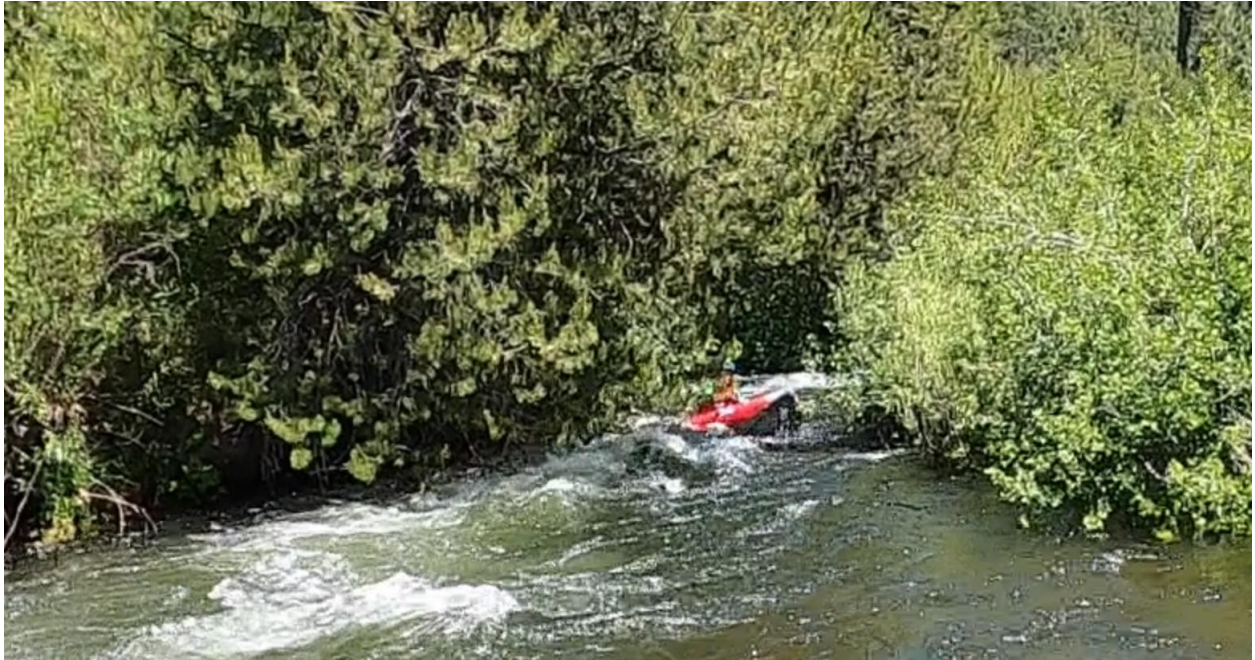
Log 6

Not a log but brush and tree branches that extend into the river channel in fast moving water around a blind turn. These branches can knock kayakers and rafters out of their boat. On my 6/14/25 trip a hardshell kayaker in my group did not successfully avoid the branches. He momentarily hung on to the branches, releasing his paddle. He then flipped and exited his kayak. I am hoping that I can stop there during one of the June 2026 recreational releases to remove some of the branches.

4/25/26 at 460 cfs

6/14/25 at 510 cfs (looking downstream)

6/14/25 at 510 cfs (looking upstream)
