A Cataract Canyon Take-out

History, current issues, and factors that may influence and inform a safer, more reliable, and long term solution.

Returning Rapids Project
Moab, Utah

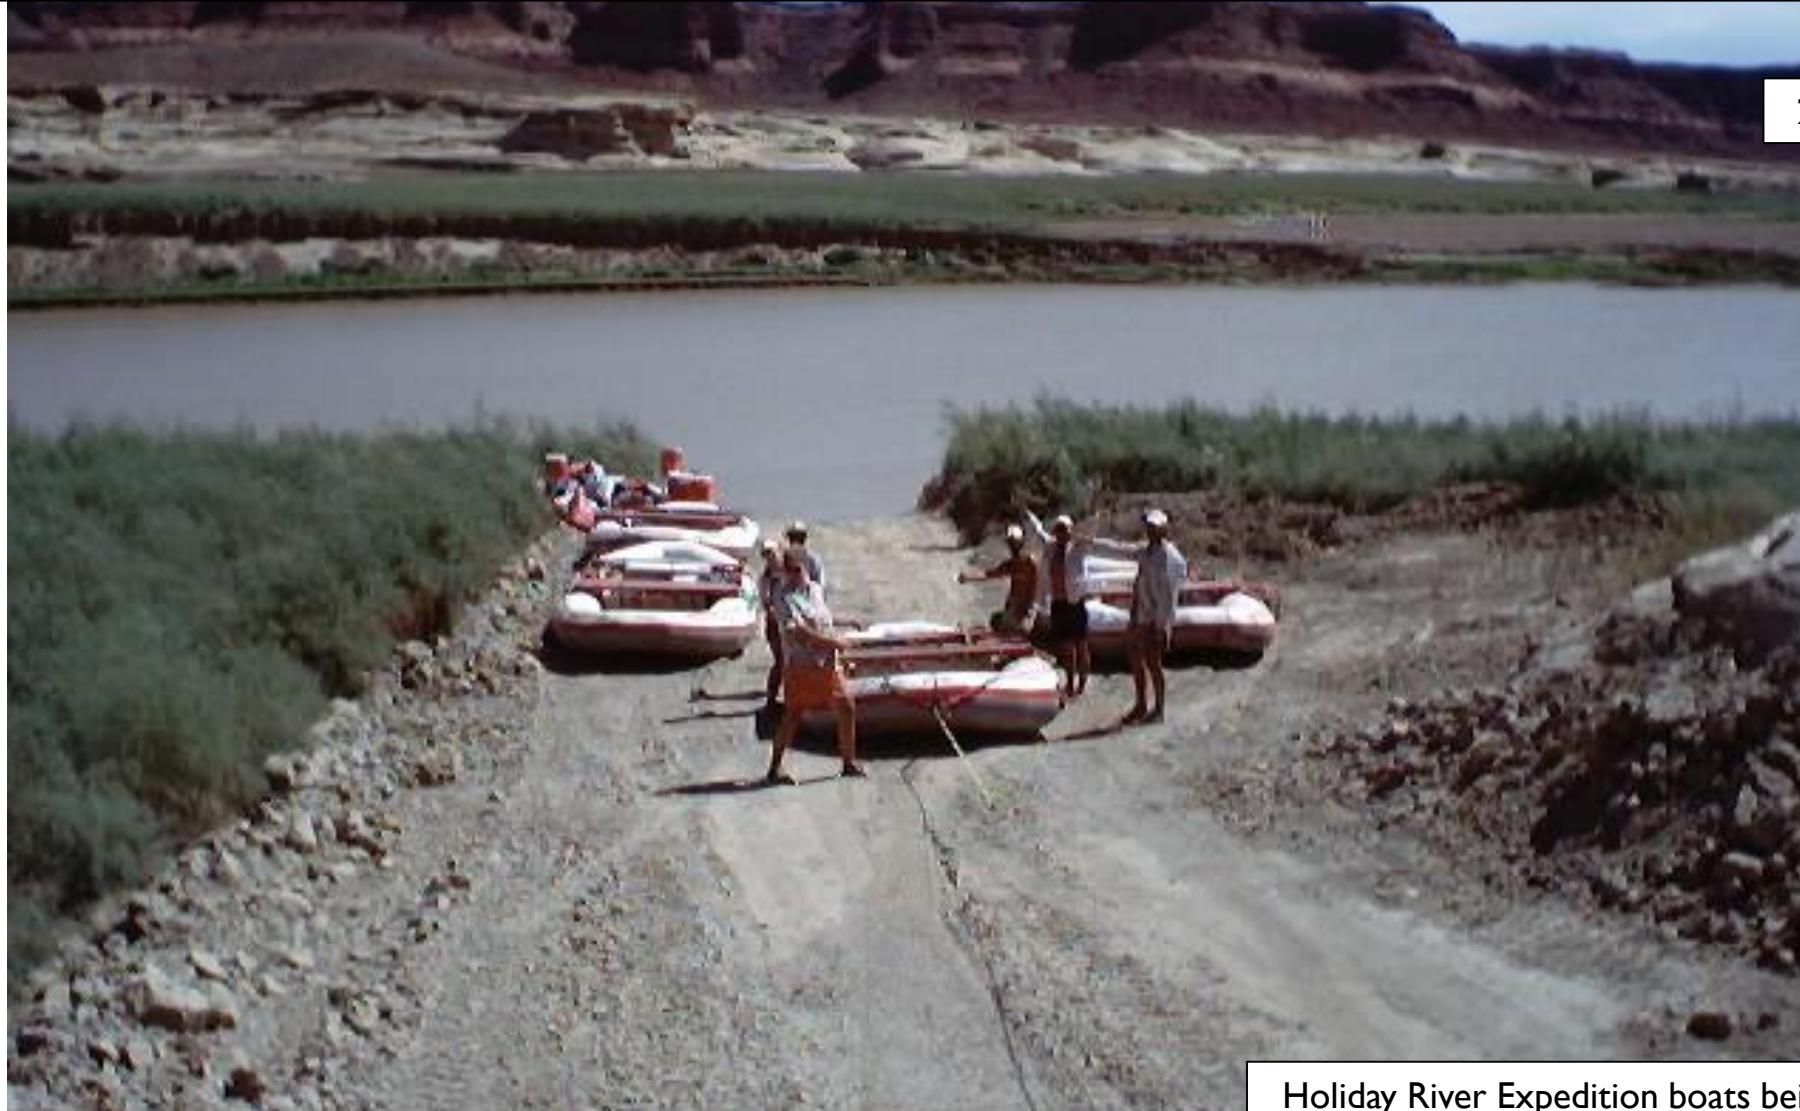
The single lane construction of the ramp made it difficult for more than one group to take boats out of the river at a time. The ramp was on the soft silt of river sediment, which made many parties not want to risk putting their vehicles/ trailer too close to the water's edge.

Holiday River Expedition boats being pulled up the single lane ramp from the water's edge
Holiday River Expeditions 2003, Tim Gaylord

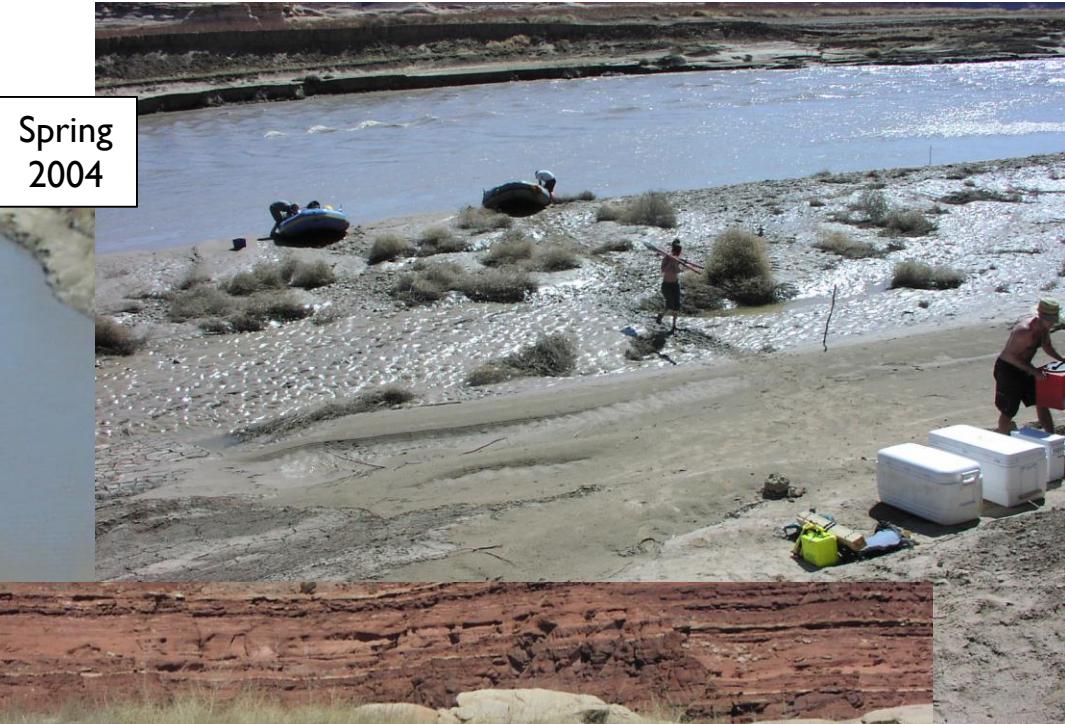
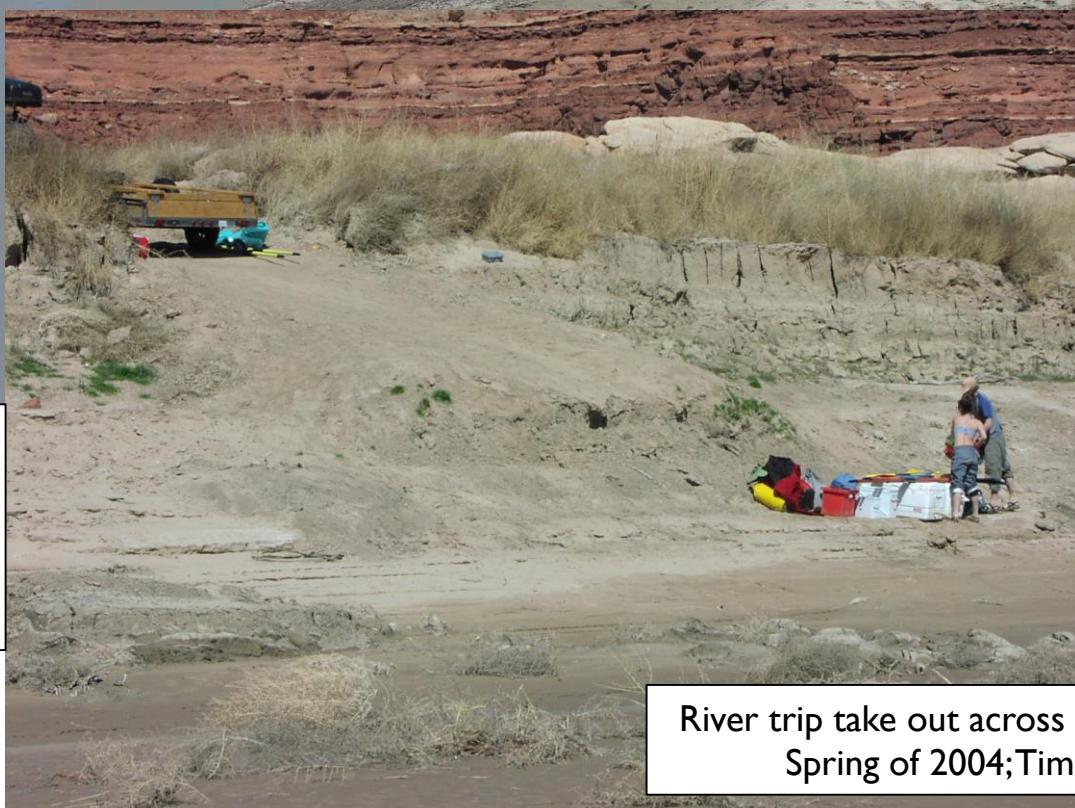
The combination of the soft lake sediments, varying river level, and mud flats at times presented groups with either a very steep ramp or cut bank.

Groups had to carry equipment across the mud bank and up the steep ramp to an area where a vehicle/ trailer could be safely backed down.

River trip take out across mud flat;
Spring of 2004; Tim Gaylord

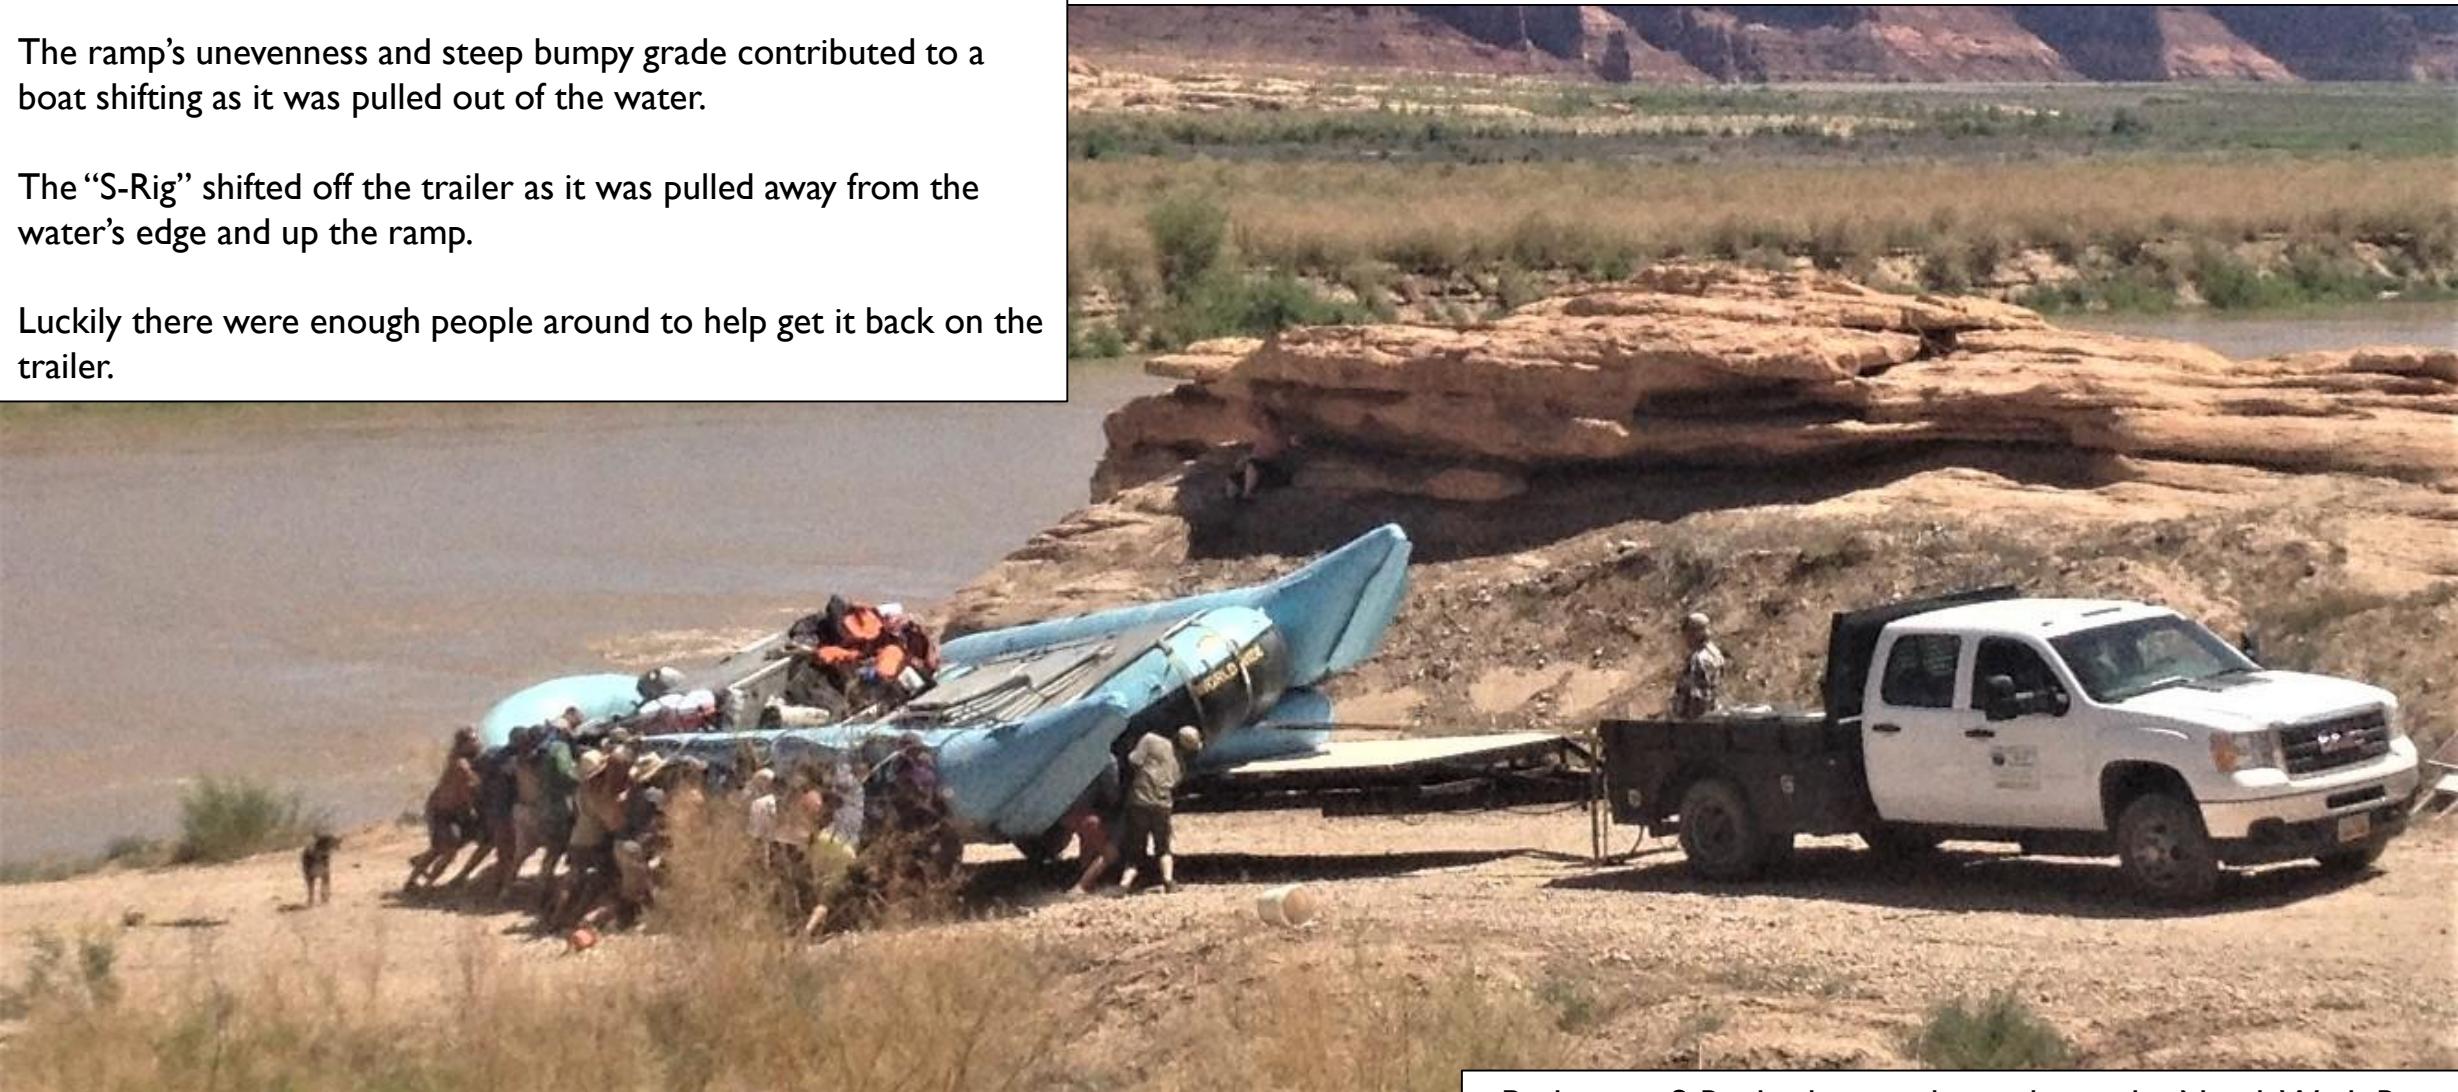
The ramp's unevenness and steep bumpy grade contributed to a boat shifting as it was pulled out of the water.

The "S-Rig" shifted off the trailer as it was pulled away from the water's edge and up the ramp.

Pushing an S-Rig back onto the trailer at the North Wash Ramp;
June 11, 2016; Peter Lefebvre

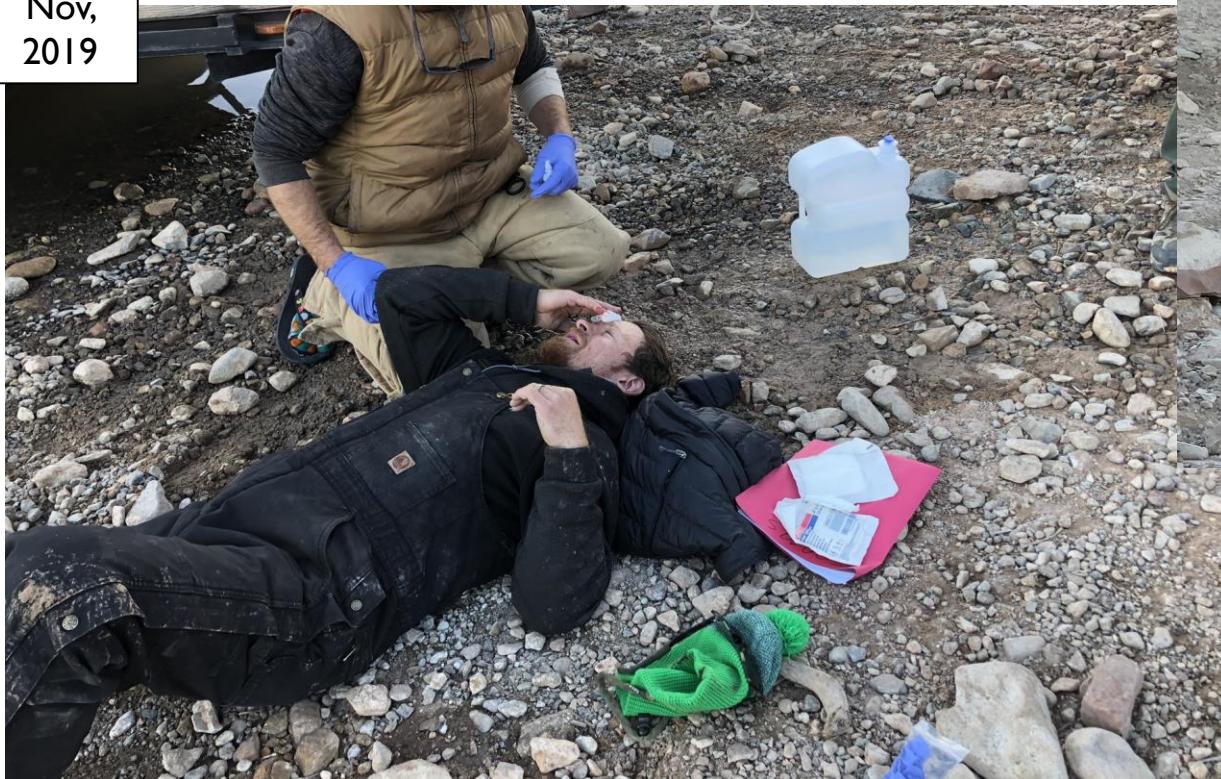
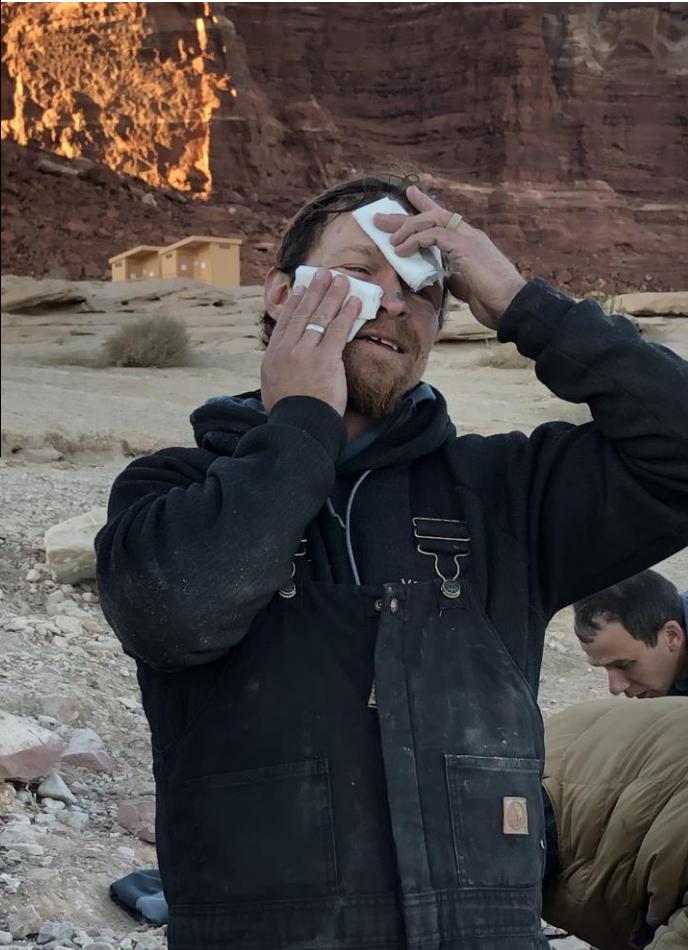
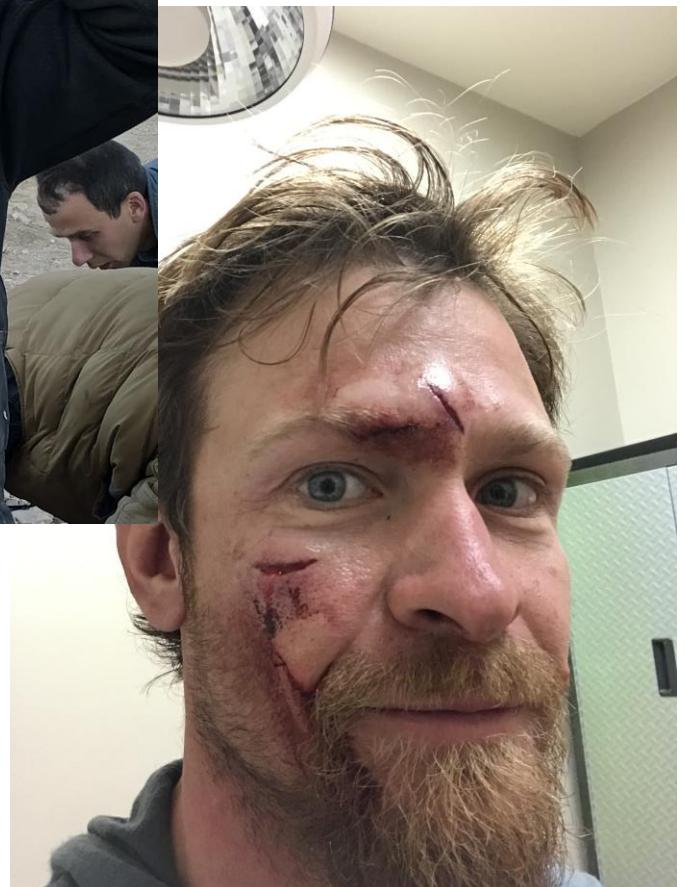
Nov,
2019

In November 2019, the condition of the ramp was such that it didn't make sense to sink a trailer, it was too steep and muddy.

While winching a zodiac style boat onto a trailer, an anchor point broke and hit the person operating the winch.

The steepness of the ramp was a contributing factor to the incident.

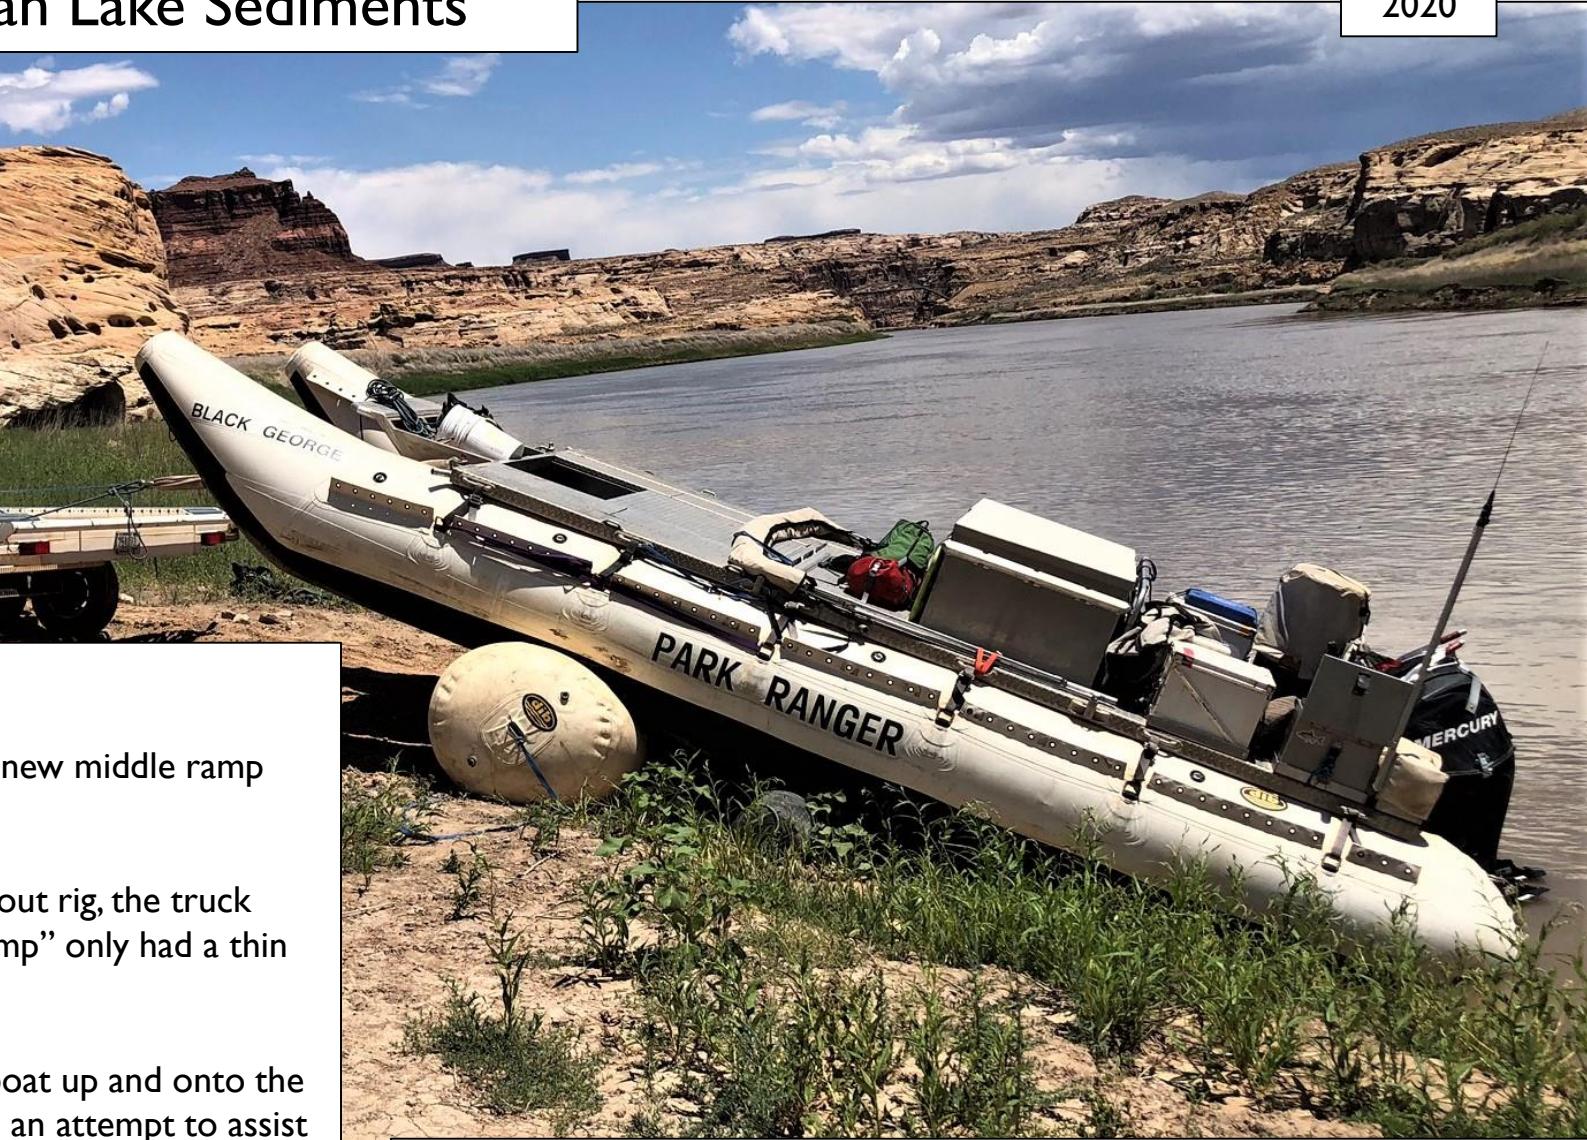
May 29, 2020

There were signs that the ramp was recently graded and a new middle ramp was established.

While pulling the trailer out of the water with the CNP snout rig, the truck became bogged down in the soft silt. (The new "middle ramp" only had a thin layer of road base over soft lake sediment.)

The crew had to resort to roller tubing and winching the boat up and onto the trailer. At one point the private parties vehicle was used in an attempt to assist pulling the truck and trailer out of the soft ramp area.

Roller tubing the Canyonlands Snout Rig; May 29, 2020; 18250 cfs
Reservoir Level at Bridge 3608, Reservoir level at Glen Canyon Dam 3604

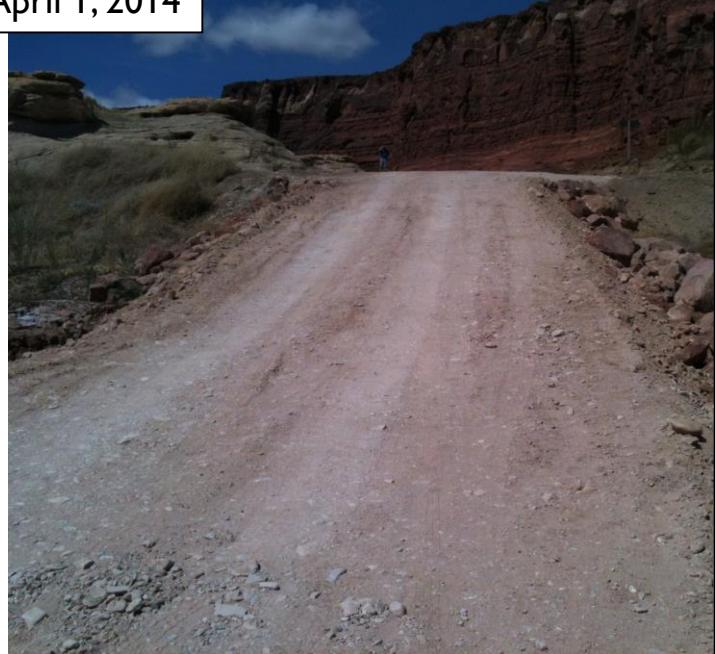
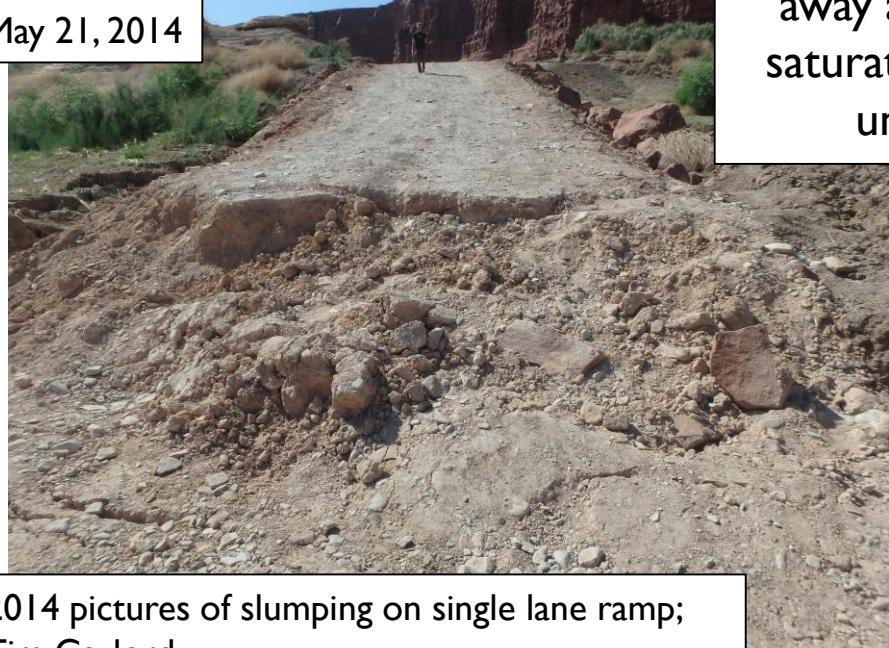
2014 pictures of slumping on single lane ramp;
Tim Gaylord

The Lake Sediments continue to prove that they cannot be a reliable foundation for a boat ramp.

Over the years, the same issue keeps re-appearing: the lake sediment sloughs away after going through periods of saturation and de-watering, making it unreliable for vehicle travel.

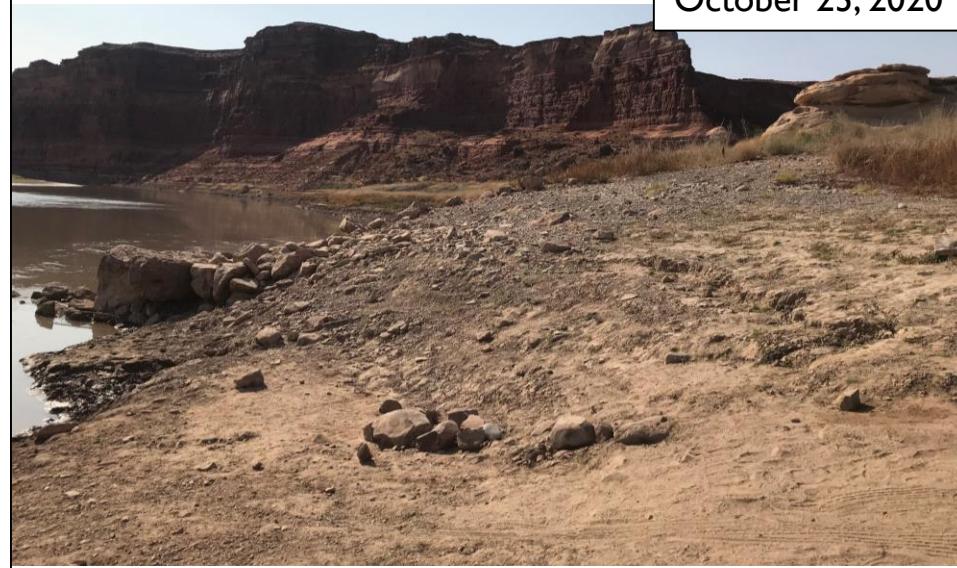
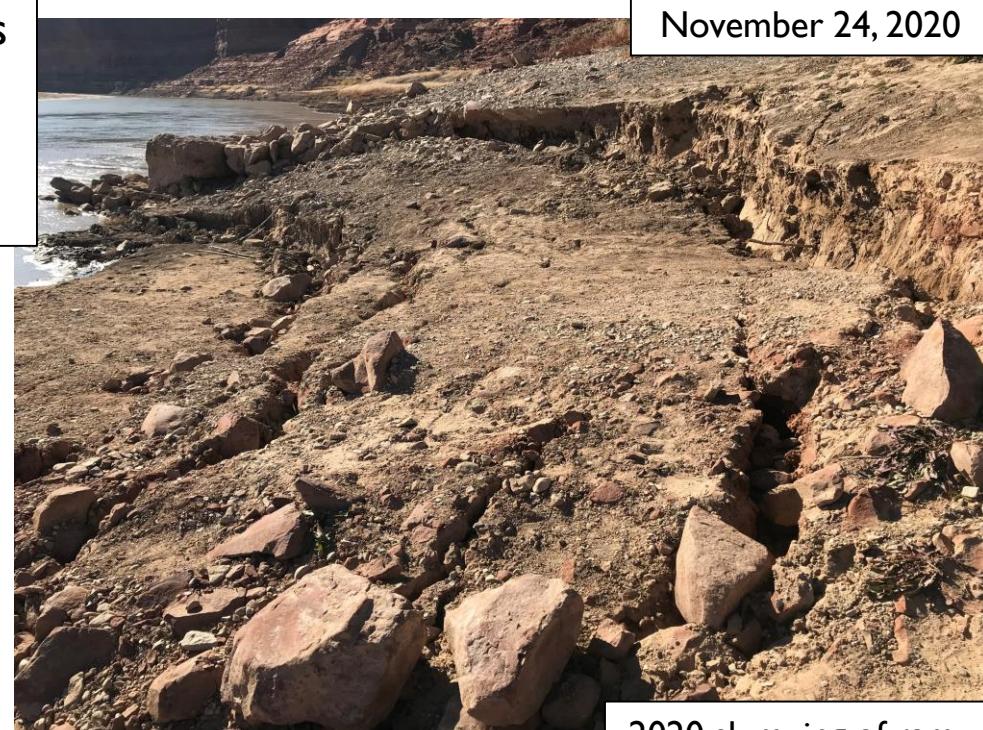
2020 slumping of ramp

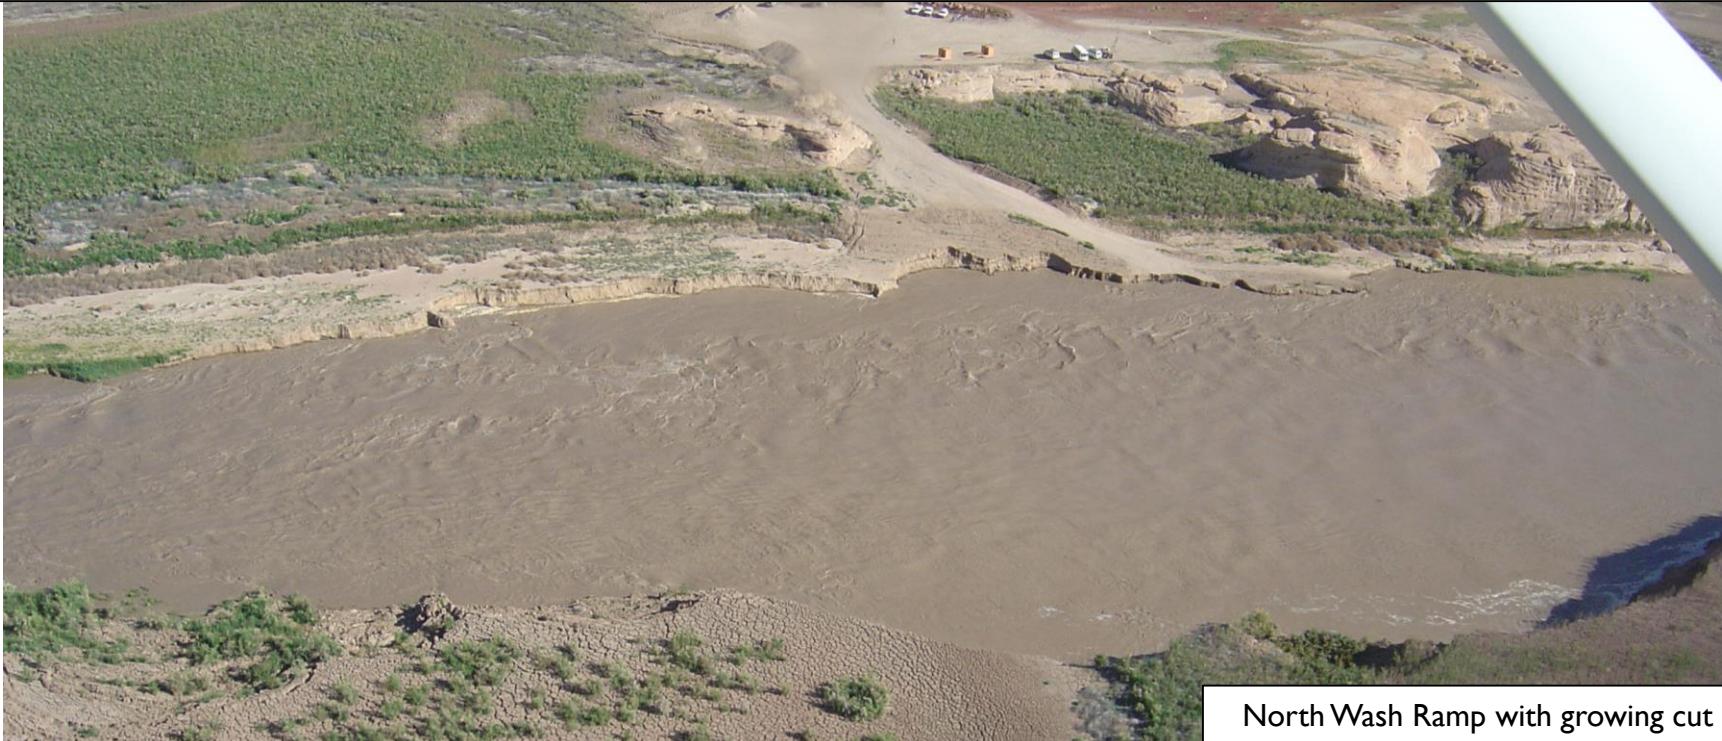
North Wash Ramp with growing cut bank Spring 2006; Steve Young

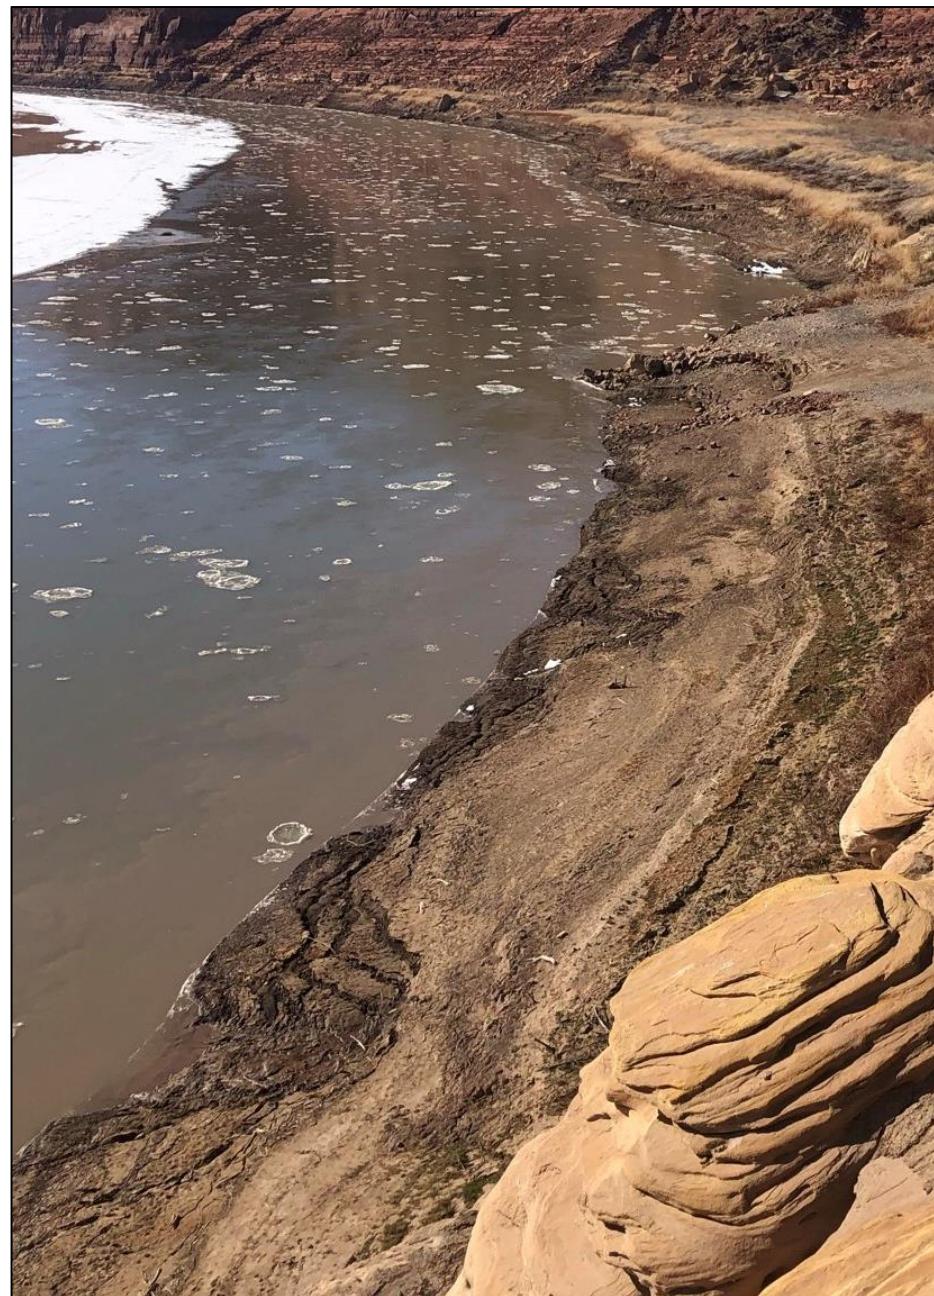
One of the main things that the North Wash Ramp continues to show through the years is that the sediments are reliably unstable.

If cycled through periods of saturation and drying out, they slough away.

When sloughing occurs, it can leave cut banks.

River bank and North Wash boat ramp showing sloughing
Jan 1, 2021

In any construction of, or continued maintenance to, a ramp, we strongly advise not to use sediment as a base for any ramp.

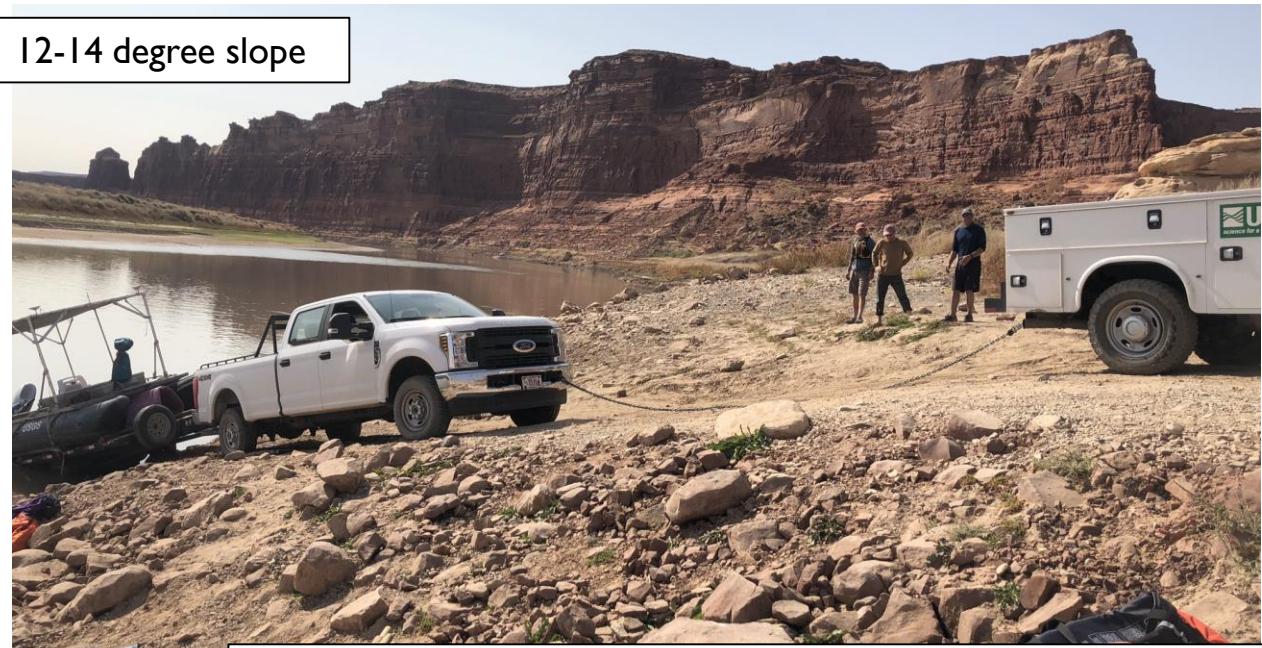
12-14 degree slope

A good boat ramp needs to be between 6-9 degrees in slope.

Too steep and it is difficult for a 2 wheel drive vehicle to use and becomes an area where users can slip/ fall while using.

Hooking 2 trucks together to pull a GCMRC boat out of the water;
Ramp slope approximately 12-14 degrees, loose and soft substrate
North Wash Boat Ramp; October 23, 2020; Meg Flynn

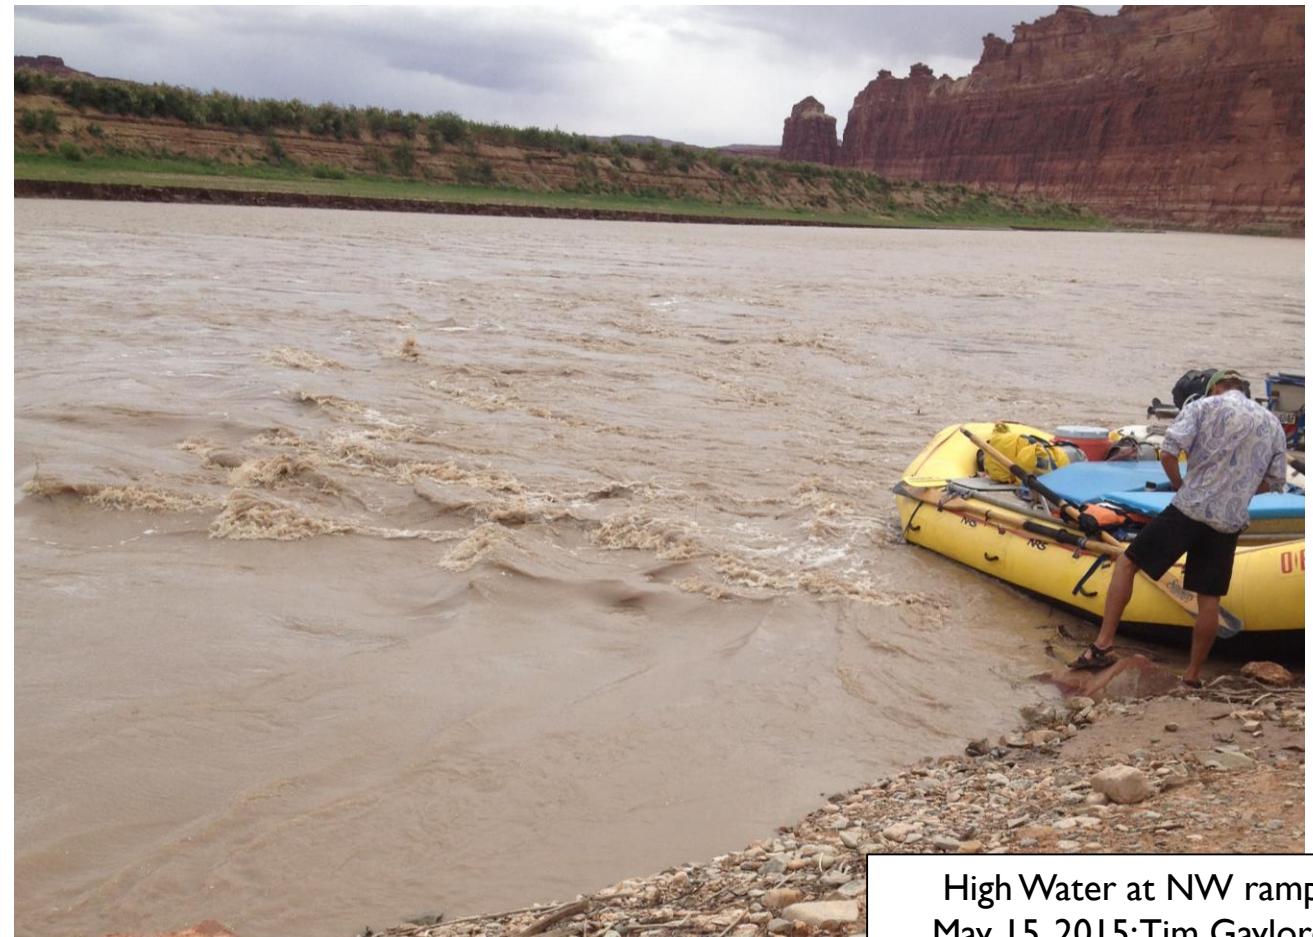
The challenges of dealing with a less than ideal ramp are compounded even more during highwater. Trying to trailer a non motored boat in 5-7 mph current is treacherous at best.

High Water at NW ramp;
May 15, 2015; Tim Gaylord

Some type of upstream jetty designed to form an eddy around the boat ramp would make for a more controlled boat loading location.

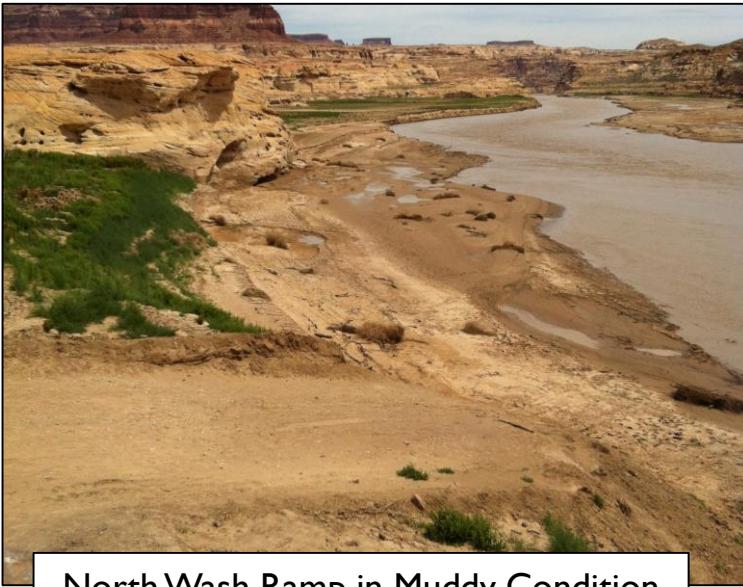
North Wash Ramp in Muddy Condition

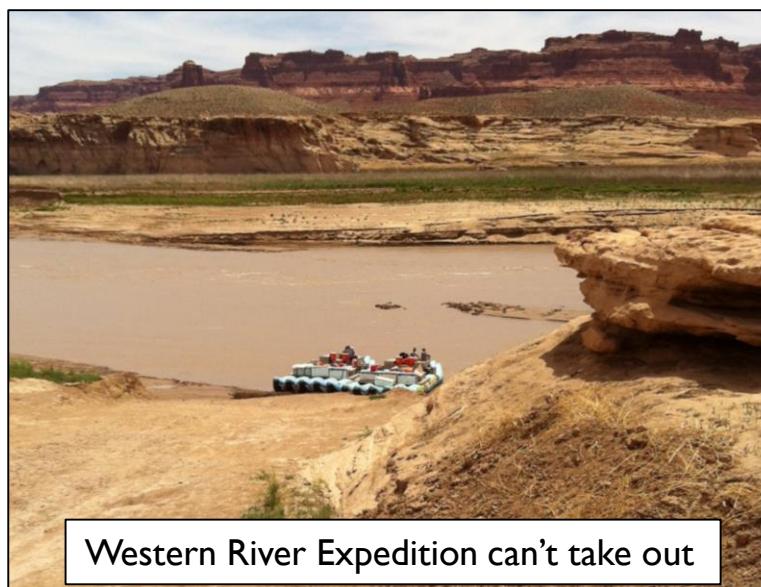
Western River Expedition can't take out

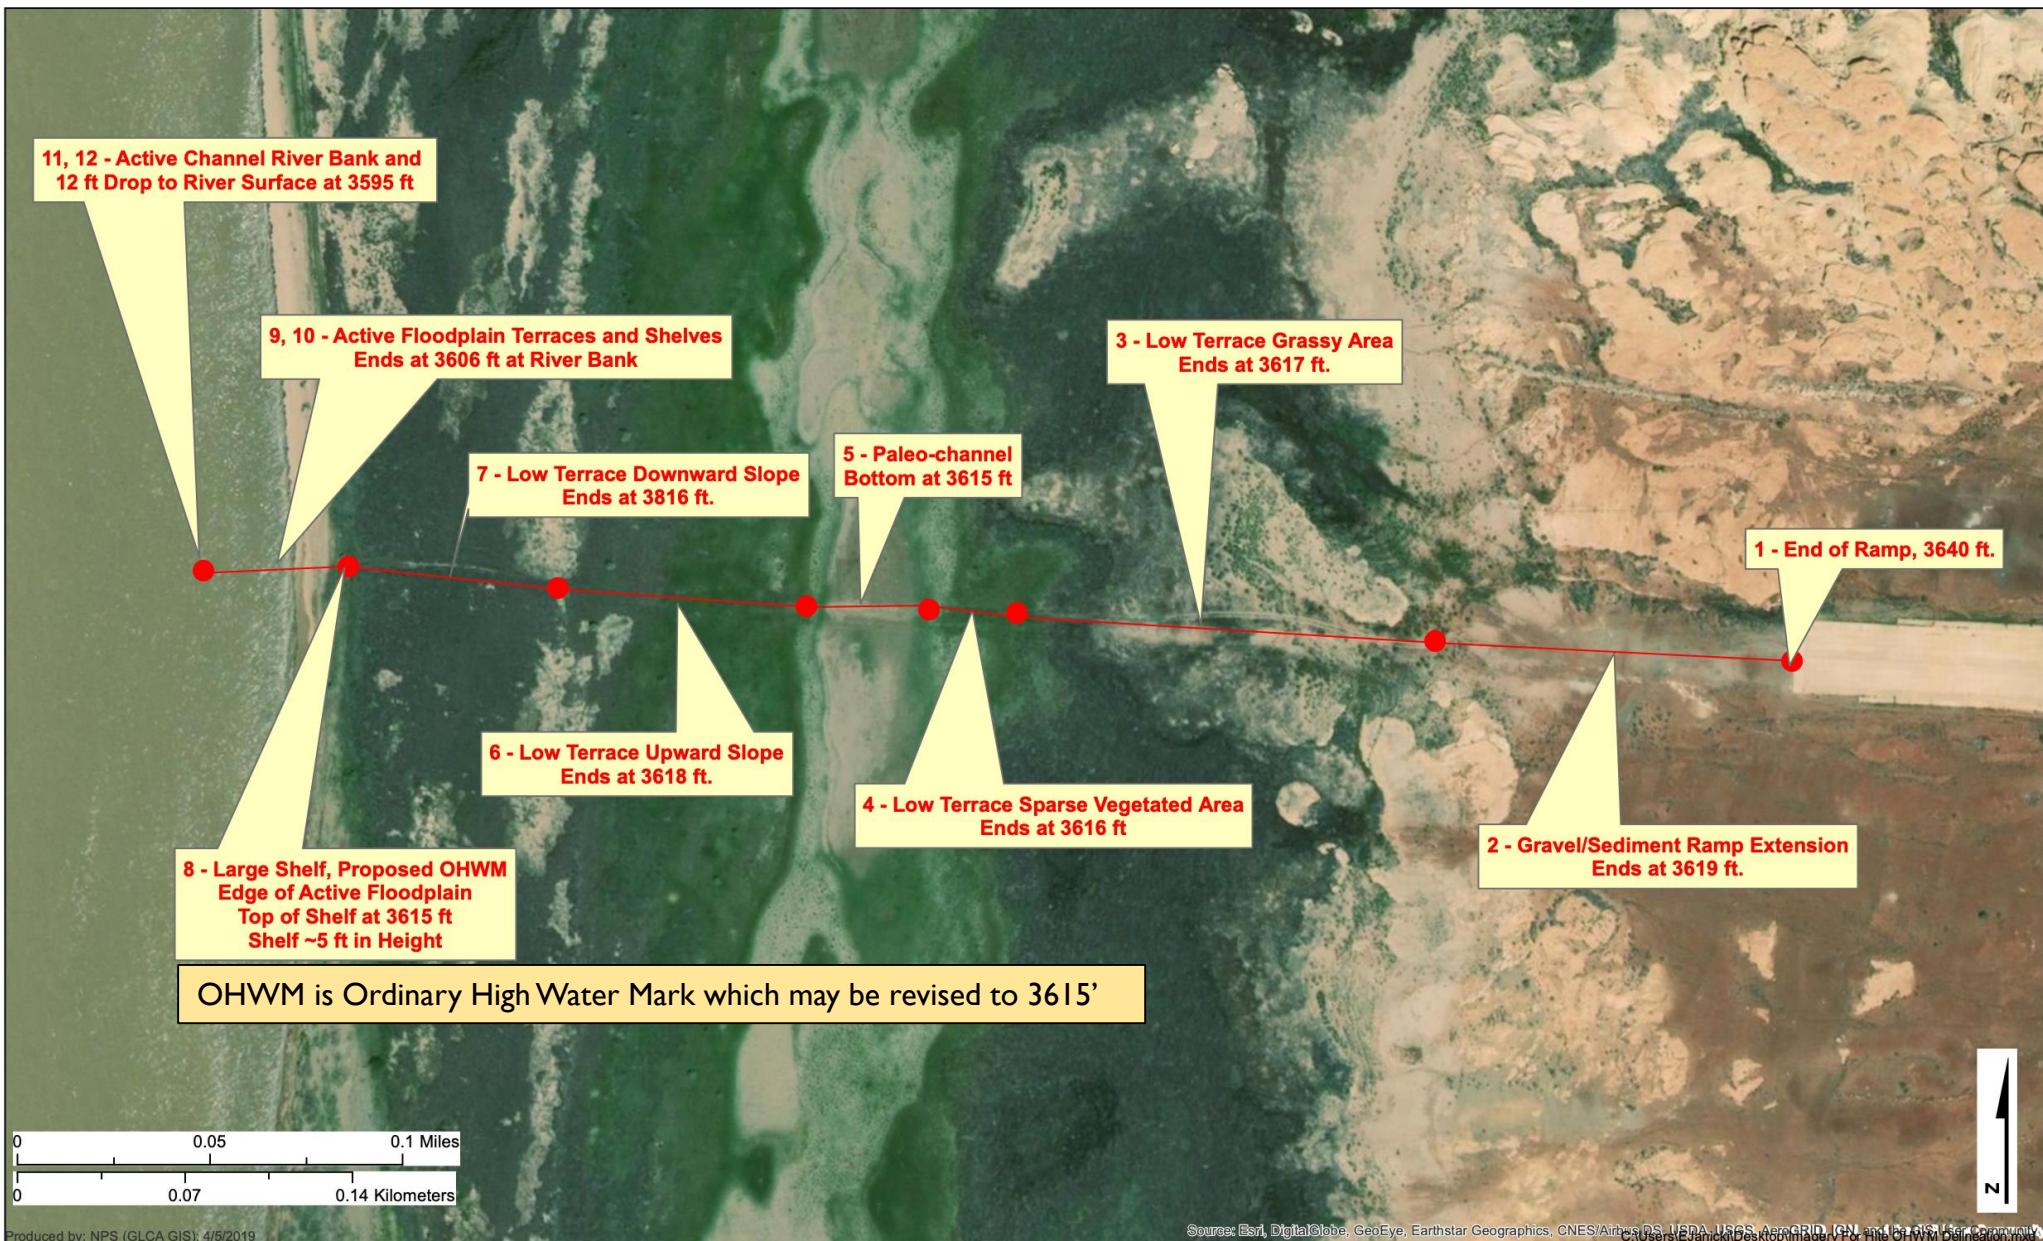
Scoping details of proposed ramp extension, 2016. Note points 3 through 11 are on lake sediment.

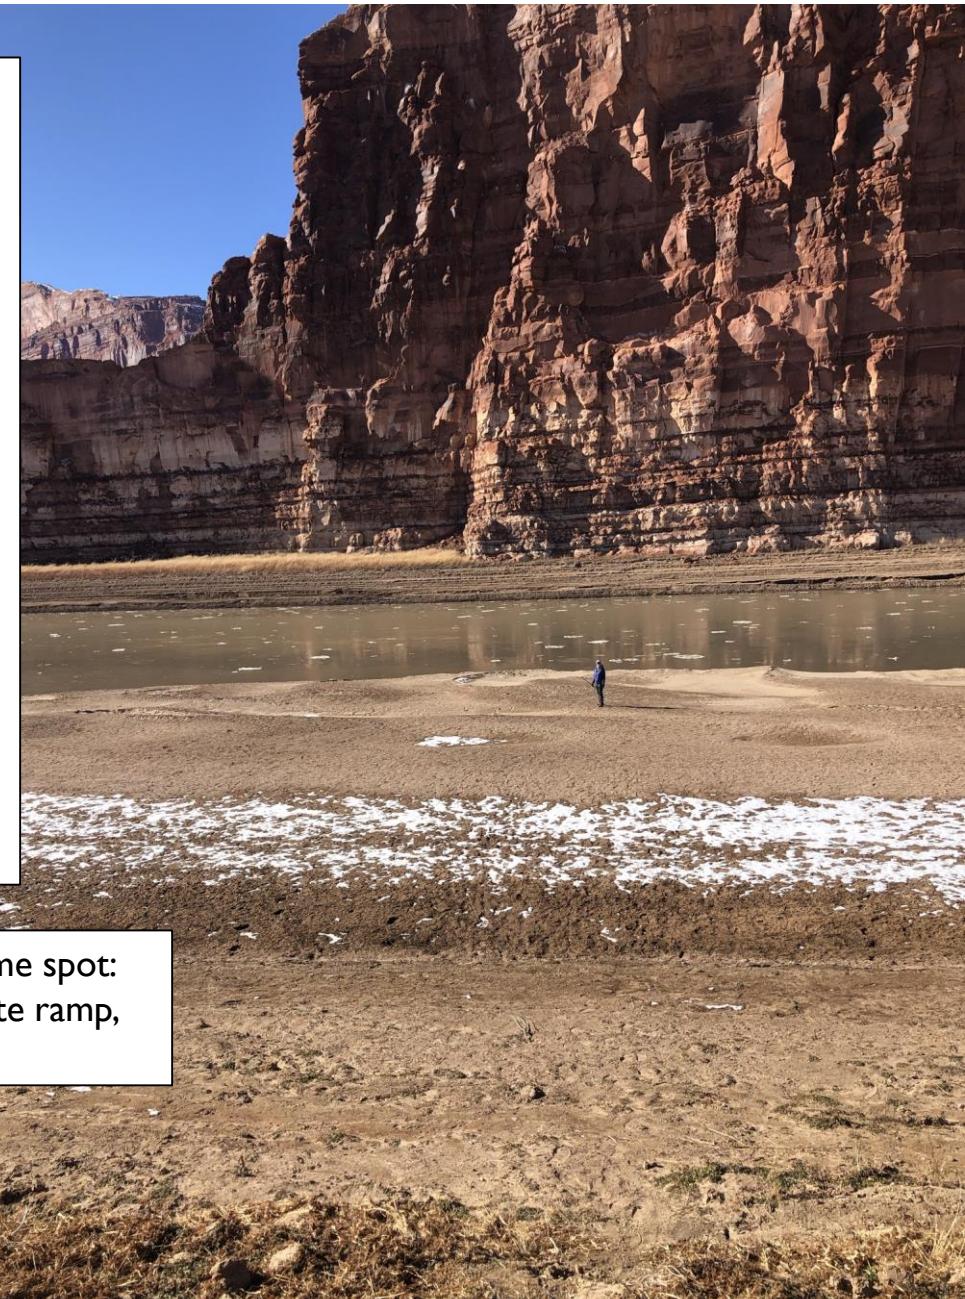
Looking down the large cut bank to the lower river bank; Jan 1, 2021
