DATE: June 6, 2018

RE: Public Safety Assessment of Skookum-Edfro Restoration Project South Fork Nooksack River

Whatcom County, Washington

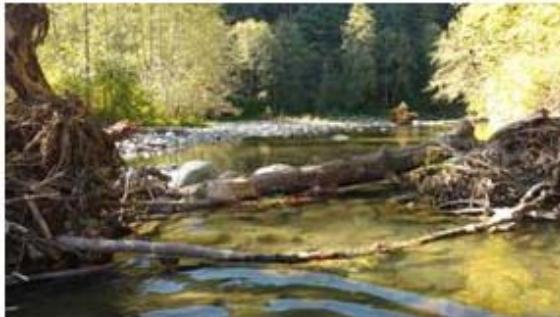
Appendix A1
Log spanning active channel
in Habitat Log 4 at RM 14.1

In the Phase 1 area (middle reach), the only structures that scored a low-moderate safety rating were the four habitat log structures located in a side channel. These structures span a large percentage of the side channel, which increases the difficulty in avoiding them. They do not receive a low safety rating because the side channel is less frequently travelled than the main channel and has a much lower discharge than the main channel. ELJs 17, 18, 19 and 20 received a moderate safety rating because of their moderate to moderate-high strainer potential, fair egress potential and relatively narrow channel width compared to the channel width upstream near ELJs 14, 15 and 16.

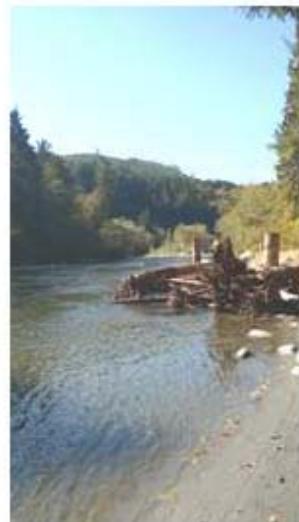
Appendix A2
Woody gnarl ELJ 14 at
upstream end of middle
reach at RM 14.3.

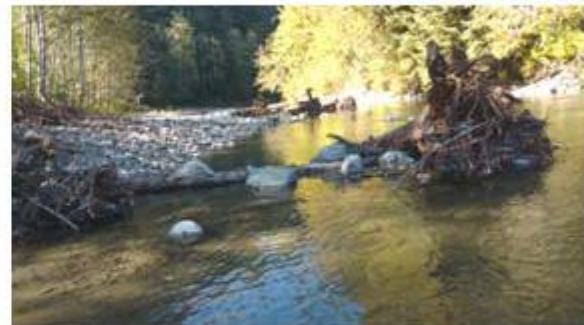
Appendix A3
Habitat structure logs in
middle reach of the project
at RM 14.1

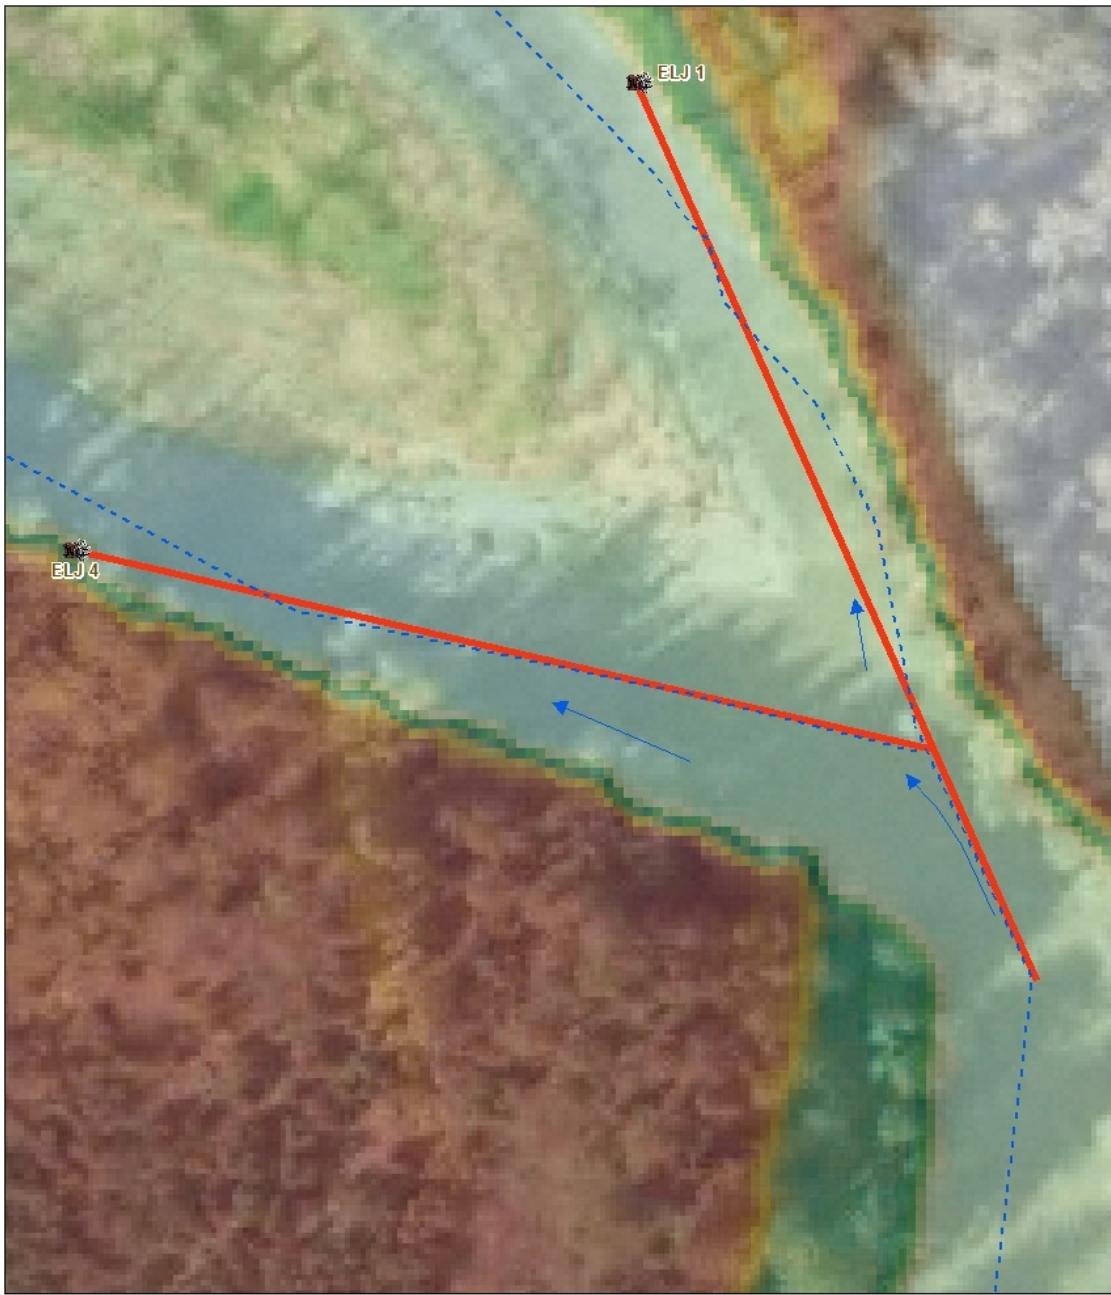
Figure 3. Sight distance example of two structures in the upper reach.

The sight distance of a structure can be defined as the maximum distance a recreational user will be able to see the structure when approaching along the thalweg of the channel (GeoEngineers 2011). The lower the sight distance, the less time a recreational user will have to develop a plan for how to avoid the structure and react appropriately. Thus, structures with more sight distance are safer than structures with less sight distance. Long sight distances were assigned low-risk ratings while short sight distances were assigned higher ratings.

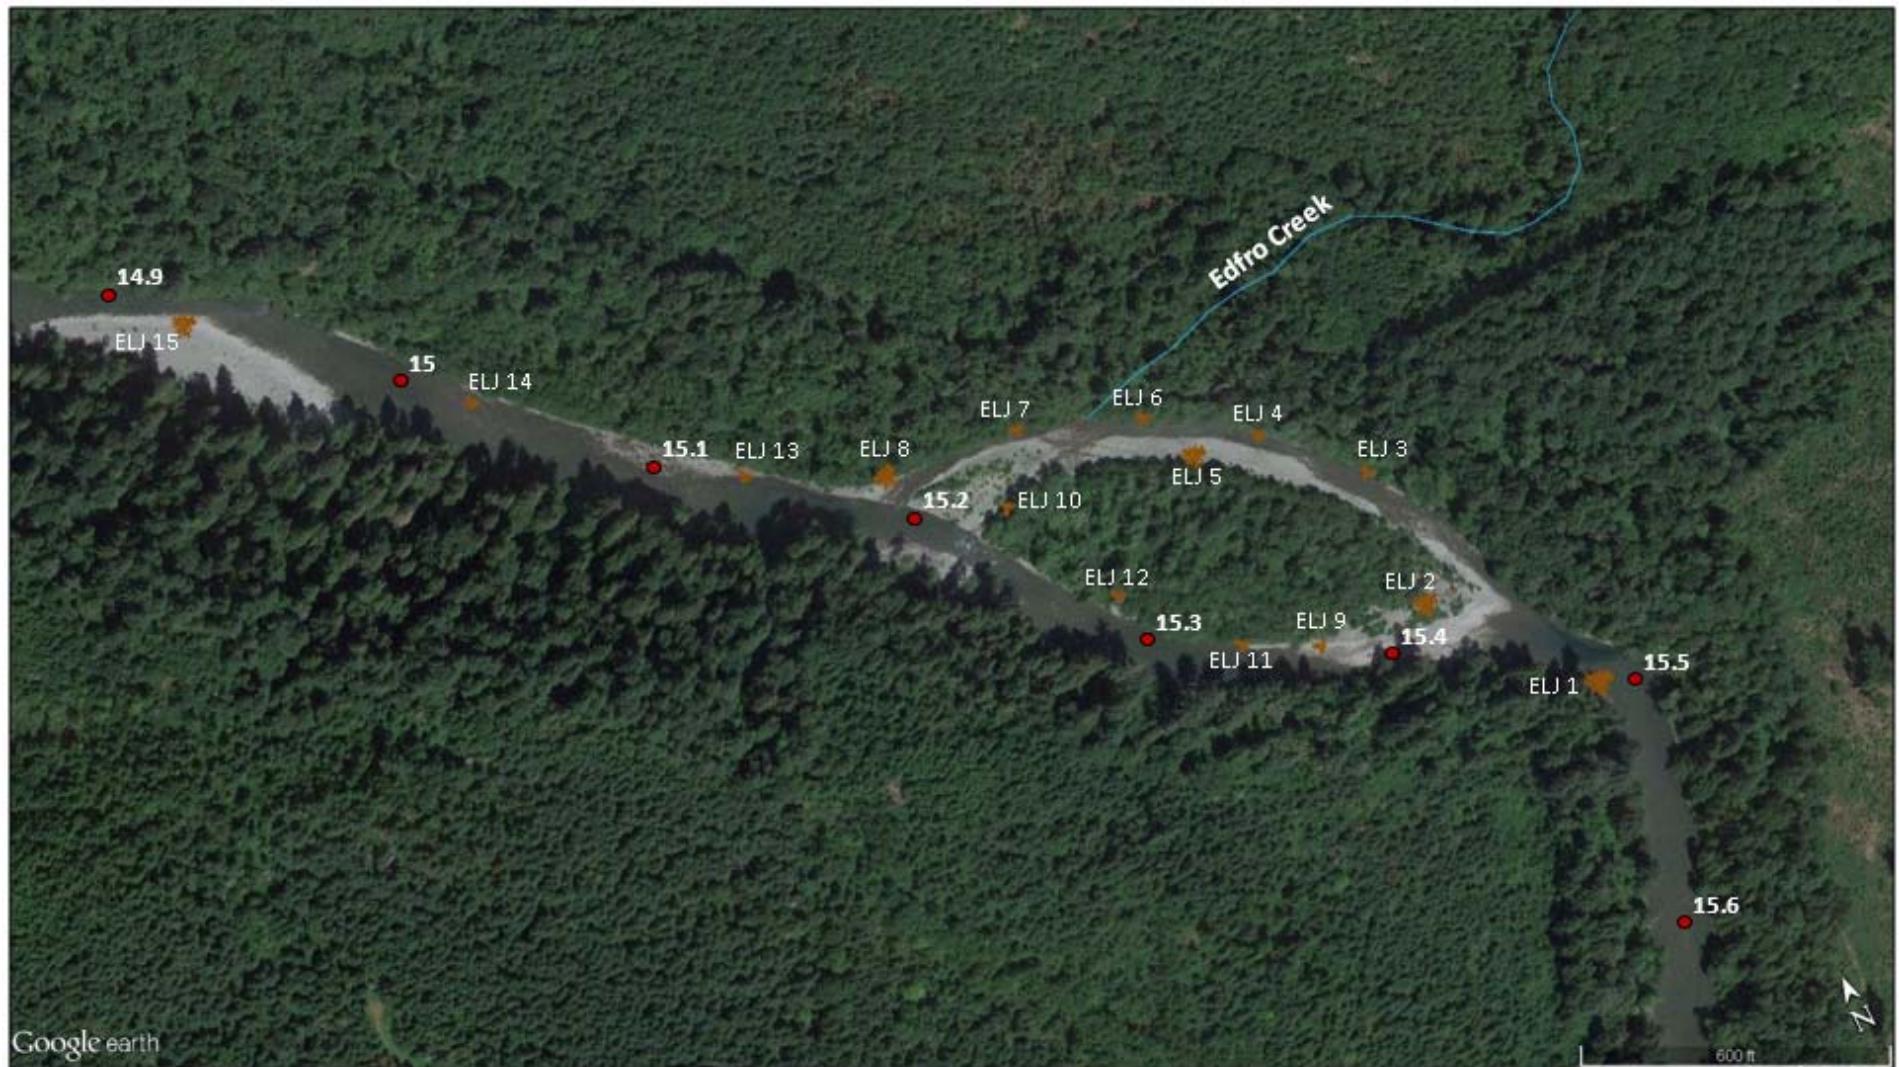
Figure 5. Site map of the Phase 2 ELJs in the upper reach.

In the Phase 2 area (upper reach) ELJ 8 scored a moderate safety rating because of its low egress potential (steep vegetated and bedrock lined banks) but good avoidance potential as this ELJ is located on the inside of the channel bend with plenty of space in the channel to avoid it. ELJ 5 received a moderate safety rating because it spans approximately 50% of the channel and has a moderate-high strainer potential, but sight distance of nearly 600 feet and good egress potential. ELJ 15 also received a moderate safety rating because of its large size and location in the middle of the channel and thus a moderate strainer potential; however, it has fair egress potential, a long site distance of approximately 1,100 feet and adequate space in the channel to avoid it. The remaining Phase 2/upper reach ELJs received high to moderate-high safety ratings because of their low to low-moderate strainer potential, good egress potential, site distances between 300 and 1,000 feet, and a wide enough channel to avoid them.

Structure ID per Figure 5	LOCATION	STRUCTURE CHARACTERISTICS		AVOIDANCE POTENTIAL				SAFETY RATING
		Located along outside of bend?	Structure type	Strainer potential	Egress potential	Upstream sight distance (ft)	Structure distance to thalweg (ft)	
ELJ 1	NO	FLOW DEFLECTION	MODERATE-HIGH	LOW	410	40	140	MODERATE
ELJ 2	NO	FLOW DEFLECTION	LOW	GOOD	420	60	170	MODERATE-HIGH
ELJ 3	YES	FLOW DEFLECTION	LOW-MODERATE	GOOD	800	20	85	MODERATE-HIGH
ELJ 4	YES	FLOW DEFLECTION	LOW-MODERATE	GOOD	610	25	110	MODERATE-HIGH
ELJ 5	NO	FLOW DEFLECTION	MODERATE-HIGH	GOOD	580	<10	105	MODERATE
ELJ 6	YES	FLOW DEFLECTION	LOW-MODERATE	GOOD	675	30	115	MODERATE-HIGH
ELJ 7	YES	FLOW DEFLECTION	LOW-MODERATE	GOOD	365	30	150	MODERATE-HIGH
ELJ 8	NO	FLOW DEFLECTION	MODERATE	GOOD	560	15	180	MODERATE-HIGH
ELJ 9	NO	FLOW DEFLECTION	LOW-MODERATE	GOOD	590	30	115	MODERATE-HIGH
ELJ 10	NO	FLOW DEFLECTION	LOW	GOOD	325	90	165	HIGH
ELJ 11	NO	FLOW DEFLECTION	LOW-MODERATE	GOOD	400	20	115	MODERATE-HIGH
