A Cataract Canyon Take-out

History, current issues, and factors that may influence and inform a safer, more reliable, and long term solution.

Returning Rapids Project
Moab, Utah

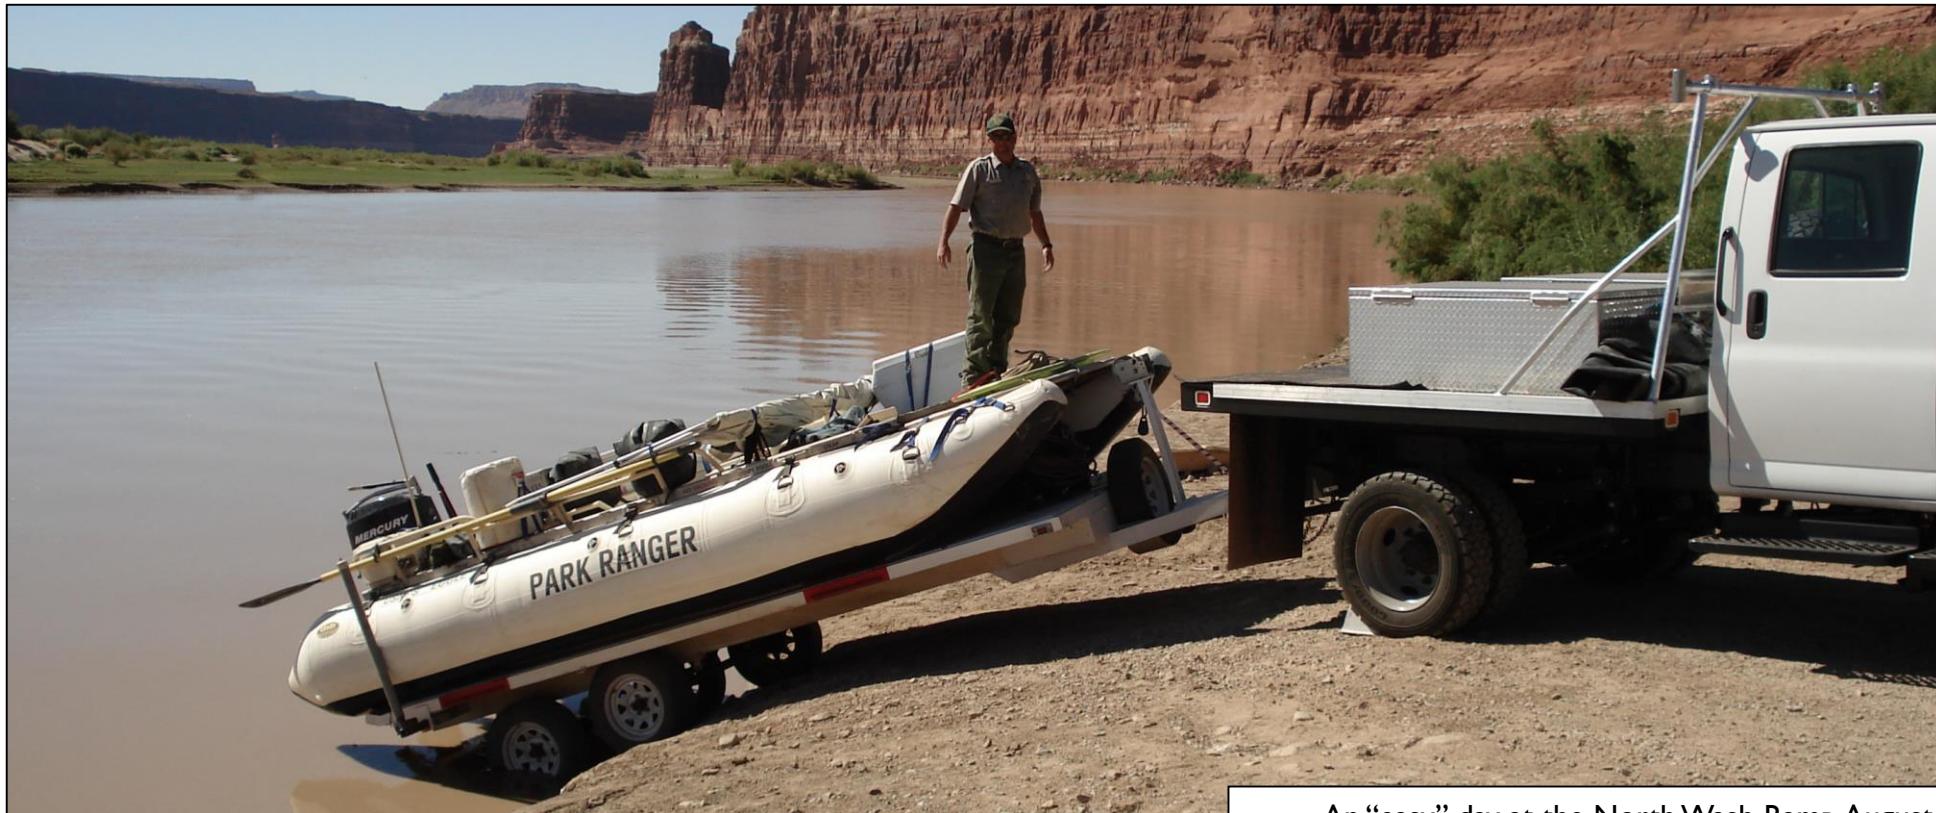
An “easy” day at the North Wash Ramp August 2006, Steve Young

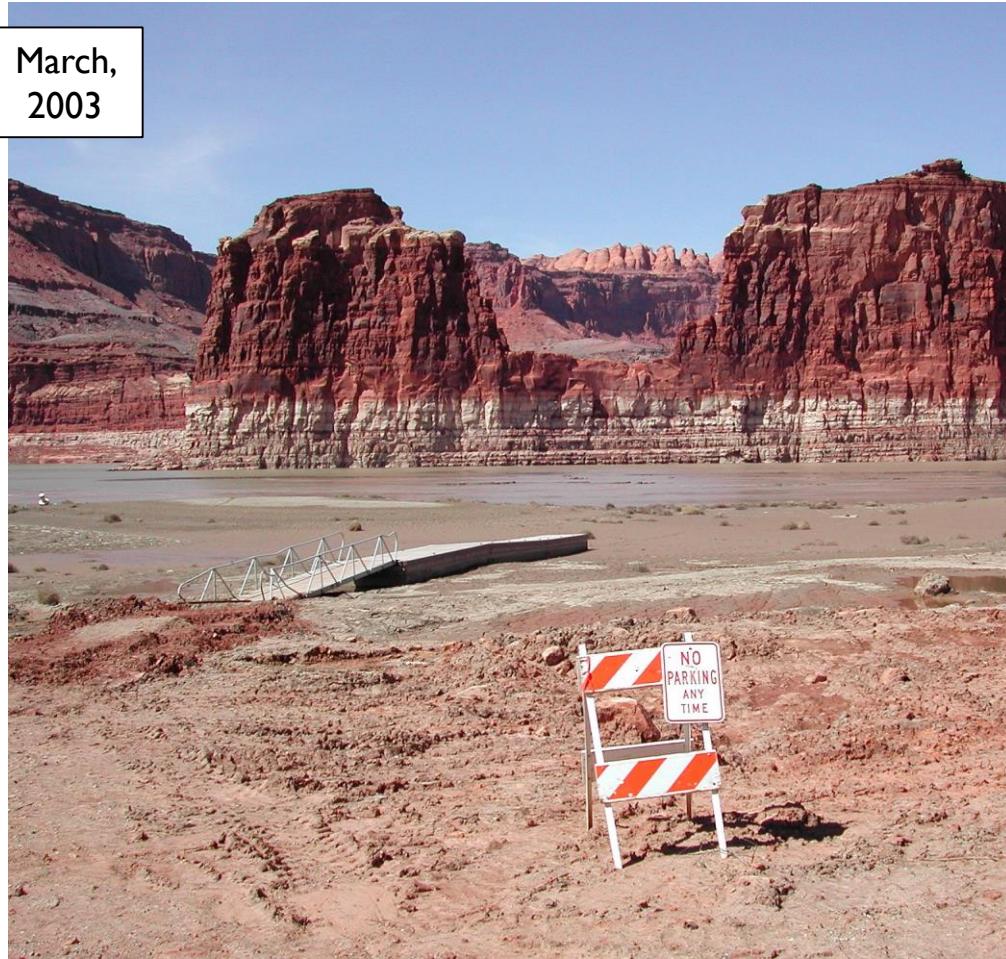
With the significant change of reservoir level in 2003, the concrete ramp at Hite "Marina" became inaccessible.

Toe of Concrete Ramp, Hite; March 2003; Dohrenwend/Weisheit

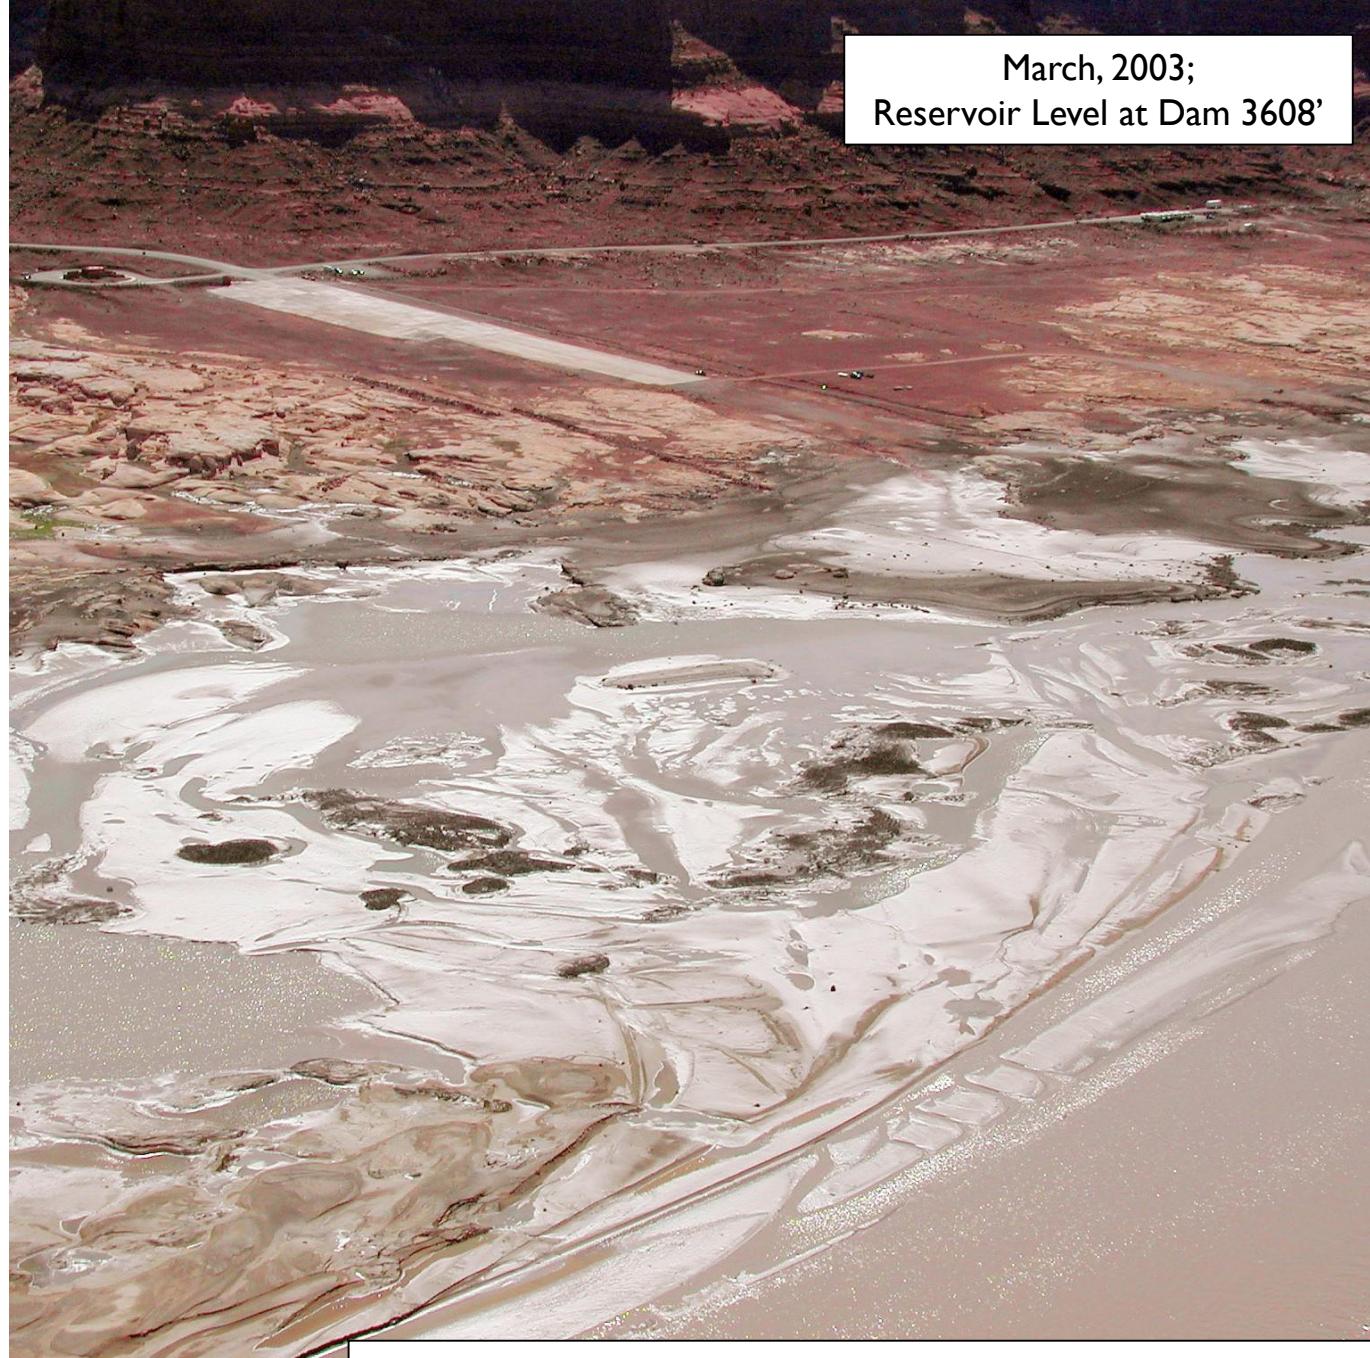
March, 2003;
Reservoir Level at Dam 3608'

Concrete ramp at Hite, March 2003; John Dohrenwend/John Weisheit

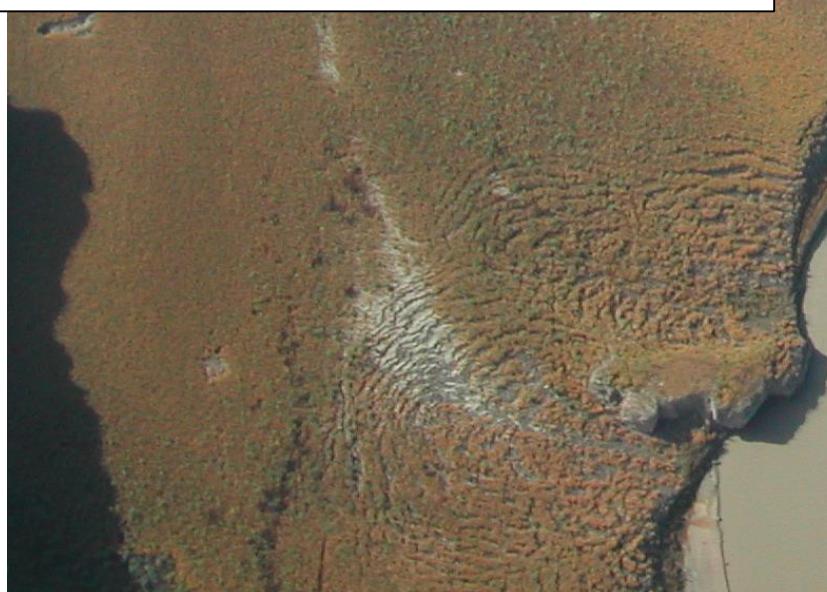
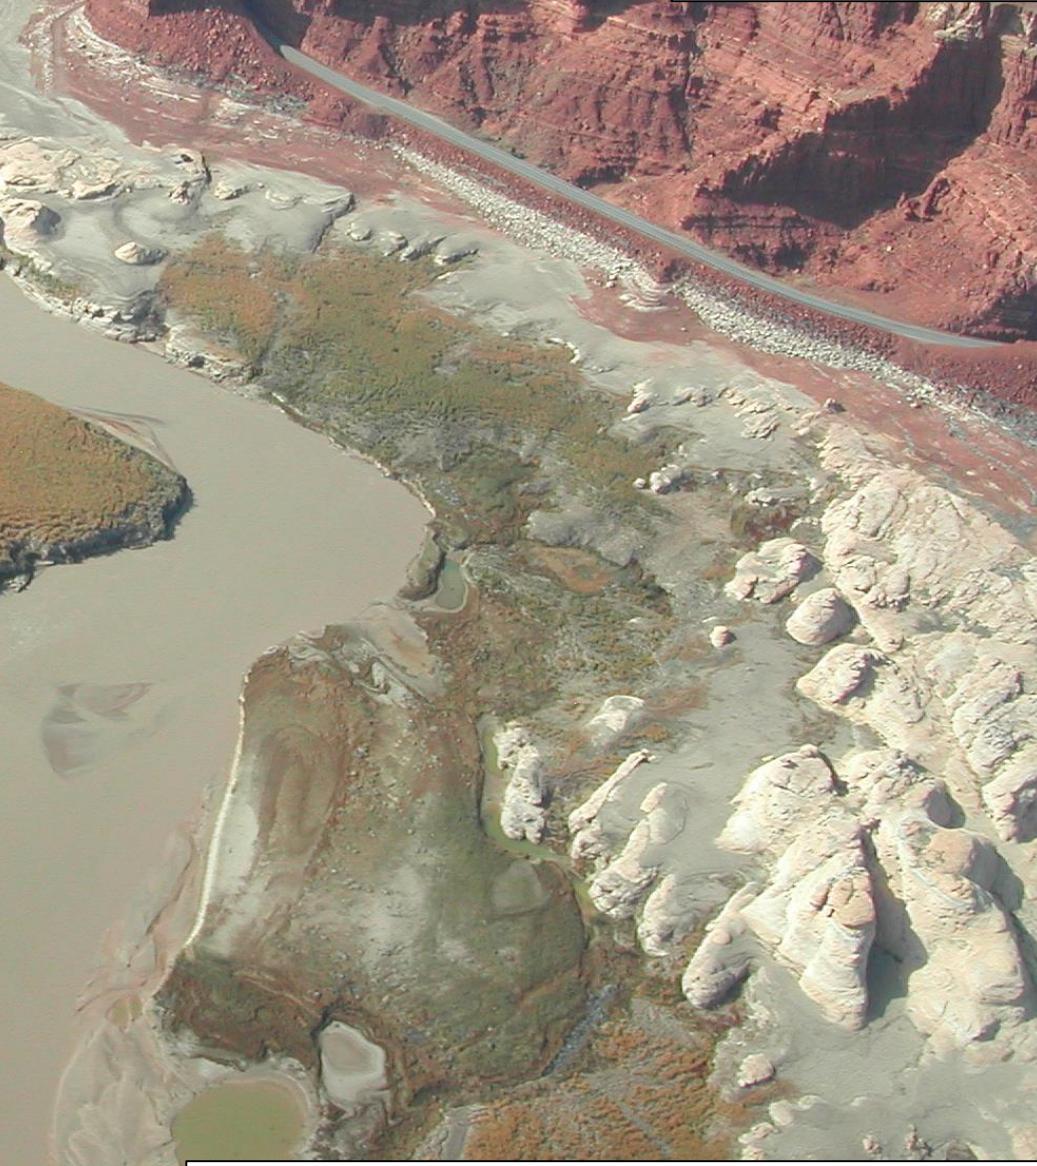
North Wash Ramp Nov 20, 2003; John Dohrenwend/John Weisheit

The single lane construction of the ramp made it difficult for more than one group to take boats out of the river at a time. The ramp was on the soft silt of river sediment, which made many parties not want to risk putting their vehicles/ trailer too close to the water's edge.

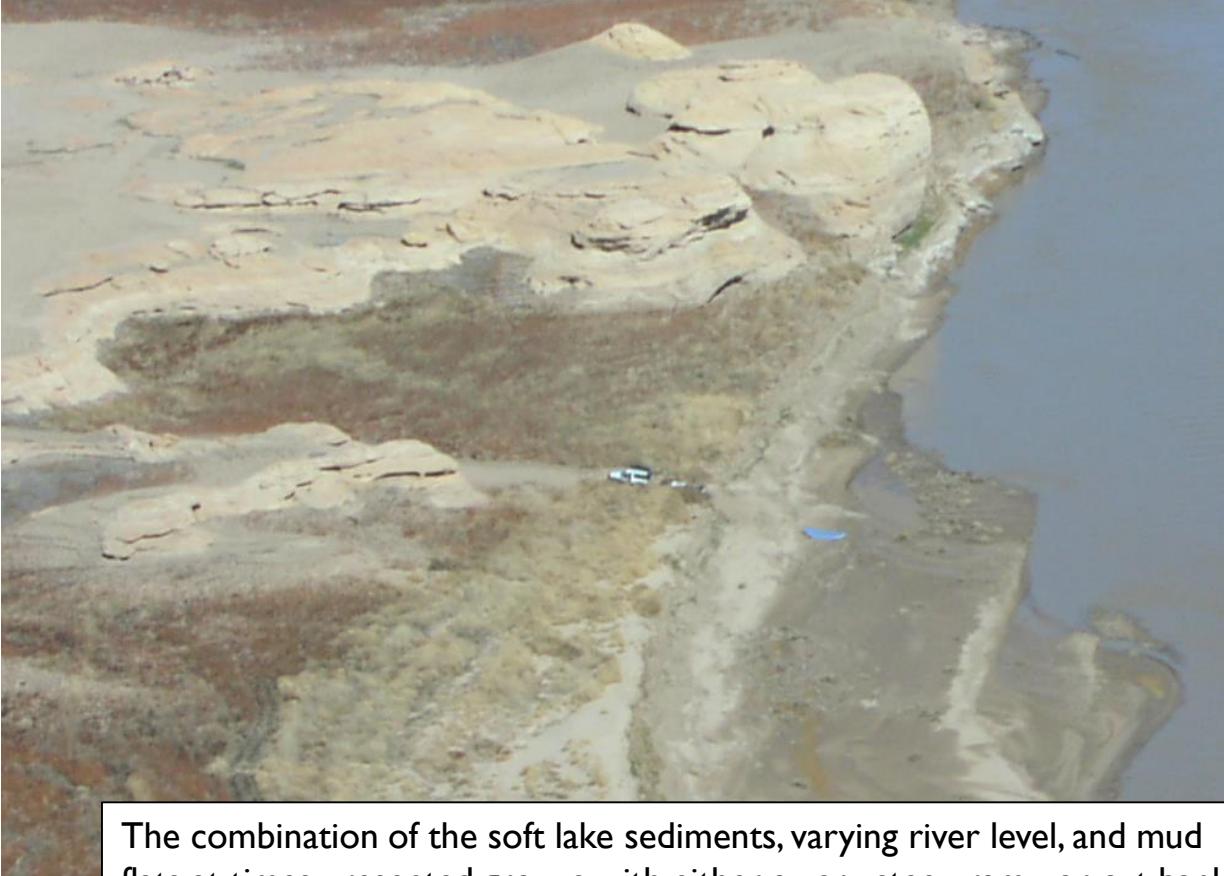
In 2004, the river receded further from the toe of the ramp and a mud bar appeared. This further blocked users from accessing the river's edge.

The combination of the soft lake sediments, varying river level, and mud flats at times presented groups with either a very steep ramp or cut bank.

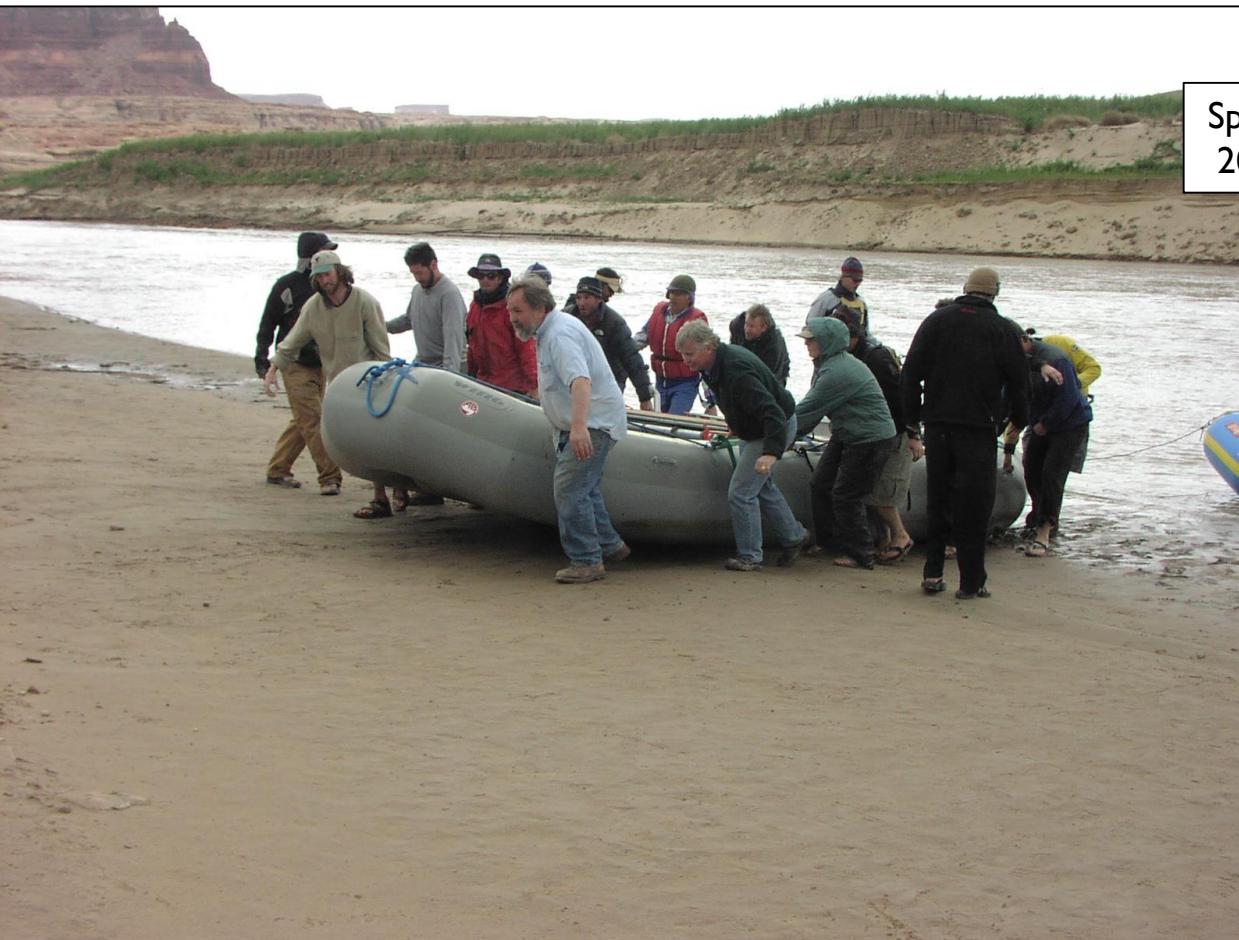
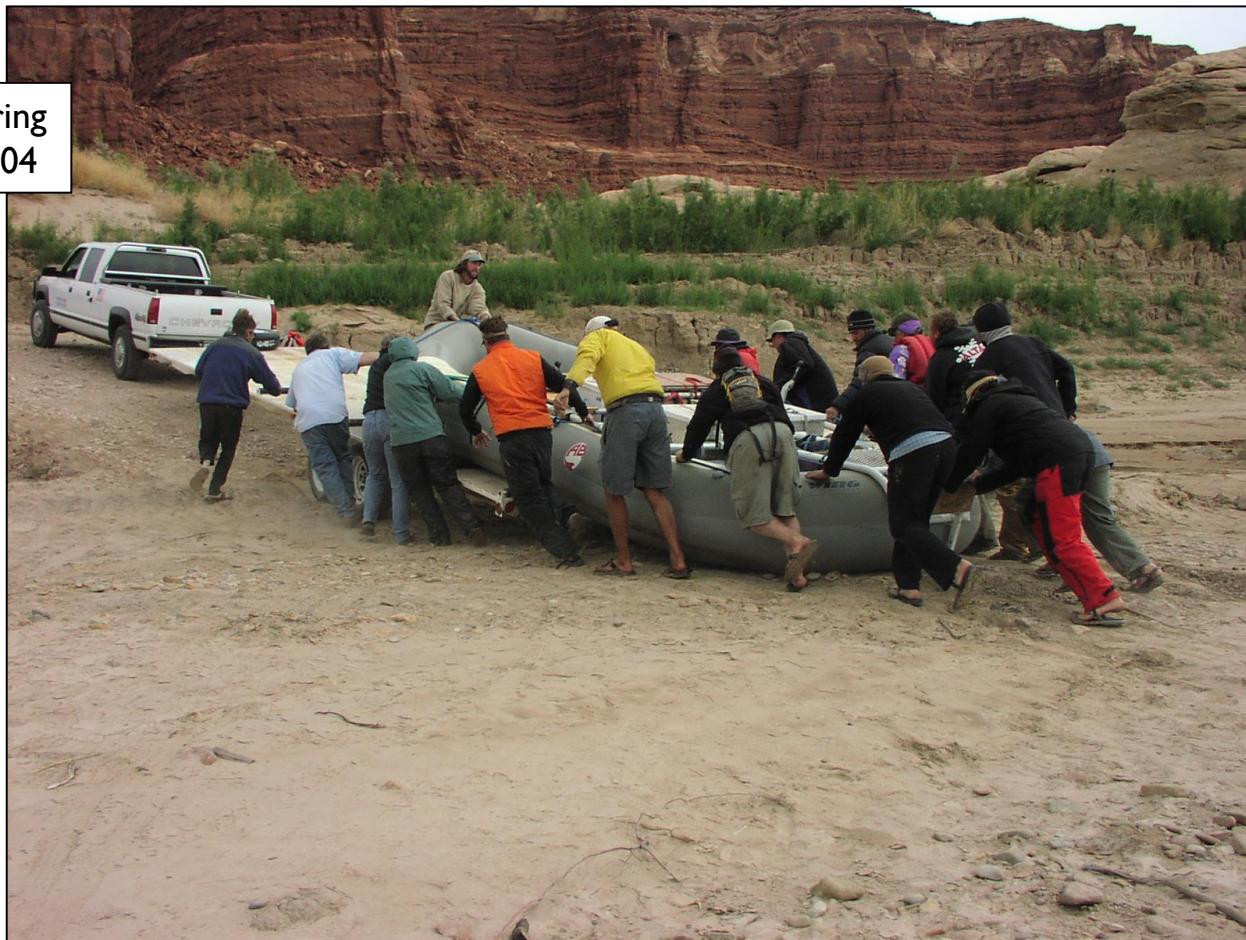
Spring
2004

If enough people were around, a raft could be carried across the mud flats to a trailer.
The task was time consuming and often there were not enough hands to use this technique.

Cataract Interpretive River Trip participants carrying an Adventure Bound 18 foot raft across mud flat;
Spring 2004; Tim Gaylord

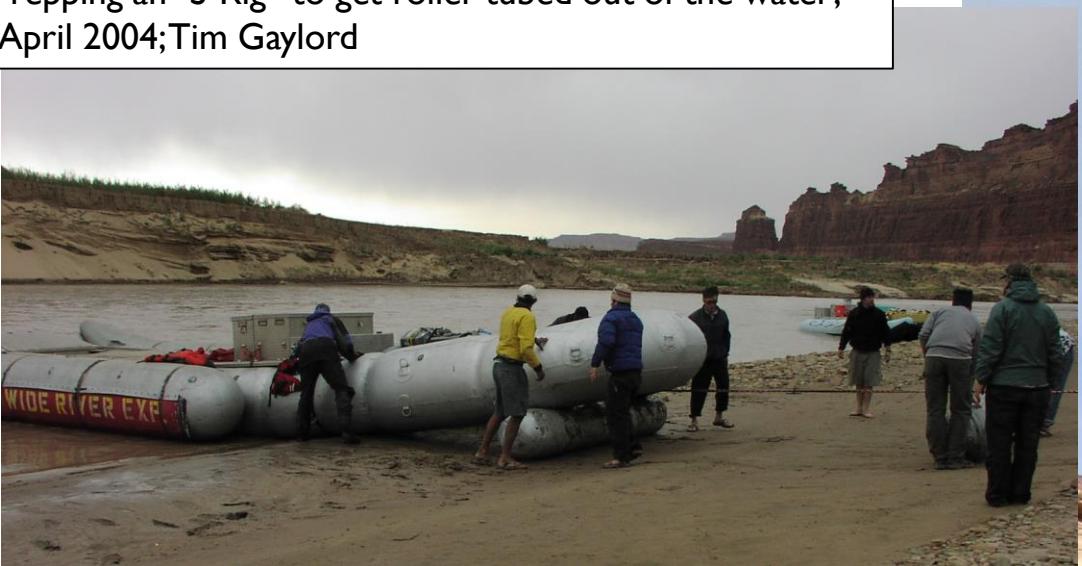
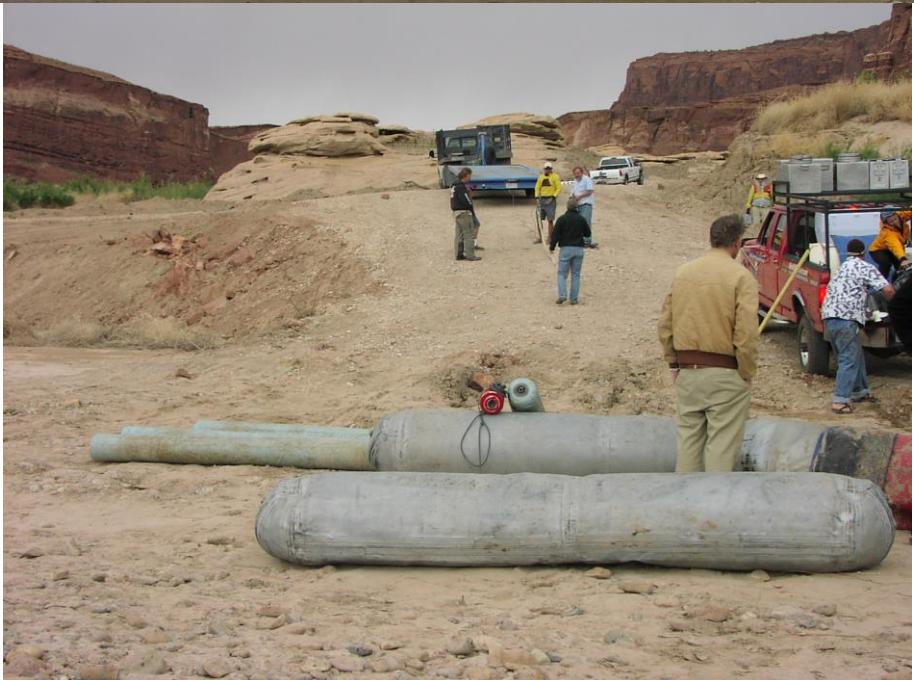
Prepping an “S-Rig” to get roller-tubed out of the water;
April 2004;Tim Gaylord

Laying out roller tubes on the North Wash Ramp;
April 2004;Tim Gaylord

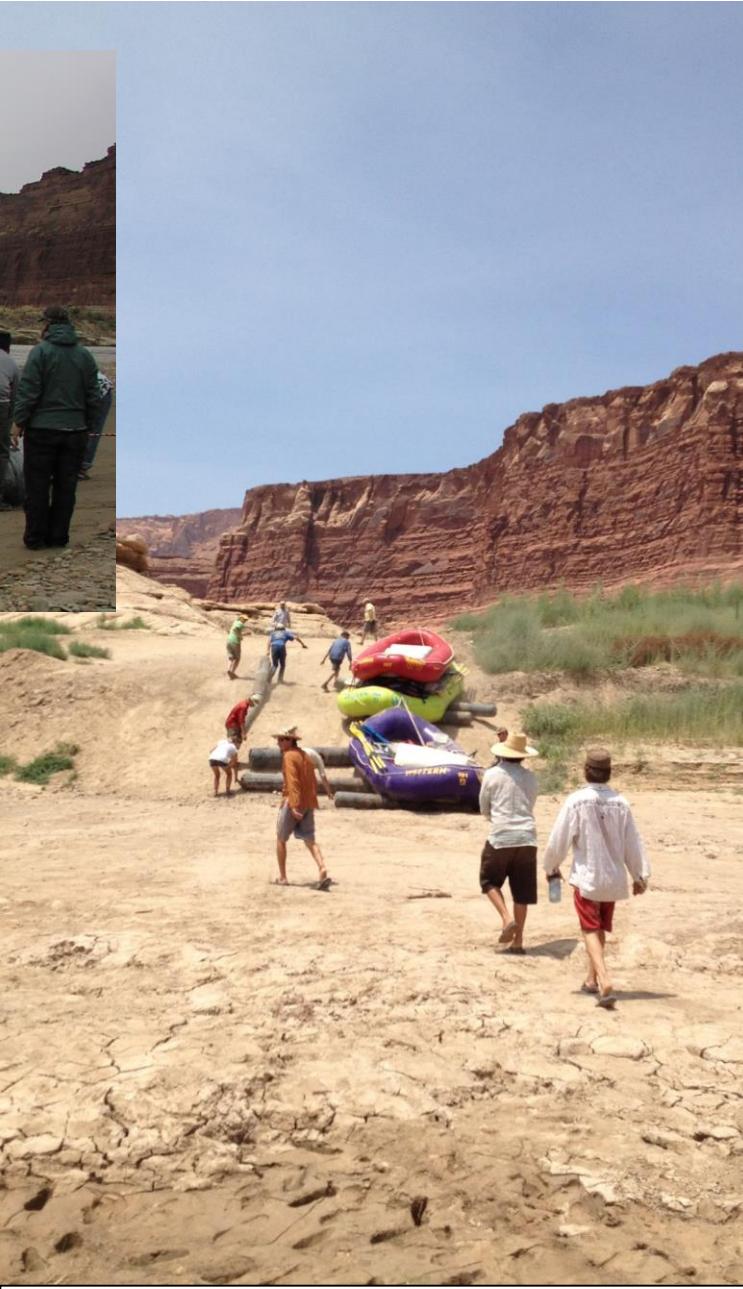
Western boats getting roller tubed up ramp;
June 2013;Tim Gaylord

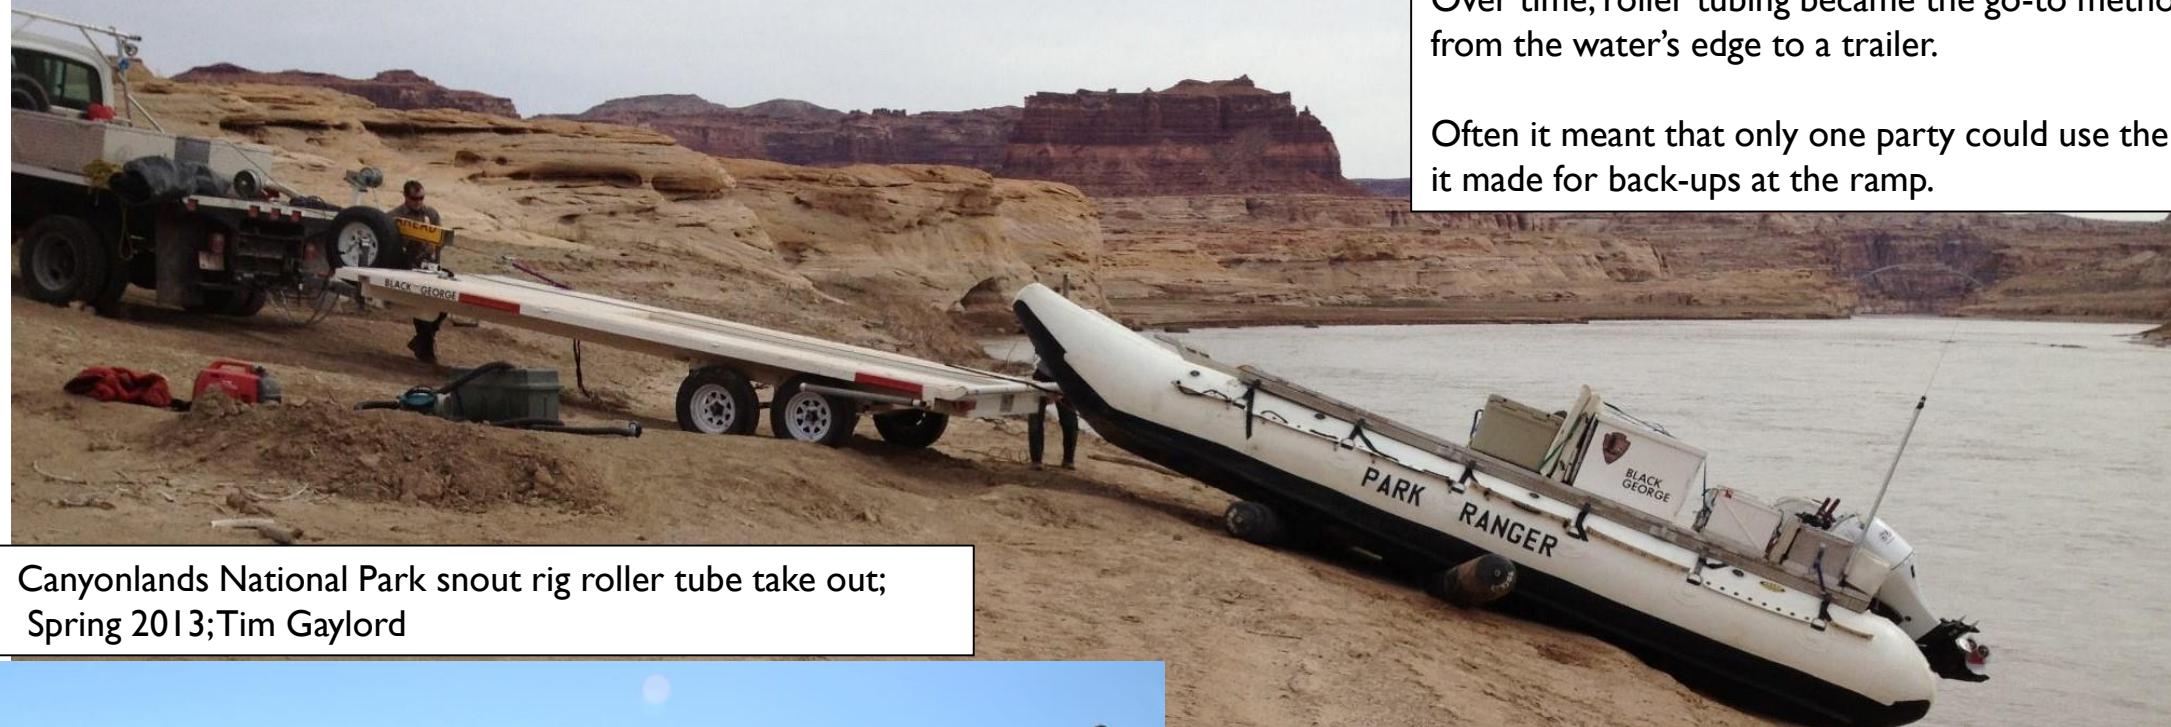
This is a very time consuming process. It puts undue wear and tear on the boats and other equipment, requires the outfitter to be equipped with additional equipment, and has people working around highly tensioned lines.

Canyonlands National Park snout rig roller tube take out;
Spring 2013; Tim Gaylord

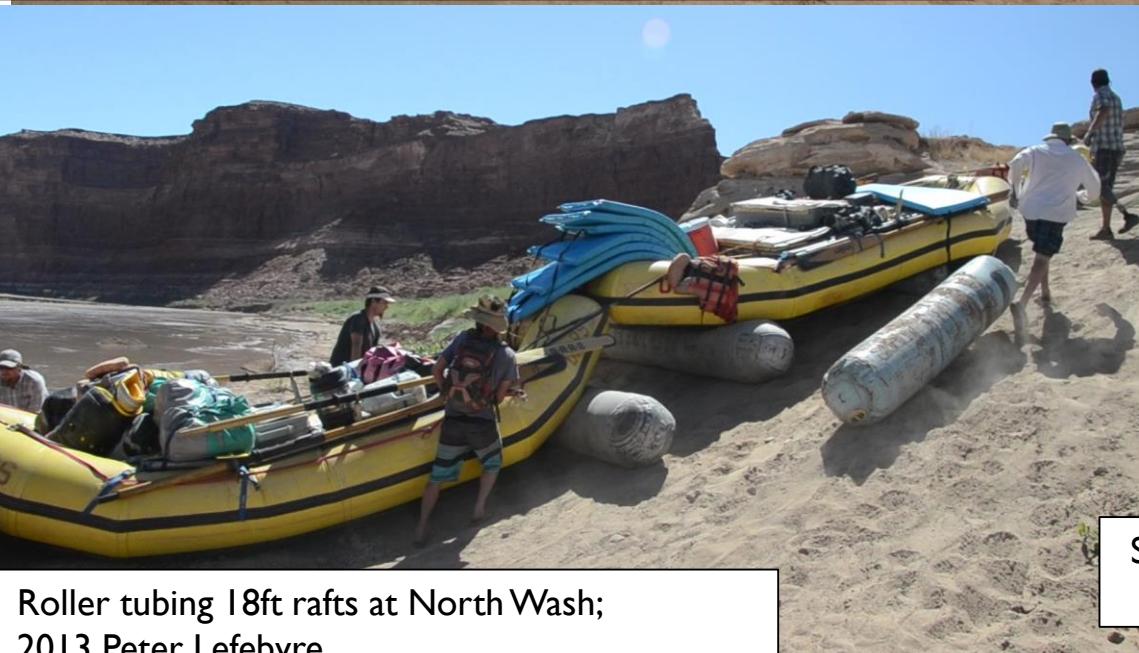
Roller tubing 18ft rafts at North Wash;
2013 Peter Lefebvre

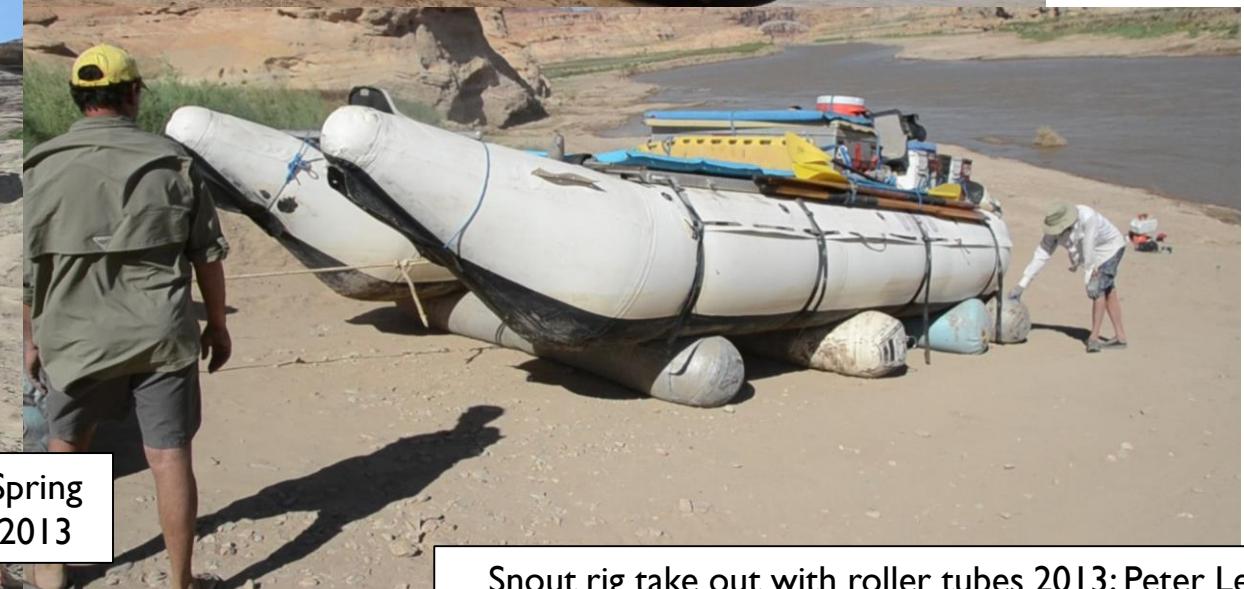
Spring
2013

Snout rig take out with roller tubes 2013; Peter Lefebvre

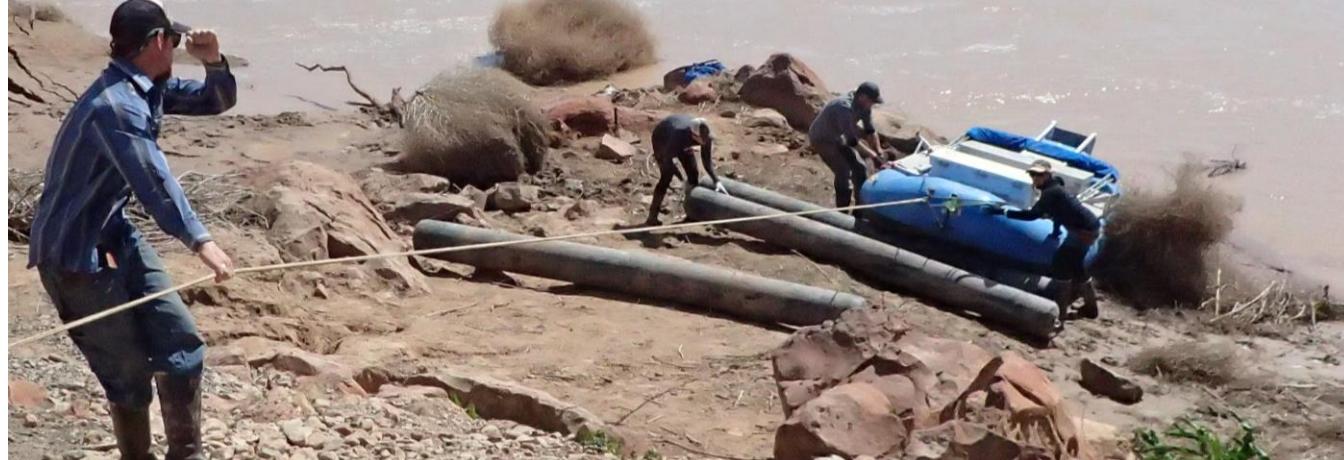
March,
2019

Roller tube 4x4 take out;
Reservoir Level 3570 at Glen Canyon Dam;
March 2019; Bego Gerhart

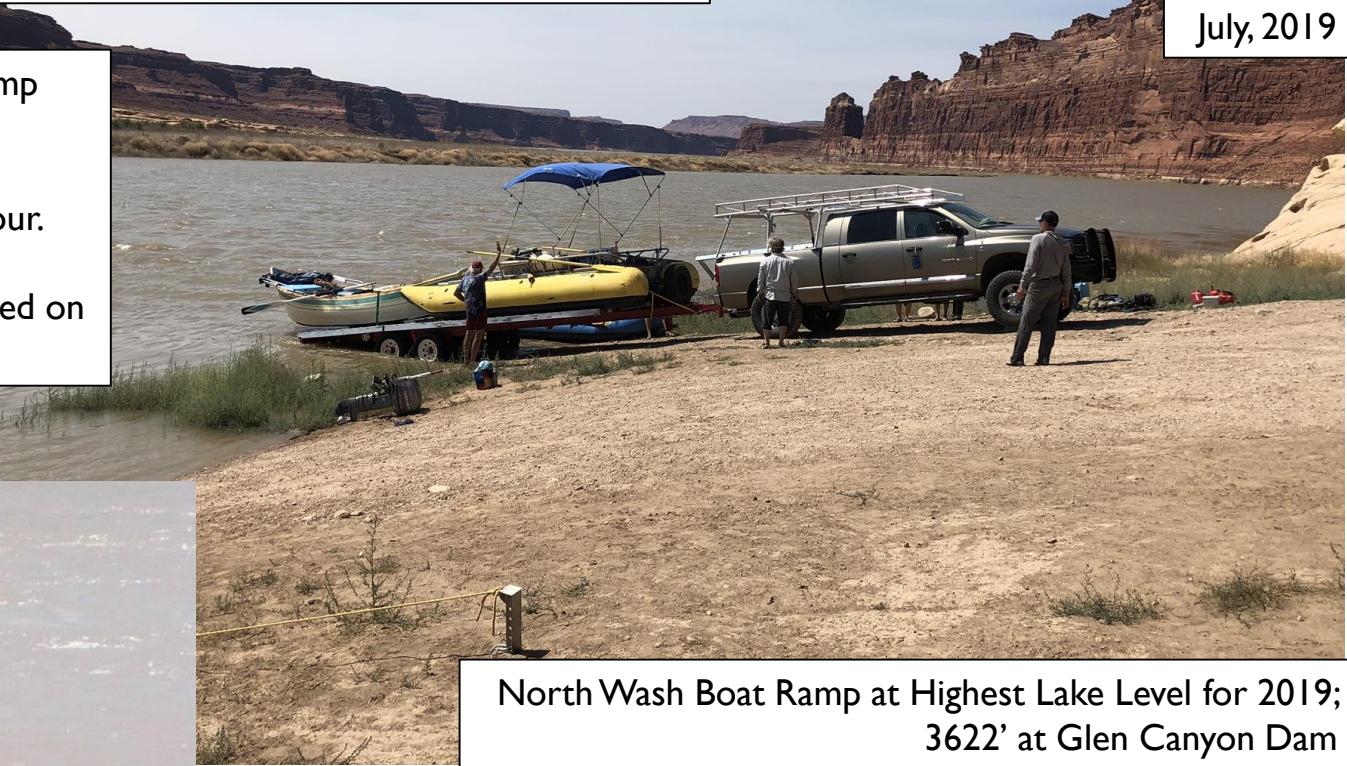
North Wash Boat Ramp at Highest Lake Level for 2019;
3622' at Glen Canyon Dam

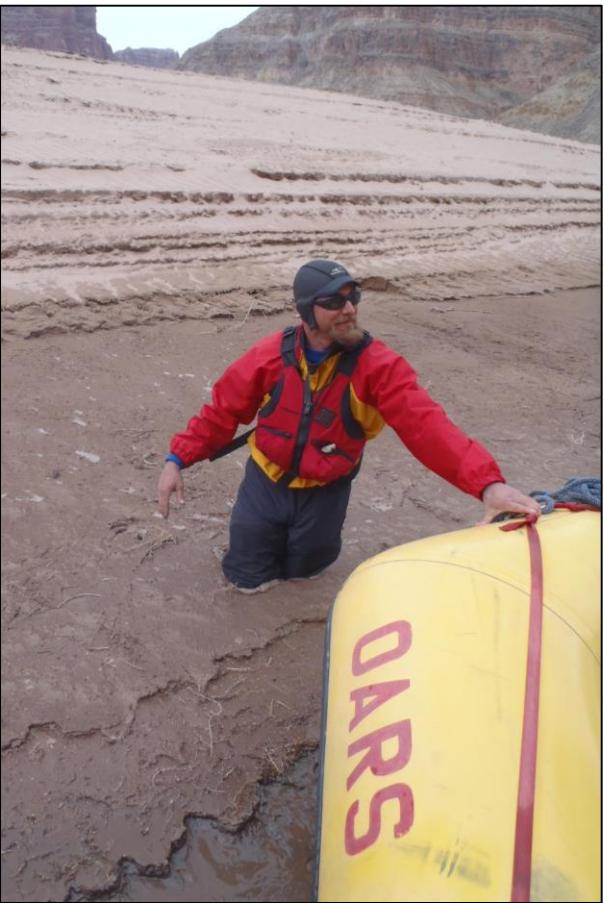
In areas where the sediment is saturated, it is not always safe for foot traffic.

Passenger stuck in Lake Sediments just downstream of Palmer Canyon;
Peter Lefebvre

In any construction of, or continued maintenance to, a ramp, we strongly advise not to use sediment as a base for any ramp.

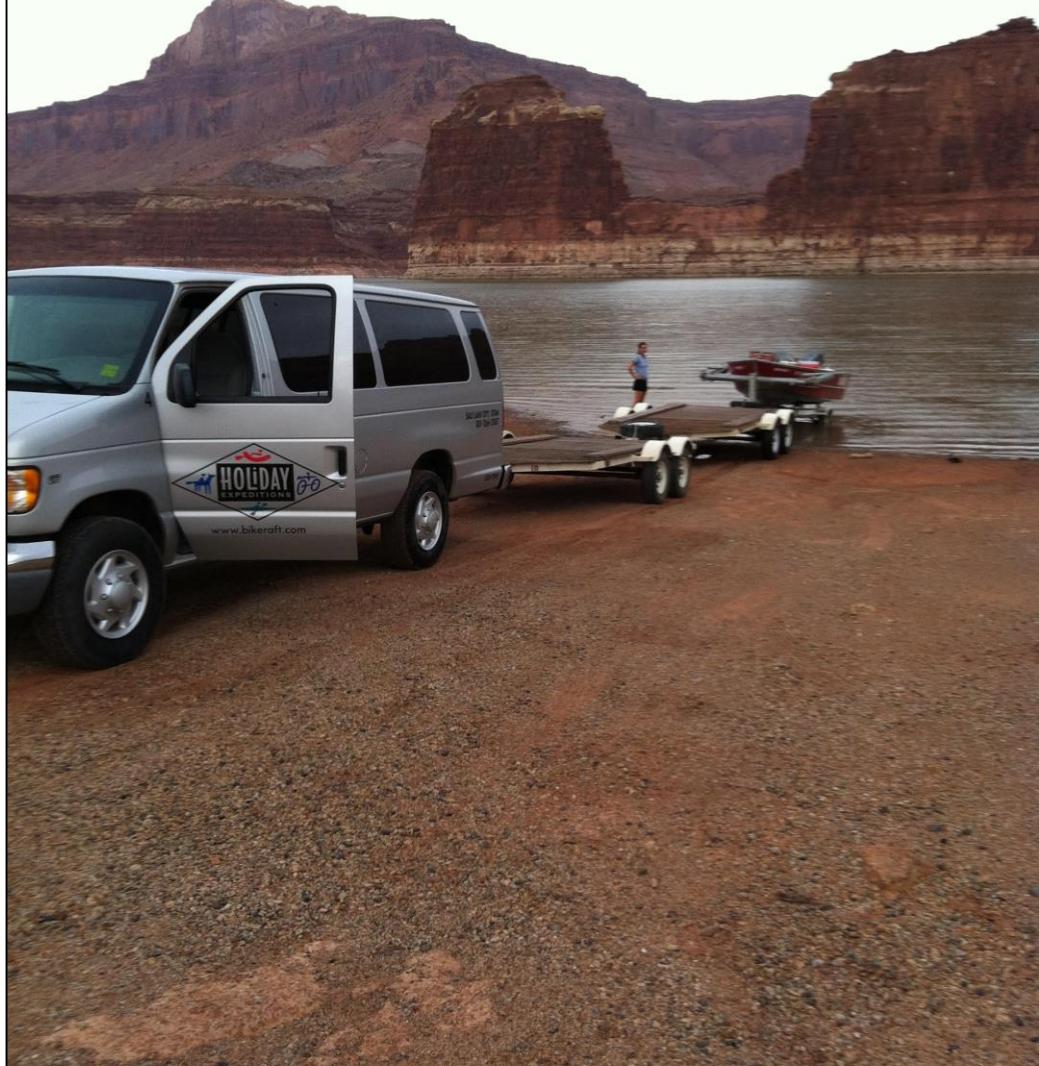
2-3 degree slope

Hite Ramp, gravel extension, triple trailer coupling to launch hard hulled craft;
Ramp slope approximately 2-3 degrees, solid substrate
Tim Gaylord

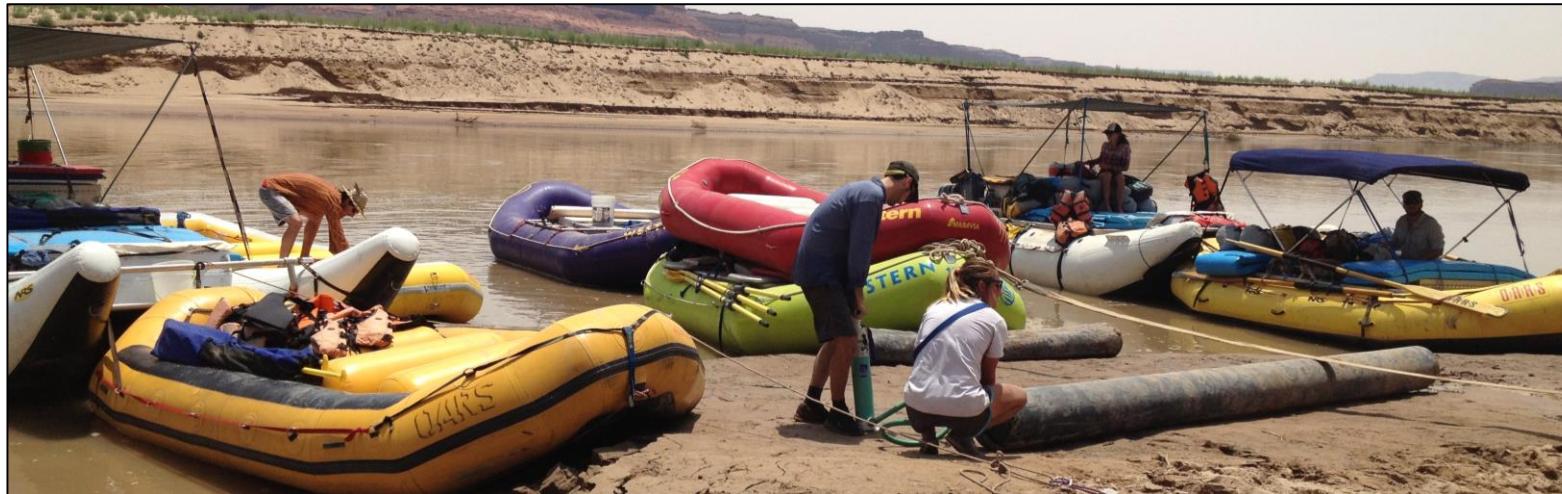
Waiting for your turn
to take out;
Tim Gaylord

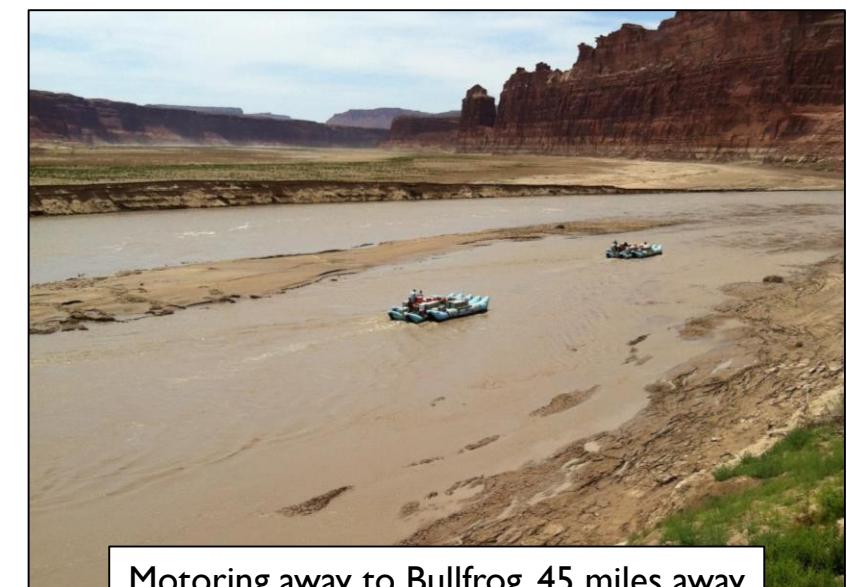
At times when the North Wash Ramp was in unusable condition for parties with larger or heavier boats, groups made a difficult decision to continue across the reservoir to take out at Bullfrog or Hall's Crossing.

Motoring away to Bullfrog, 45 miles away

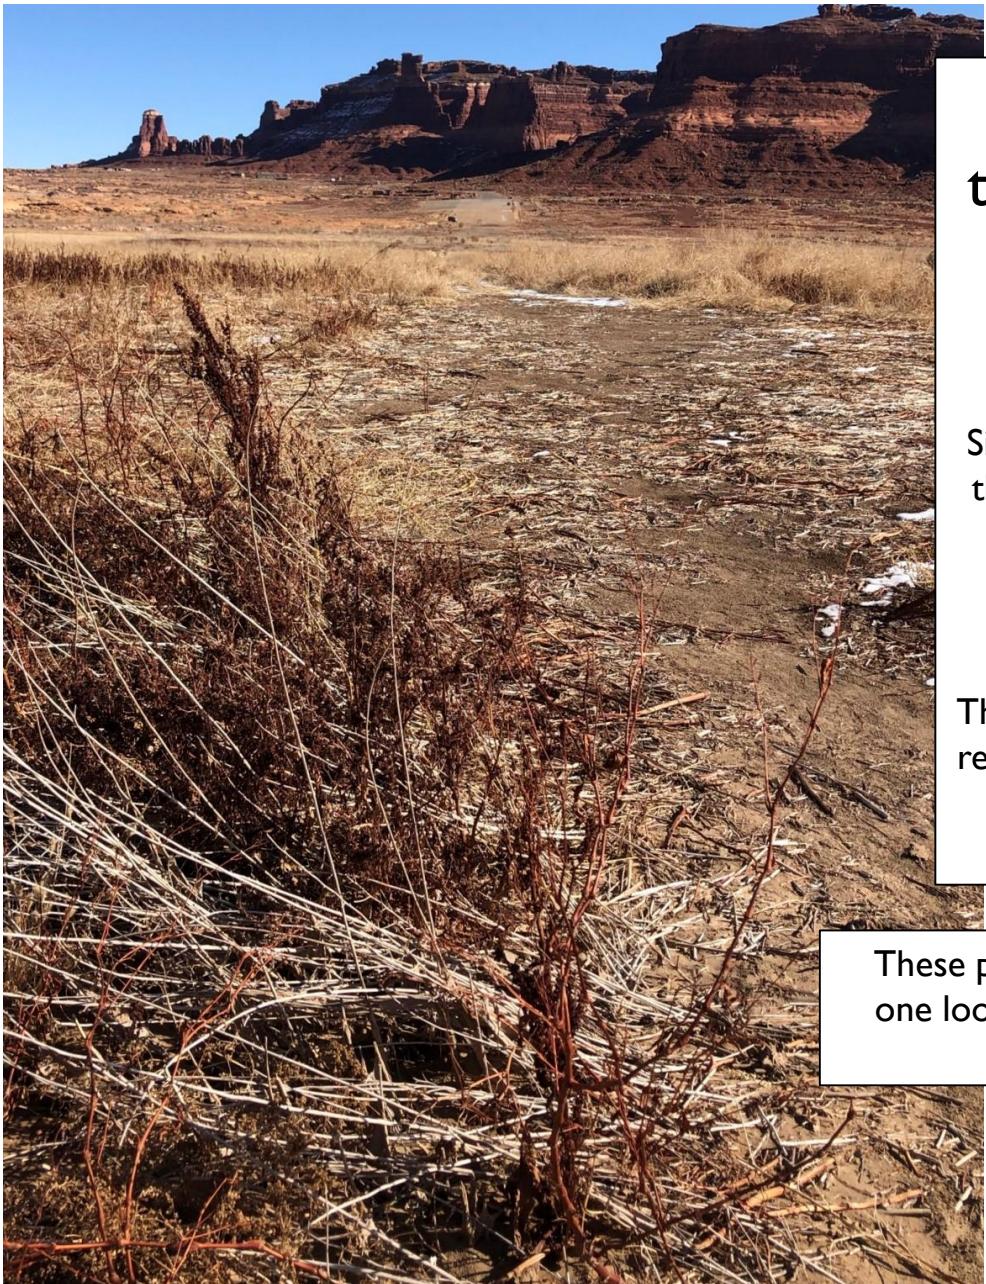
Looking back towards the end of the concrete ramp; Jan 1, 2021

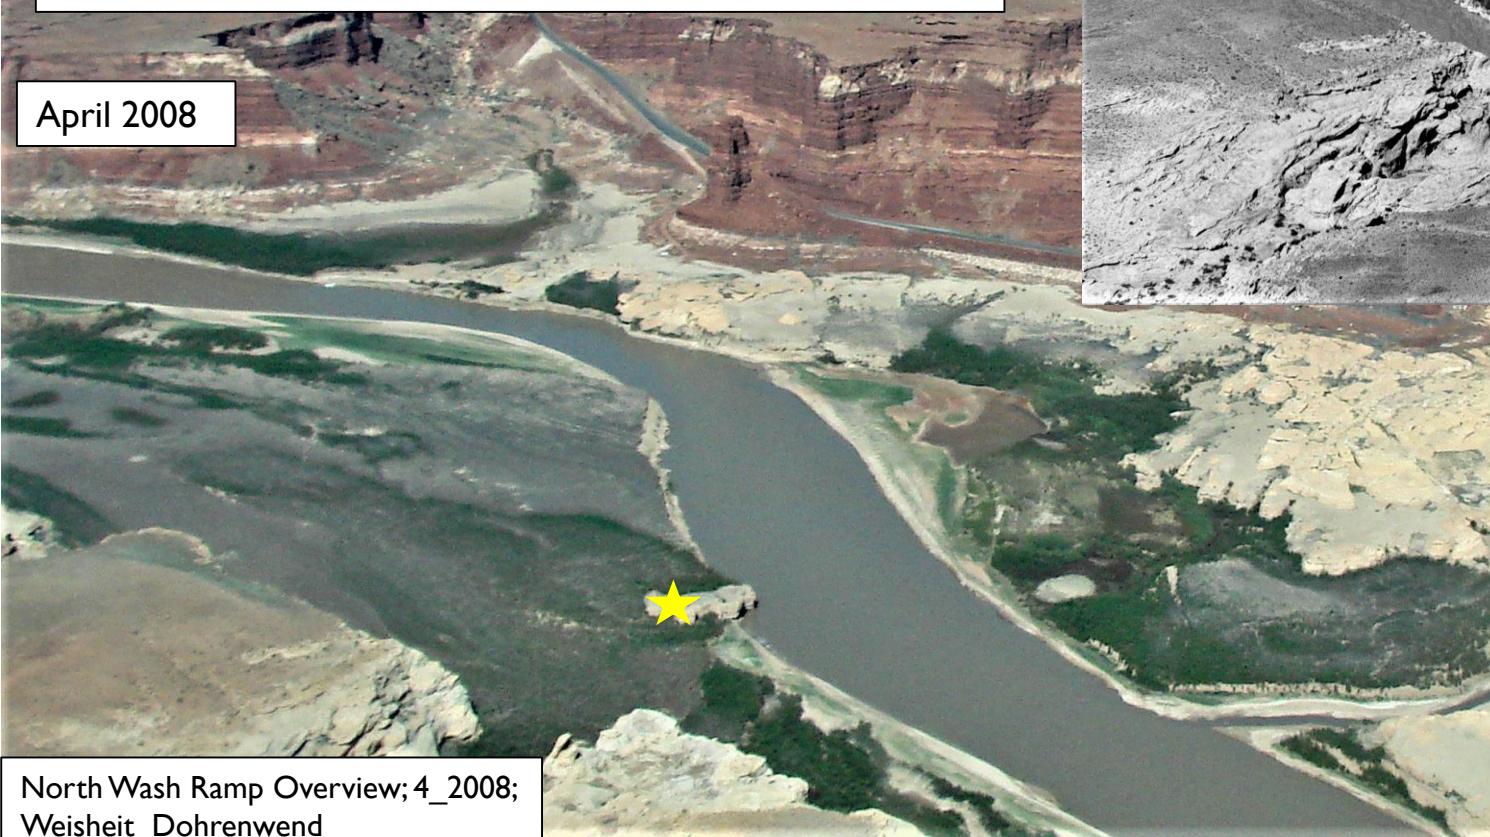
April 2008

It is currently "Perched" about 150 feet above its old channel as it flows by the current location of the North Wash Boat Ramp.

North Wash Ramp Overview; 4_2008;
Weisheit_Dohrenwend
