A Cataract Canyon Take-out

History, current issues, and factors that may influence and inform a safer, more reliable, and long term solution.

Returning Rapids Project
Moab, Utah

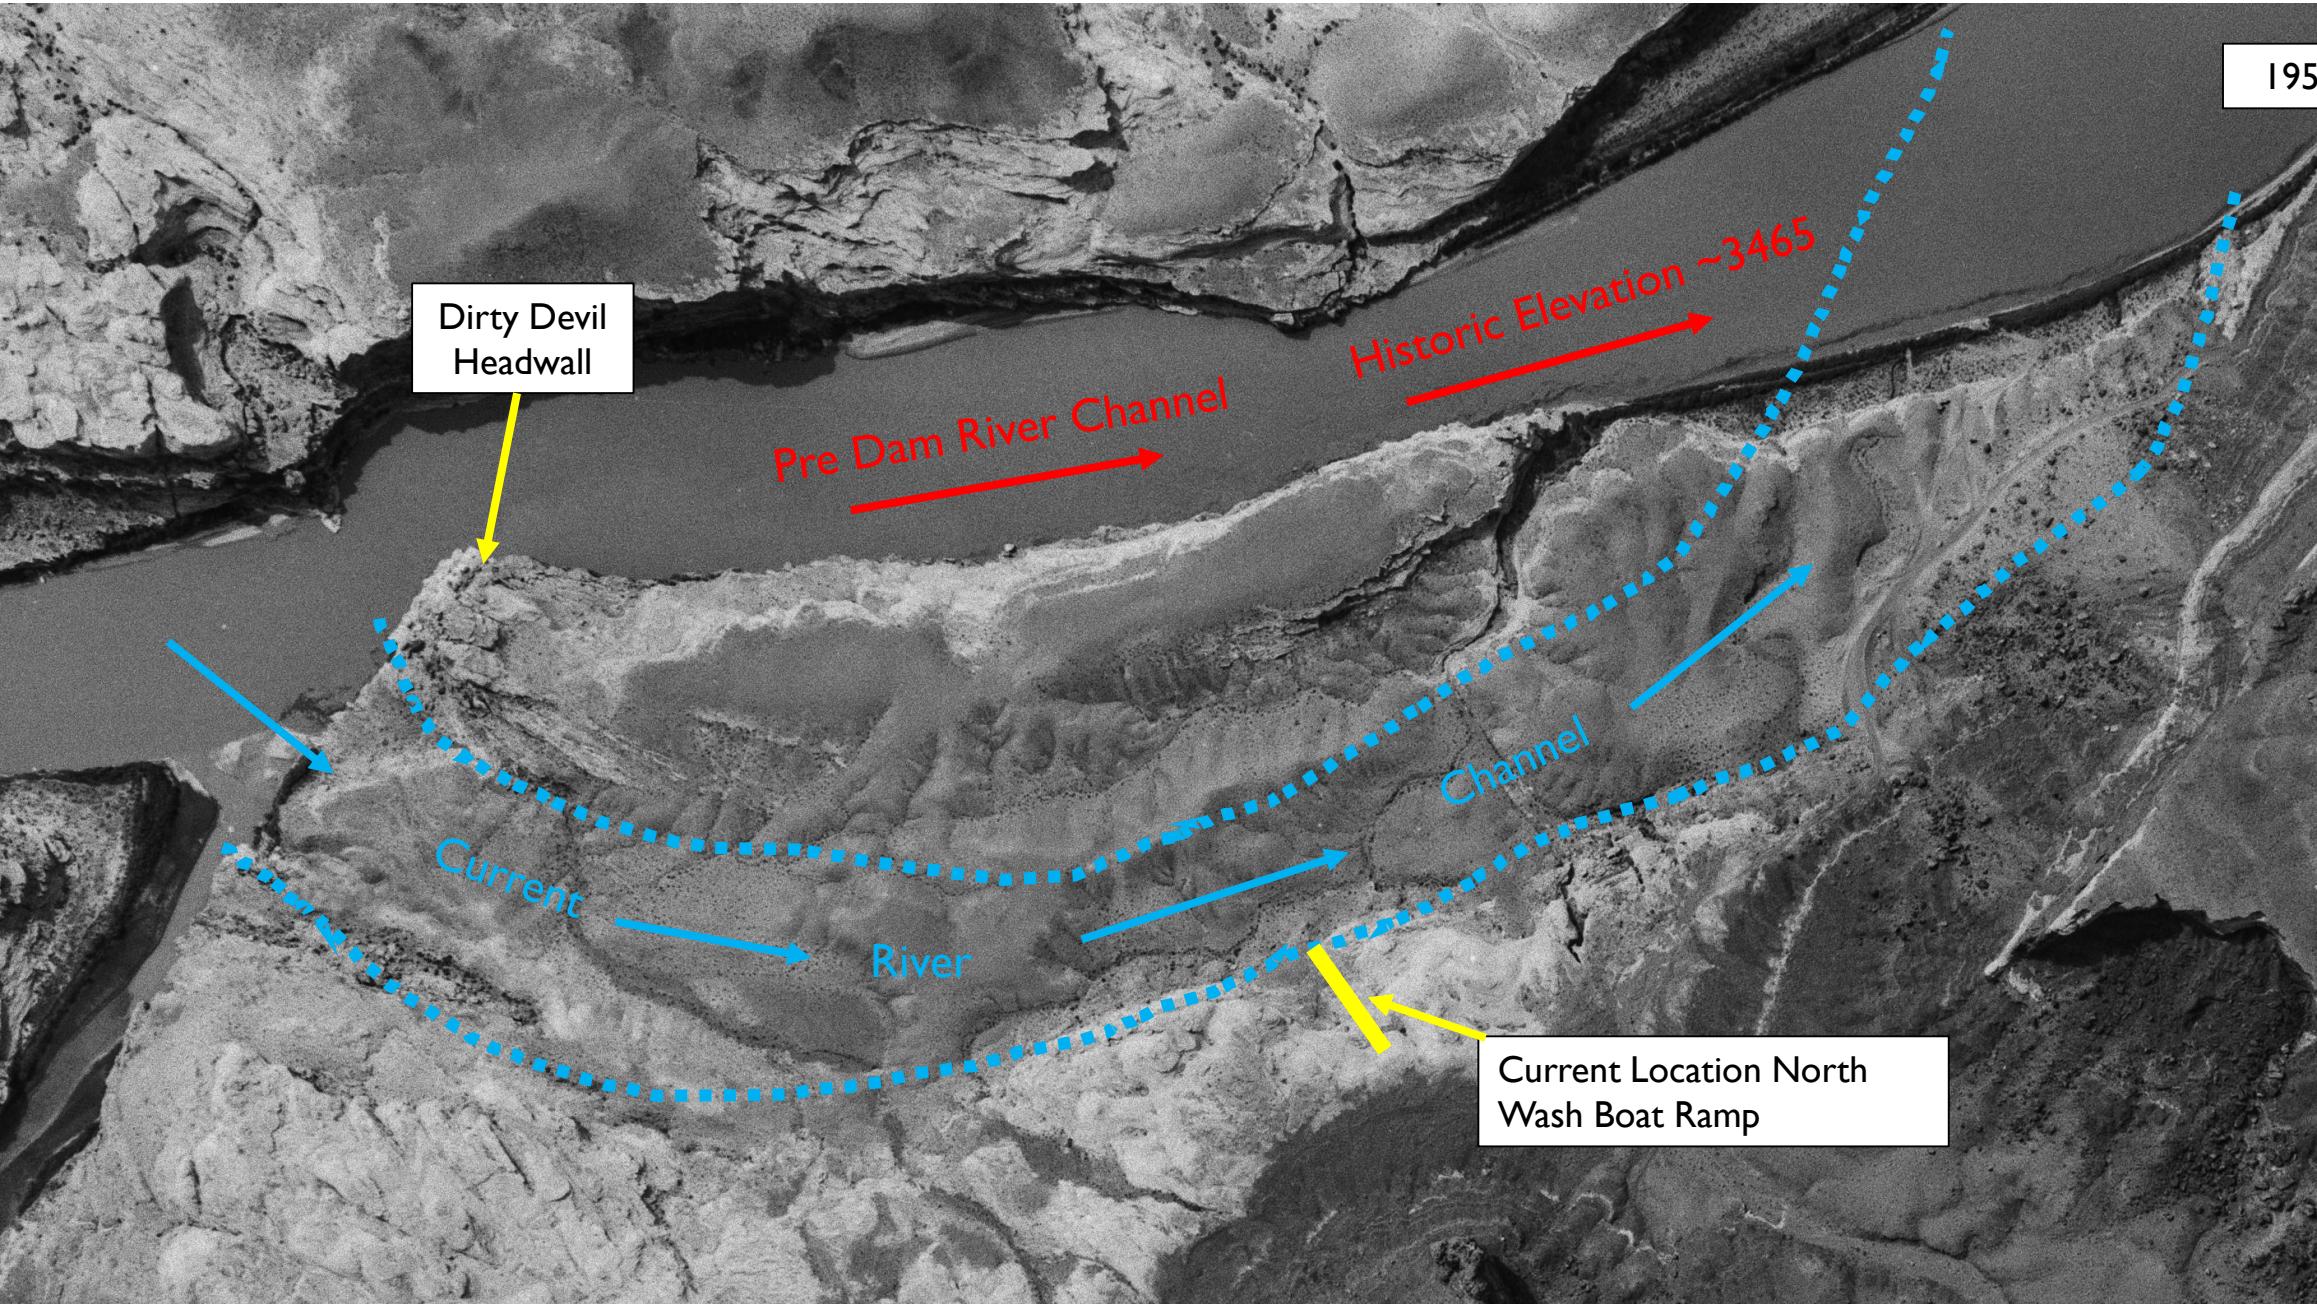
USGS Overflight Picture
August 7, 1959

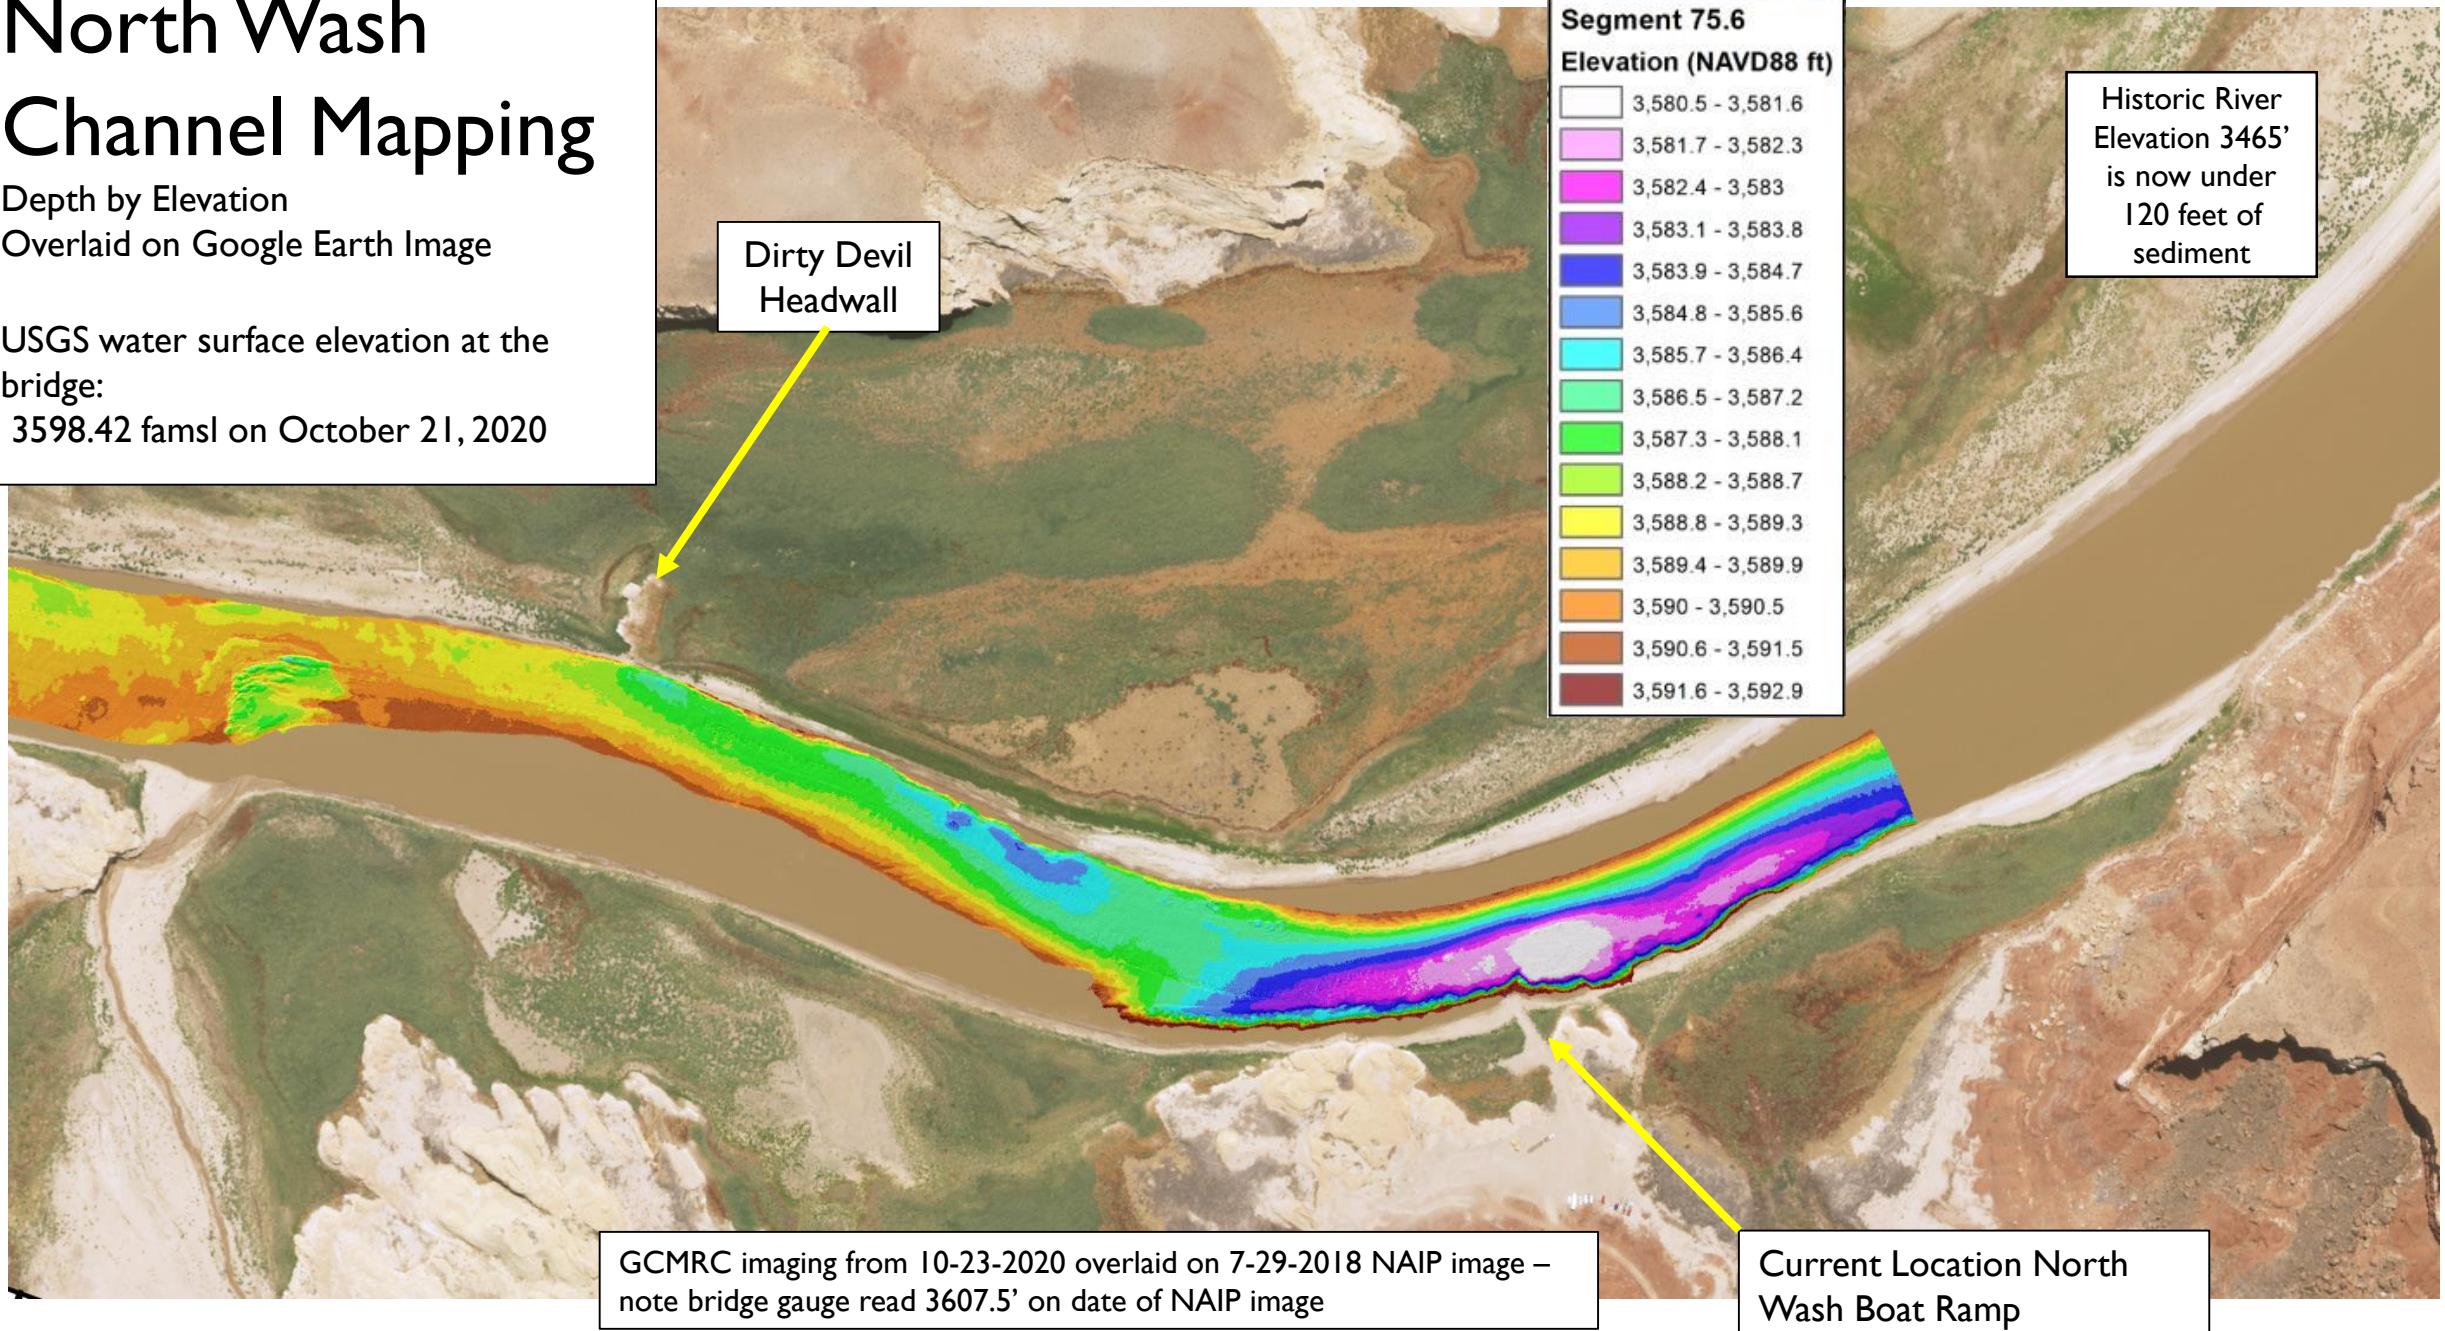
North Wash Channel Mapping

Depth by Elevation
Overlaid on Google Earth Image

USGS water surface elevation at the
bridge:
3598.42 famsl on October 21, 2020

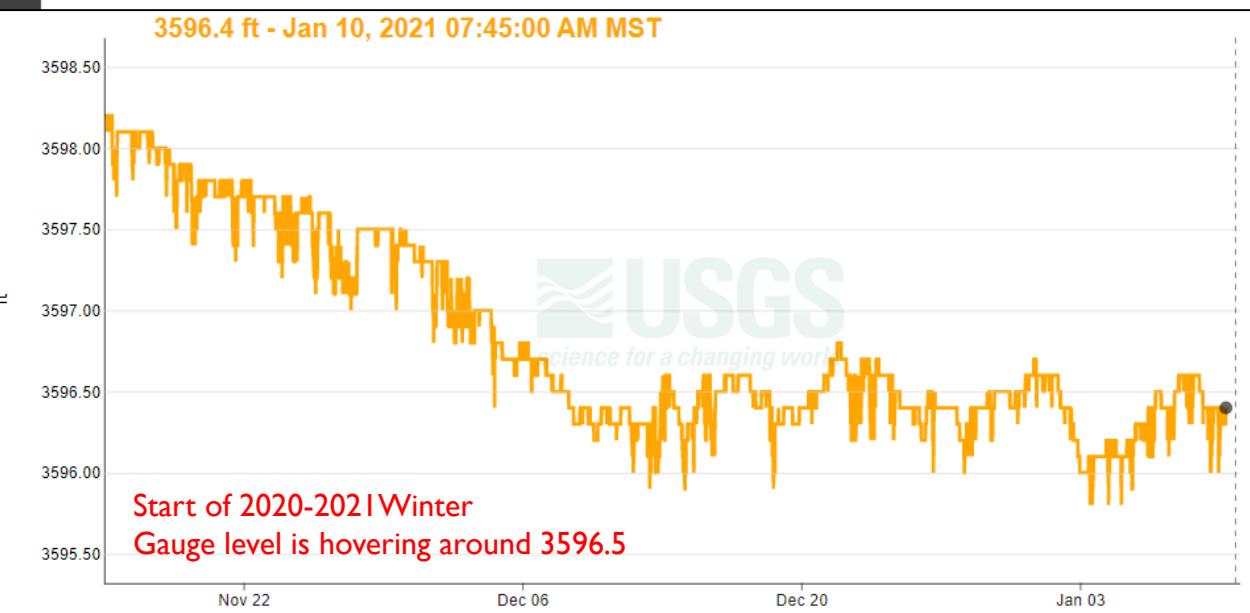
History of USGS Colorado River Bridge Gauge Near Hite and Glen Canyon Dam Winter Variances

During the winter of 2018-19 the river carved down approximately 9 feet near the Colorado Bridge near Hite.

The downcutting rate was approximately 1.5-2 feet per month.

In September of 2020 the bridge gauge and the dam gauge levels diverted and the river was flowing on its delta/ on the perched river area.

This reading of 3596 (famsl) and dropping was the lowest the USGS gauge at the Colorado River Bridge near Hite has ever recorded.

At the time of this writing, the river level at the Colorado Bridge near Hite has stopped downcutting at a rate similar to the winter of 2018-2019. This may show that the perched river could be flowing over a more erosion resistant layer.

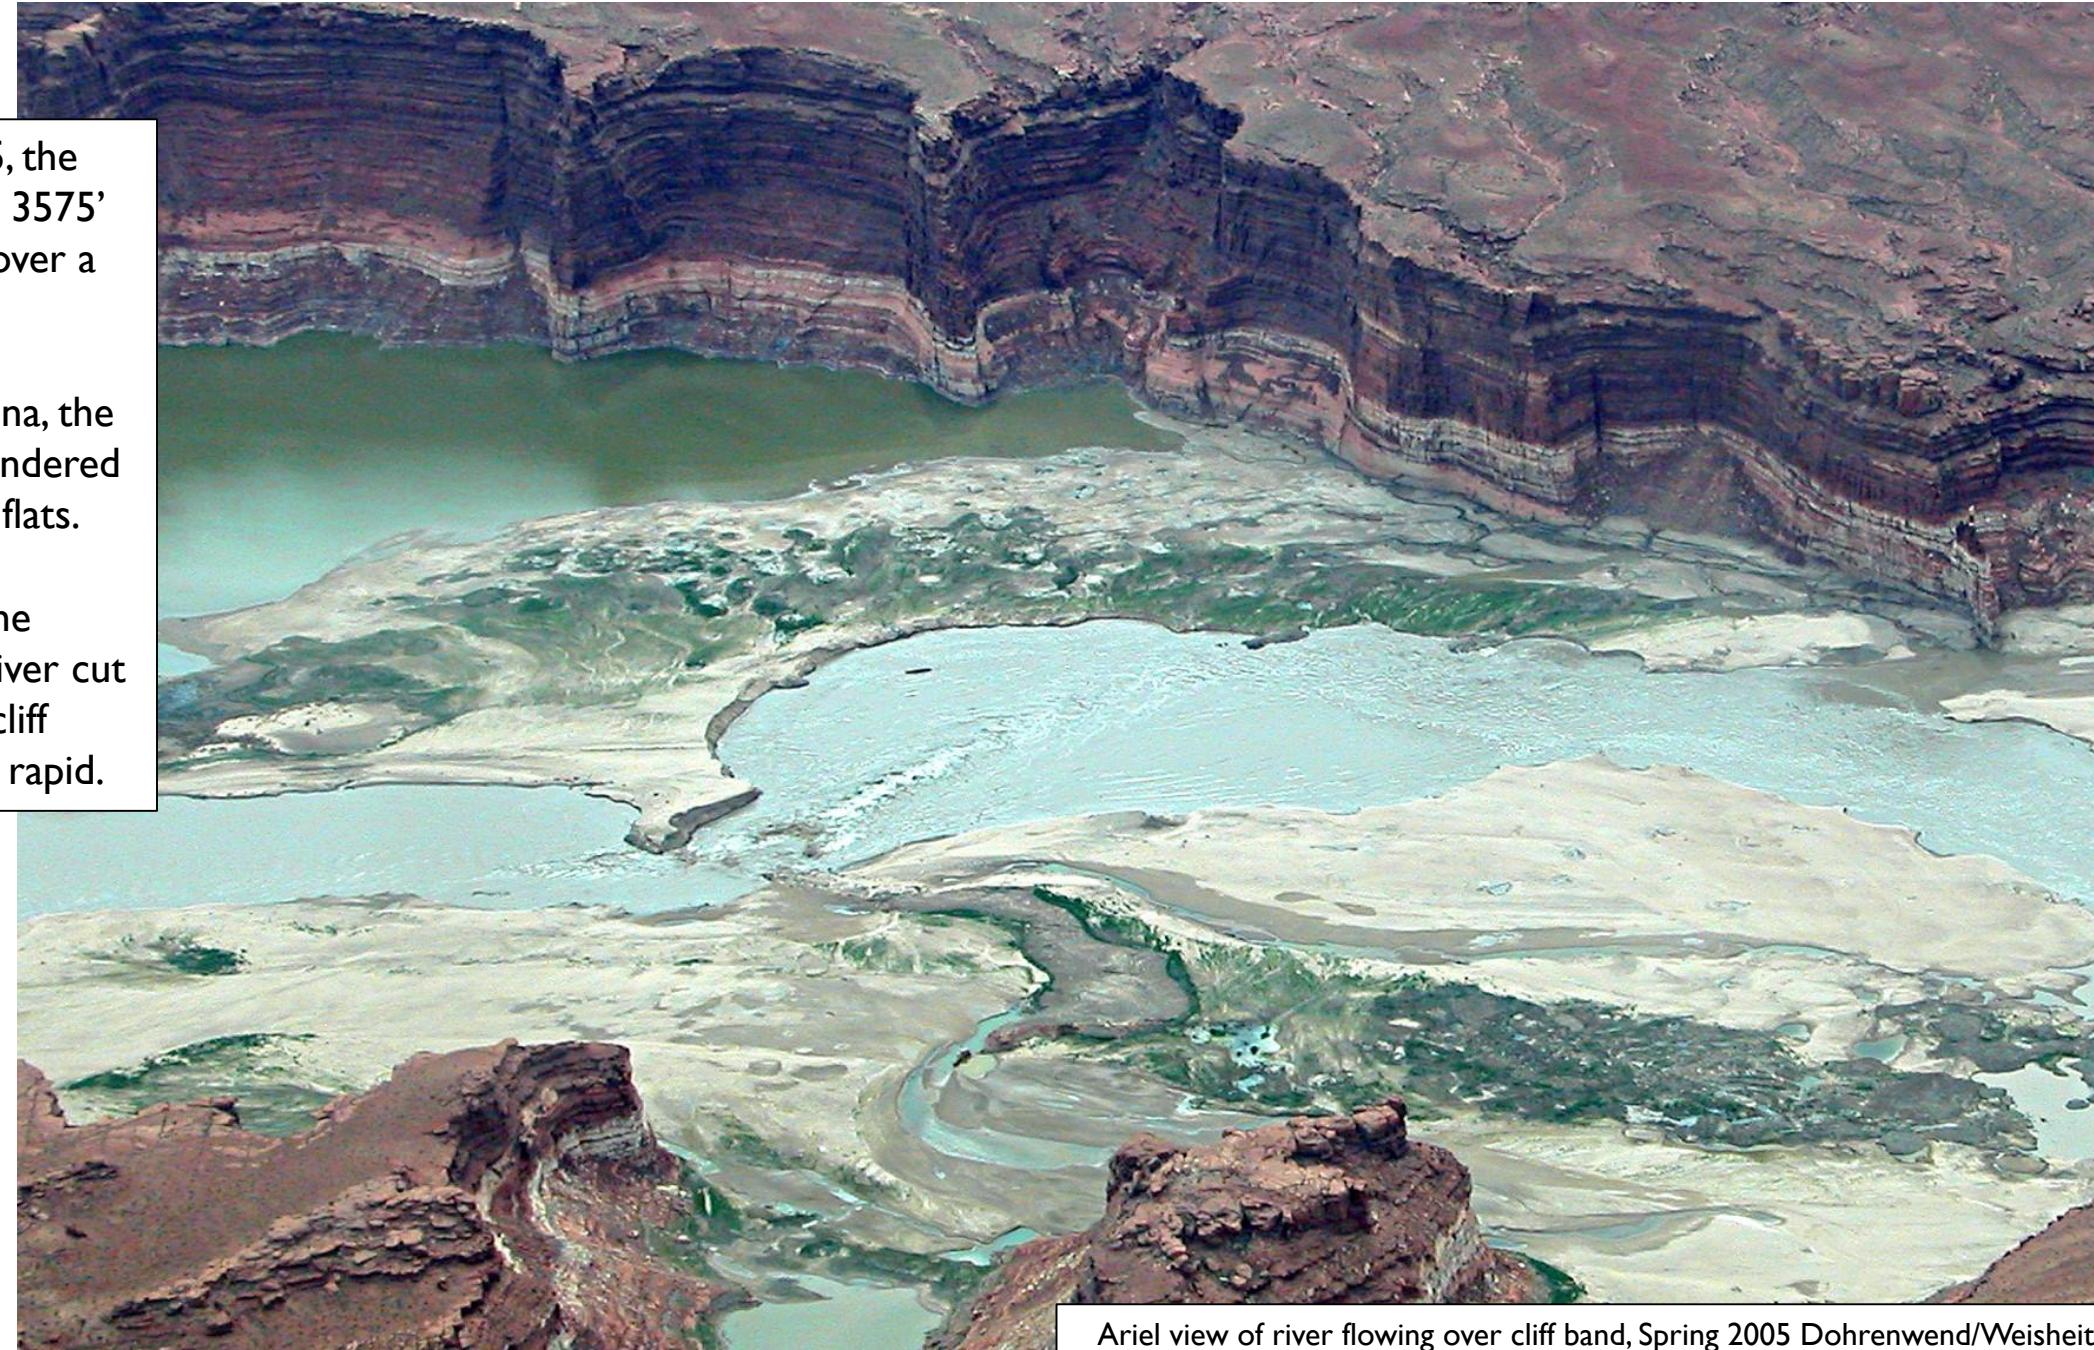
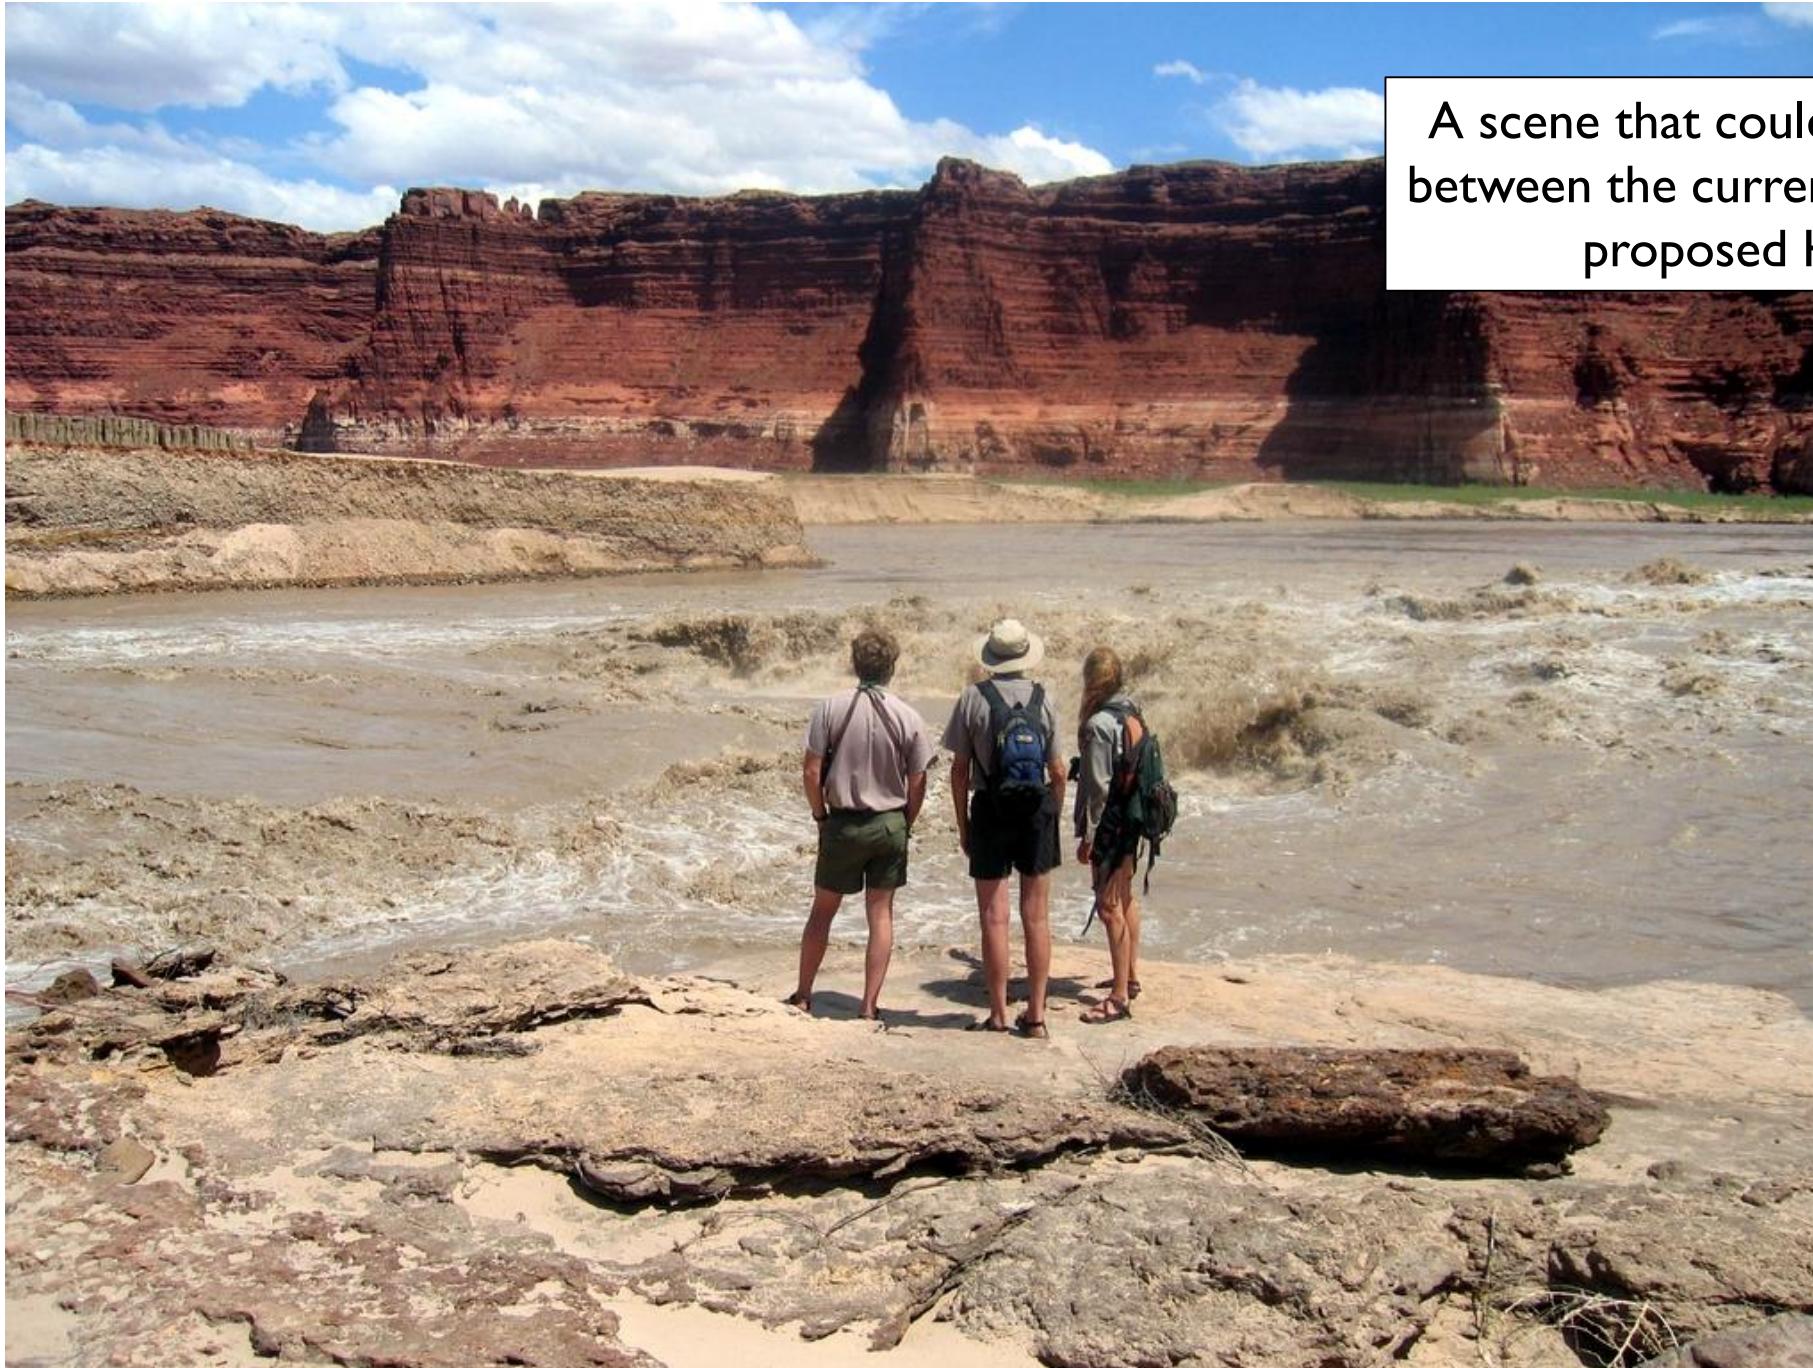
During a period in the spring of 2005, the river cut down to a bedrock cliff band, creating a new rapid.

A scene that could again take place in the area between the current North Wash Ramp and the proposed Hite Ramp Extension.

This was only a temporary feature. It disappeared as the river cut back towards its historic channel in the spring of 2005. Later that summer, as the reservoir refilled, it covered the area.

However, several parties were caught unaware by this hydraulic hazard.

Boats were flipped and lost.

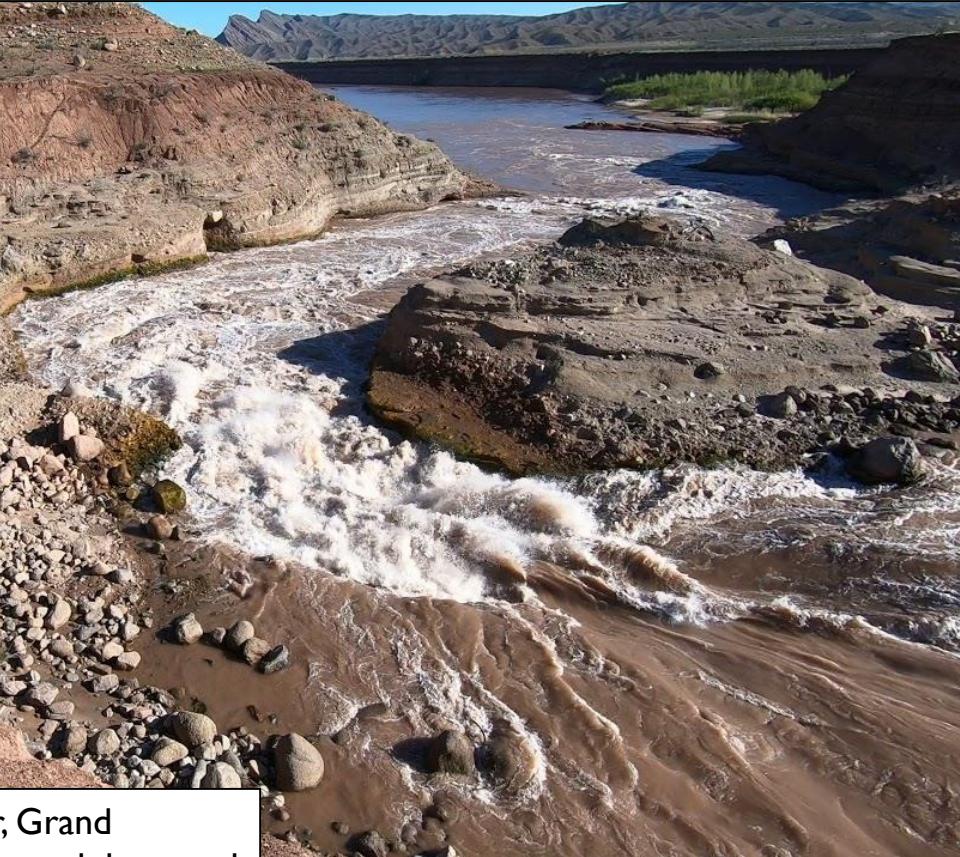
Pearce Ferry Rapid, Colorado River, Grand Canyon. River trips used to float through here and take out at South Cove on Lake Mead. A takeout had to be created upstream of this location.

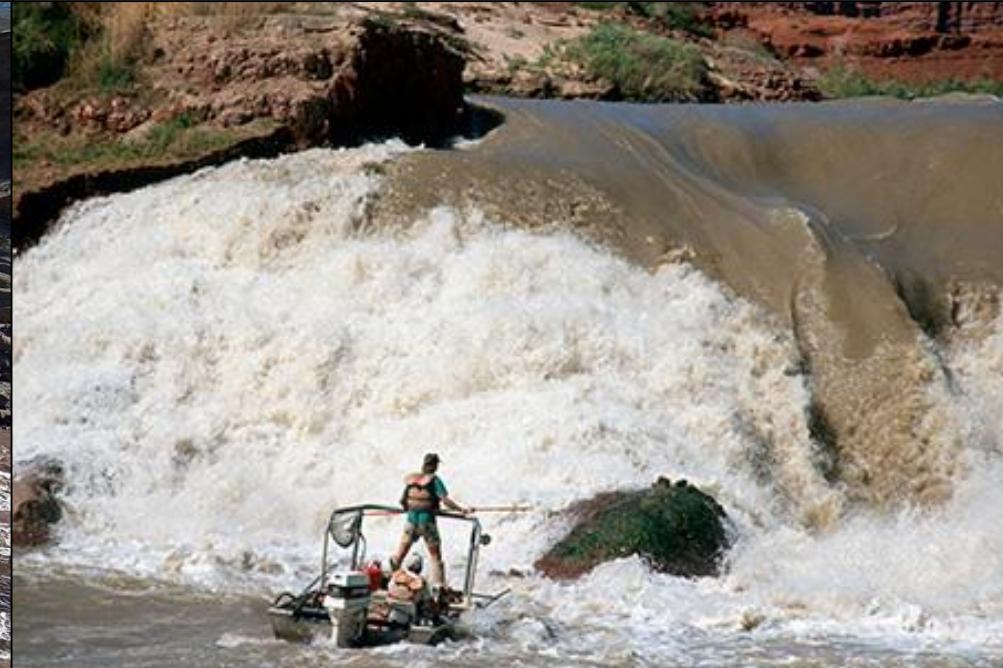
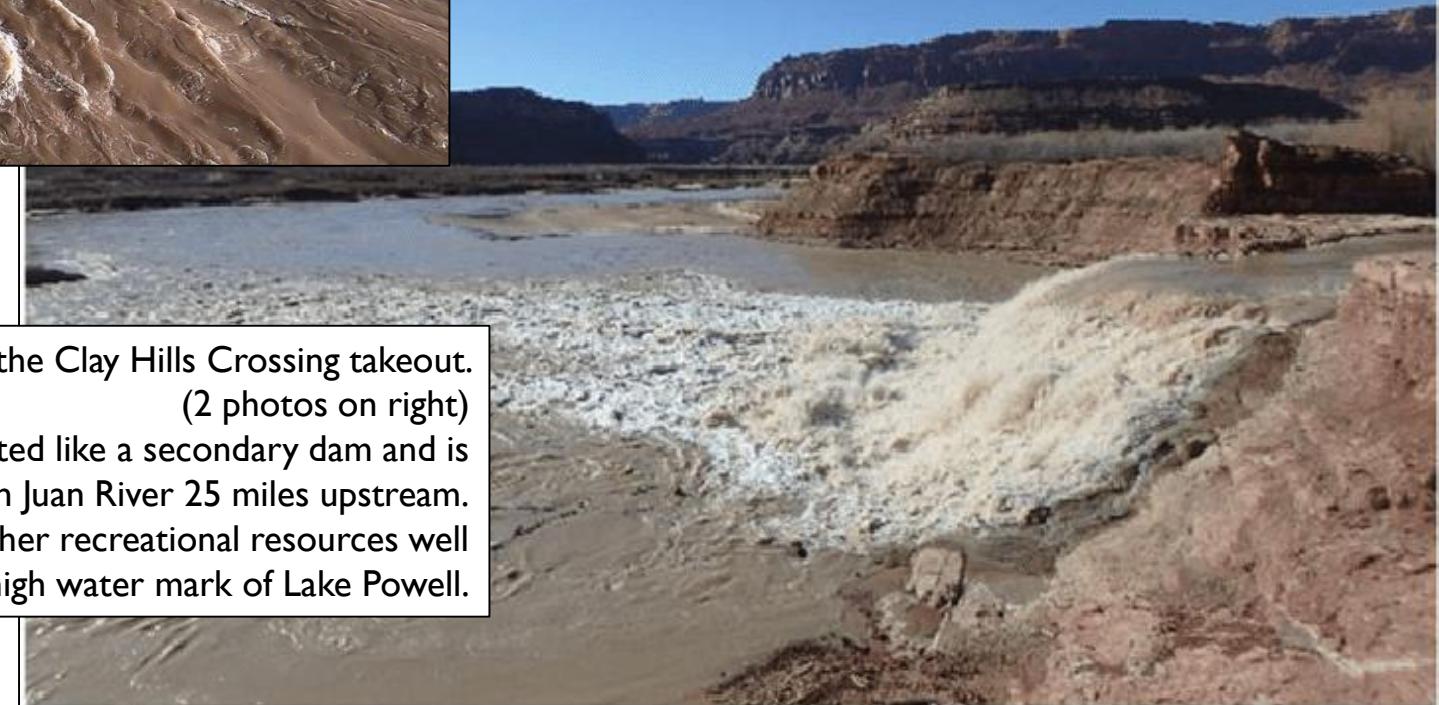
Paiute Farms Waterfall. San Juan River below the Clay Hills Crossing takeout.
(2 photos on right)

While not a well traveled section of river, this feature has acted like a secondary dam and is causing sediment aggradation on the San Juan River 25 miles upstream. This sedimentation has consumed rapids and altered other recreational resources well above the high water mark of Lake Powell.

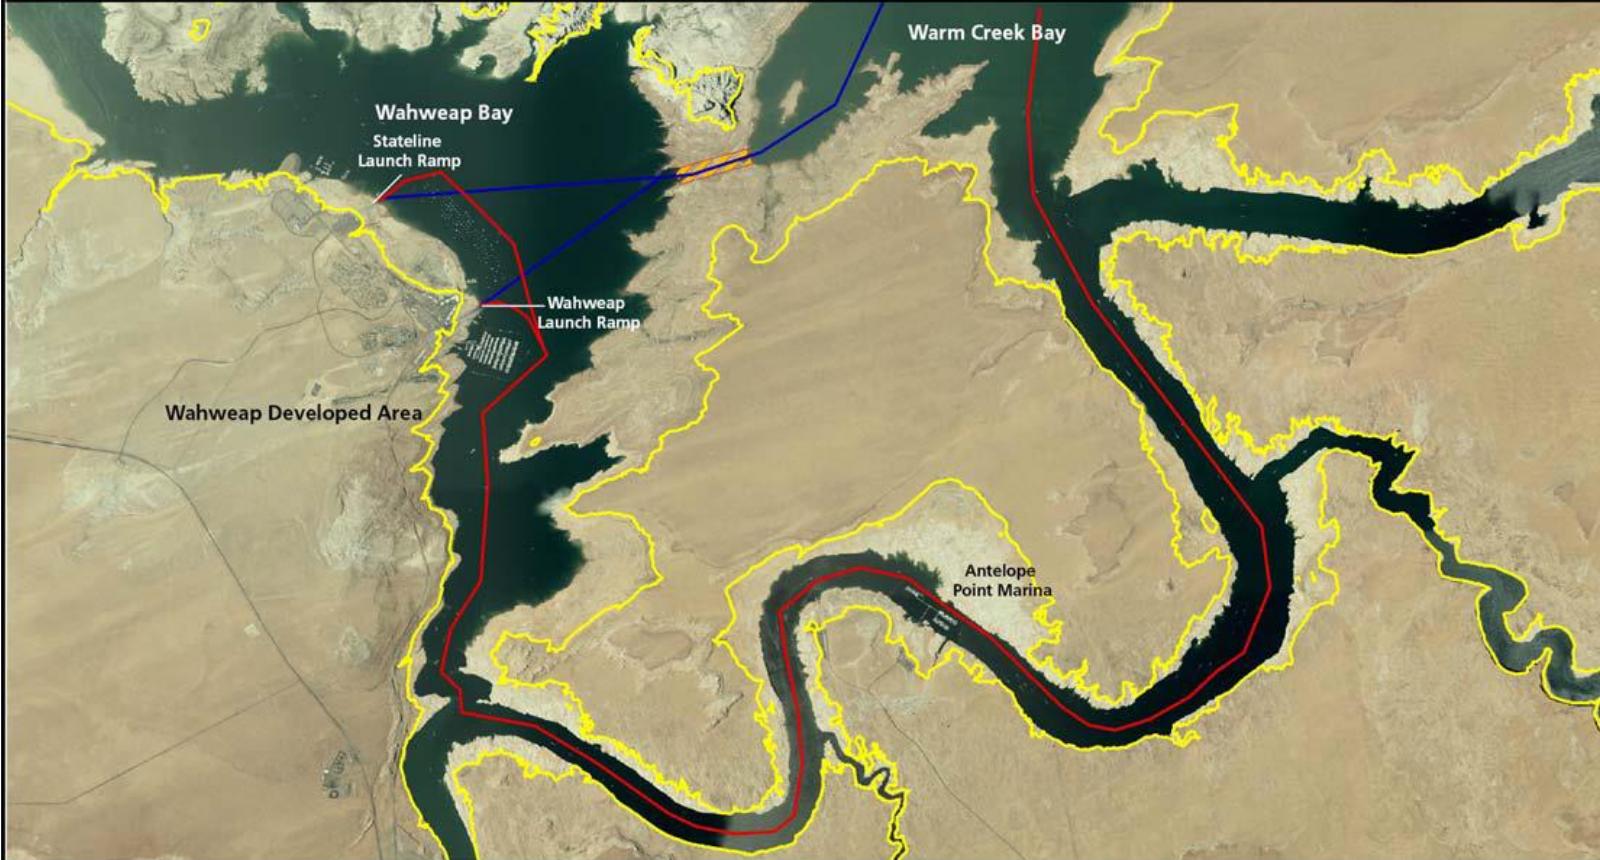
Castle Rock Dredging Project

- Shortens the “up-lake” travel for house and powerboaters by 12 miles
- Saves both time and fuel for reservoir related users

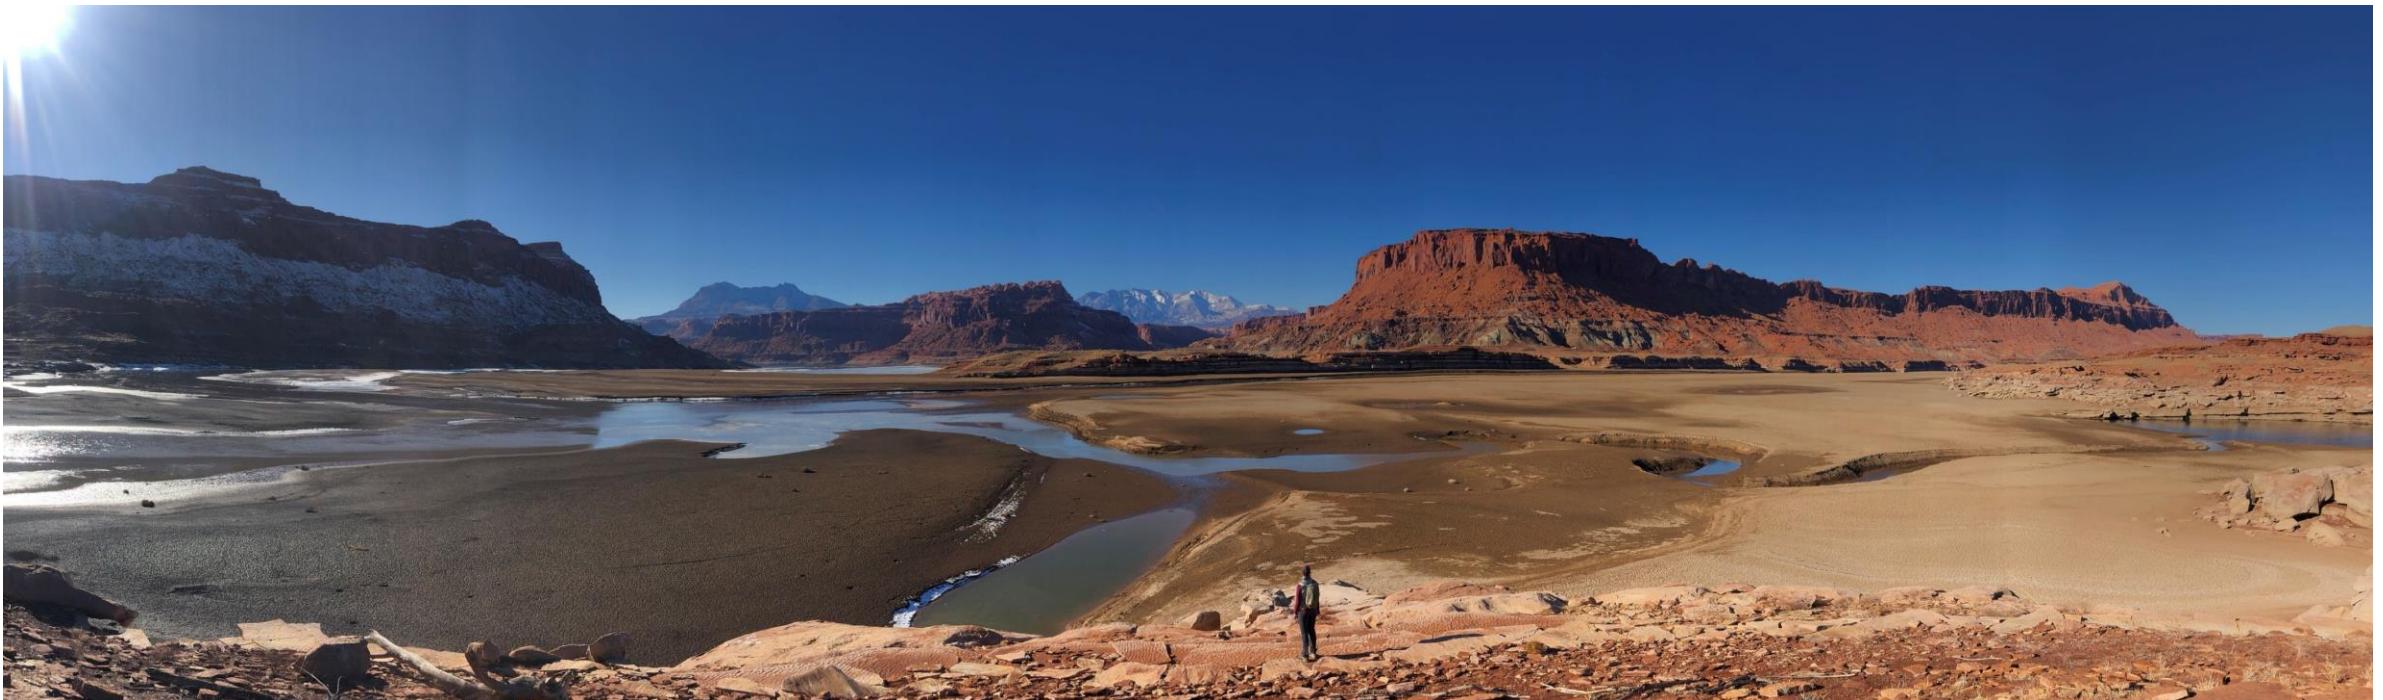
Looking out across the sediment delta near Farley/White Canyons; Jan 1, 2021
